# Listed Building Consent Supporting Statement

Property: Old Scantlings, Church Street, Shoreham-by-Sea, West Sussex, BN43 5DQ

Grade: II Listed Building

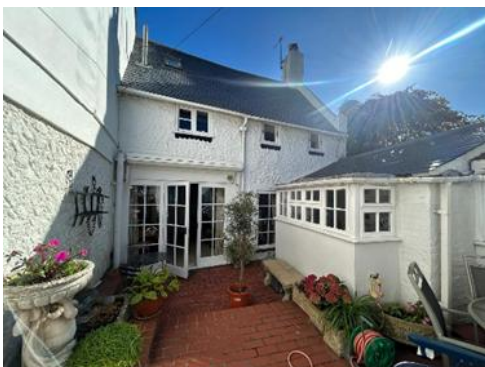
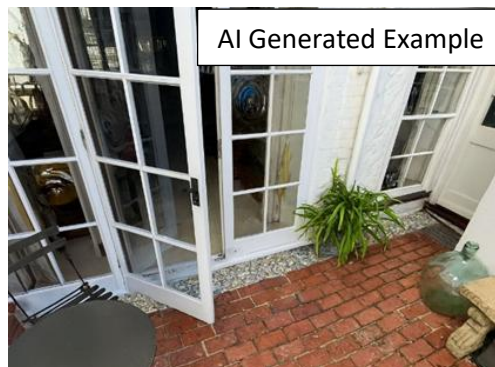
##### Rear French Drain Installation

A French drain will be installed along the rear elevation of the property in front of the former patio doors.

The installation will consist of:

- Excavation of a drainage trench adjacent to the wall
- Installation of a perforated drainage pipe wrapped in a geotextile membrane
- Backfilling with 40–50 mm aggregate or decorative stone
- Connection of the drainage pipe to the existing drainage outlet

The French drain is a fully reversible system. If it ever needs to be removed, it can be done easily without permanent alteration. The brick pavers that will be raised during installation will be carefully retained and can be re-laid at any time if required.

External ground levels at the rear of the property sit close to the internal floor level. During periods of rainfall, moisture can accumulate against the base of the wall, and there is evidence of moisture entering the solid floor.

The installation of a French drain will intercept surface water and groundwater and divert it safely away from the building. This will reduce moisture pressure on the solid floor and help protect the structure from damp conditions.

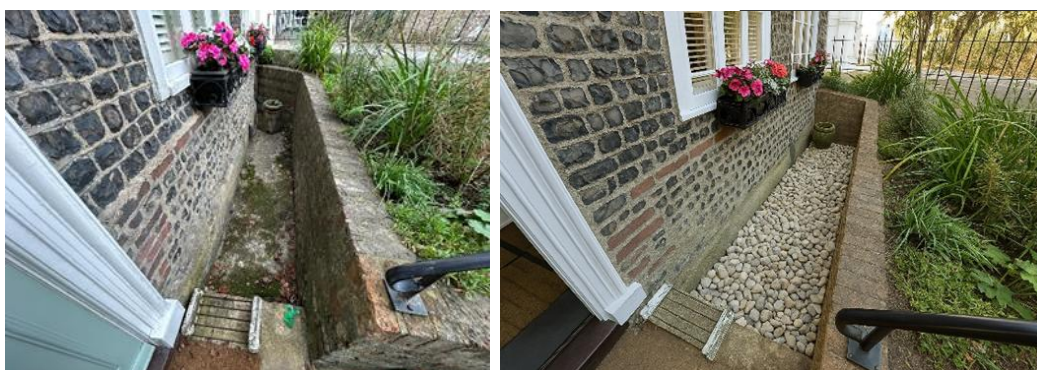
### Removal of Front Concrete Slab and Ground Finishing

The existing concrete slab at the front of the building will be removed.

Once removed:

- The underlying ground will be exposed
- A breathable weed-suppressant membrane will be installed
- The area will be finished with 40–50 mm stone aggregate

Impermeable concrete surfaces prevent ground moisture from evaporating naturally. As a result, moisture can become trapped beneath the slab and forced into the building.

Replacing the concrete with a breathable aggregate surface will allow moisture to evaporate naturally and reduce damp conditions within the structure.

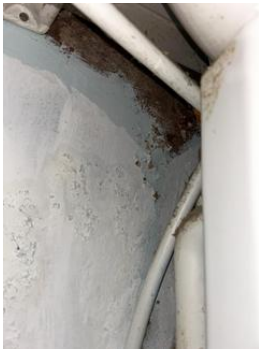
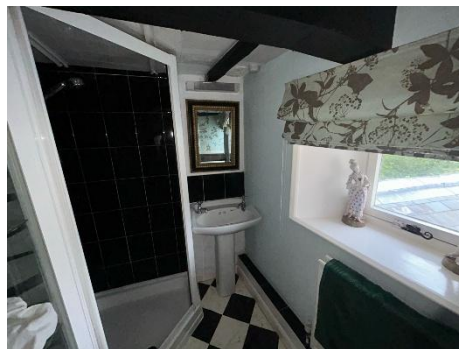
### Removal of Salt-Contaminated Plaster – Main Bedroom

Salt-contaminated modern gypsum plaster will be removed from the wall behind the sink and shower area within the main bedroom.

Once removed, the masonry will be made good and left exposed as a breathable surface.

AI Generated  
Example

Salt contamination occurs when moisture migrates through masonry and deposits salts within plaster finishes. These salts attract moisture and have caused the plaster to deteriorate.

Removing the affected plaster allows the wall to breathe and prevents repeated failure.
