Airborne Sound Insulation testing in accordance with Test Standards BS EN ISO 140-4:1998

Report Reference Number: 39276

Test Date: 31/05/2024

This report describes the test procedure and the results obtained from the pre-completion sound insulation testing at
6 Windsor Road, Worthing, BN11 2LX.

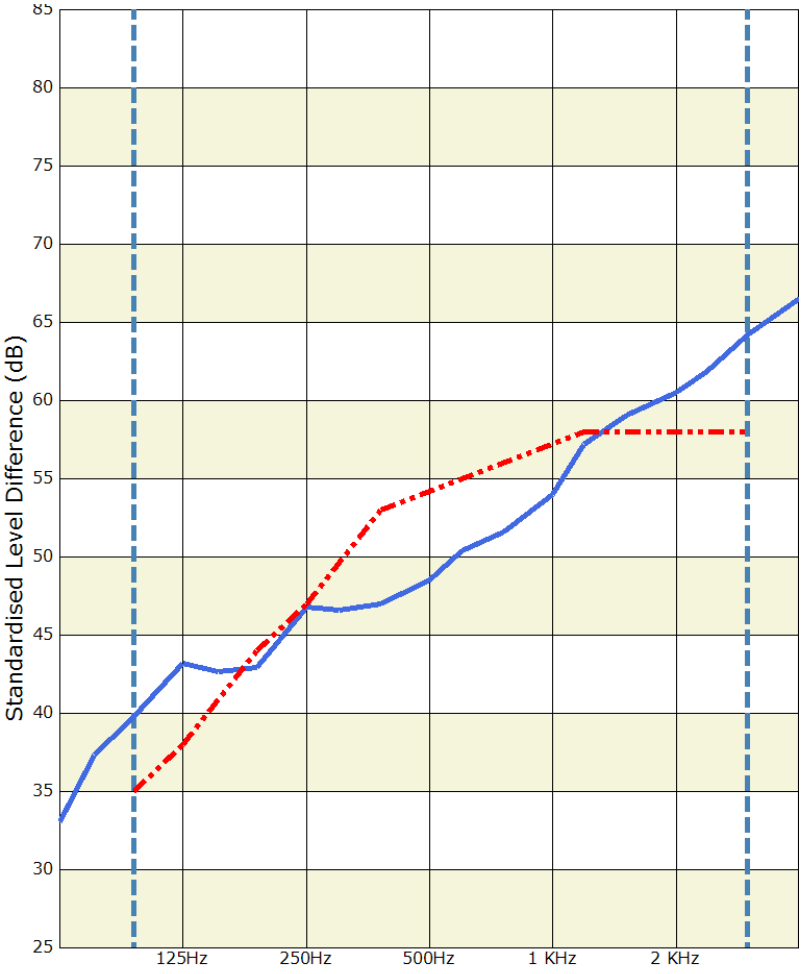
$D_{nT,w}$ (C; C_{tr}) [dB]: 54 (-1, -4) dB
$D_{nT,w}$+ C_{tr} [dB]: 50 dB
Minimum Pass Level [dB]: 43 dB

PASS
Adverse Aggregated Deviations [dB]: 29.0

Test Exceptions (if any): Source Room furnished, Receive Room furnished, 6dB Rule not met, Low background noise.
Property 8 undergoing renovation.
Property 6 and 8 occupied and furnished.
Property 8 living room furniture stored towards party wall.
Property 6 Kitchen Diner cupboards opened on party wall for testing.

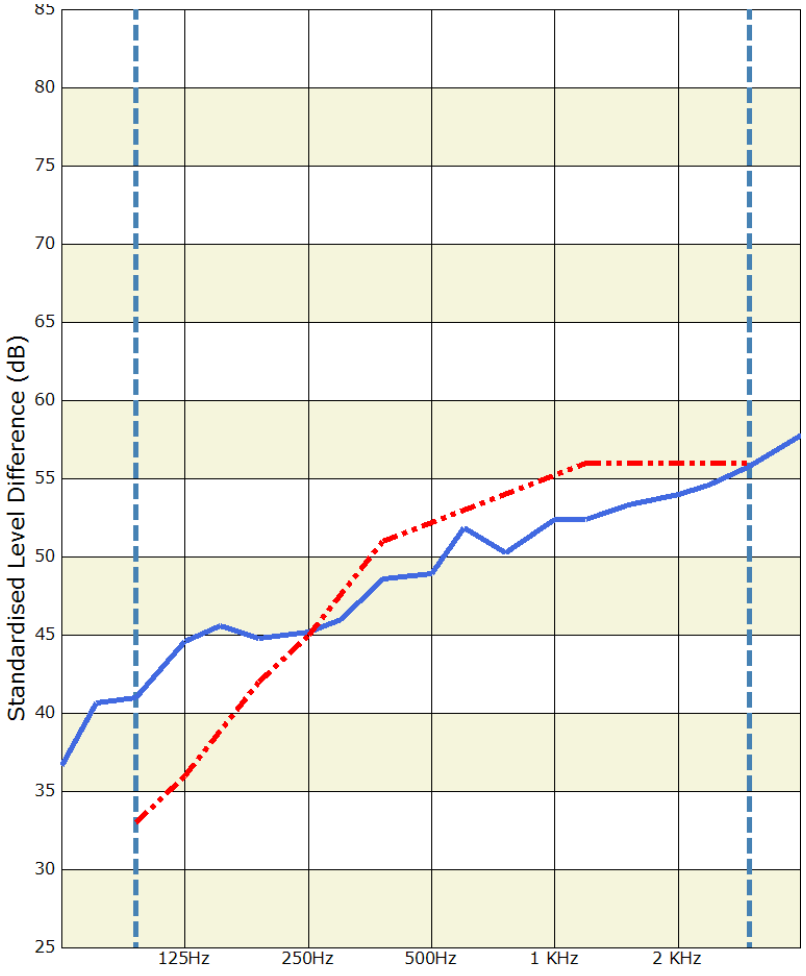
$D_{nT,w}$ (C; C_{tr}) [dB]: 52 (0, -2) dB
$D_{nT,w}$+ C_{tr} [dB]: 50 dB
Minimum Pass Level [dB]: 43 dB

PASS
Adverse Aggregated Deviations [dB]: 24.8

Test Exceptions (if any): Source Room furnished, Receive Room furnished, 6dB Rule not met, Low background noise.
Property 8 undergoing renovation.
Property 6 and 8 occupied and furnished.
Property 8 Bedroom 7 sofa on party wall.
Property 6 Bedroom 8 bed on party wall.
