Manor House Attic
Shoreham College

Additional Remedial Works - SW Room

| Scale | Job | Dwg | Rev |
|---|---|---|---|
| 1:20 @ A3 | 4094 | AL-105 | - |

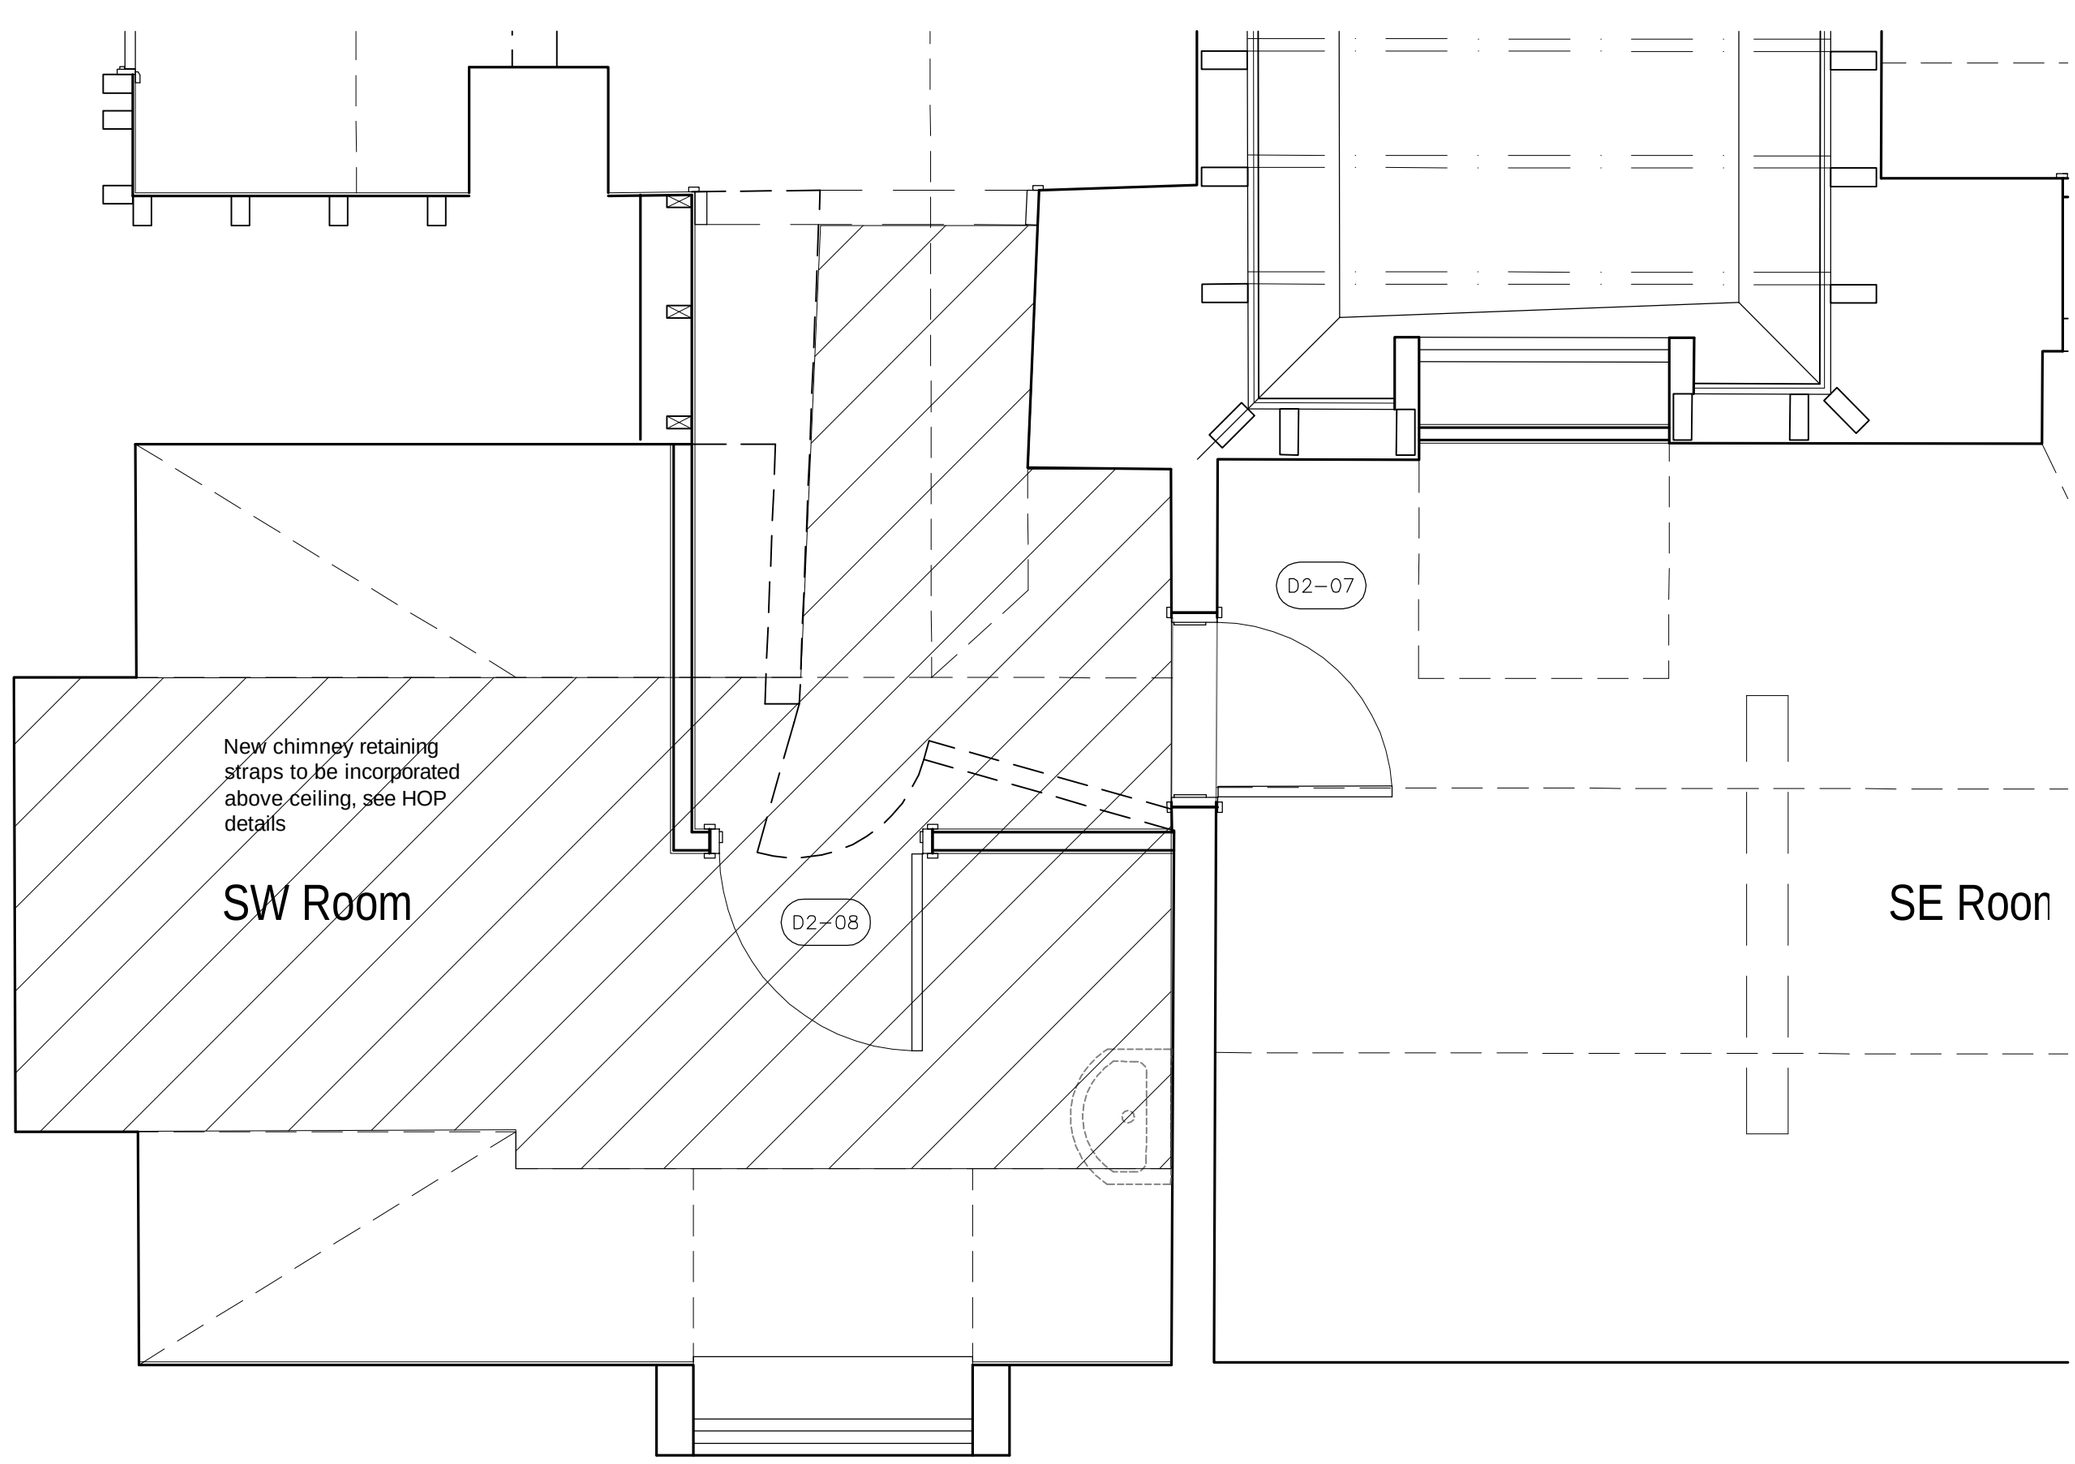
Hatched area is where modern under-boarded plasterboard ceiling which is sagging and lacking support is to be removed to assess the state of the older ceiling above.

Older ceiling above under-boards was found to be in a poor condition, missing in many places and damaged / live in the majority of the remaining areas. It is proposed to remove the remainder and replace this with a new plasterboard ceiling onto the original timber structure.
