Airborne Sound Insulation testing in accordance with Test Standards BS EN ISO 140-4:1998

Report Reference Number: 86569

This report describes the test procedure and the results obtained from the pre-completion sound insulation testing at
The Elephant in the Room, 40 Goring Road, Worthing, BN12 4AD.

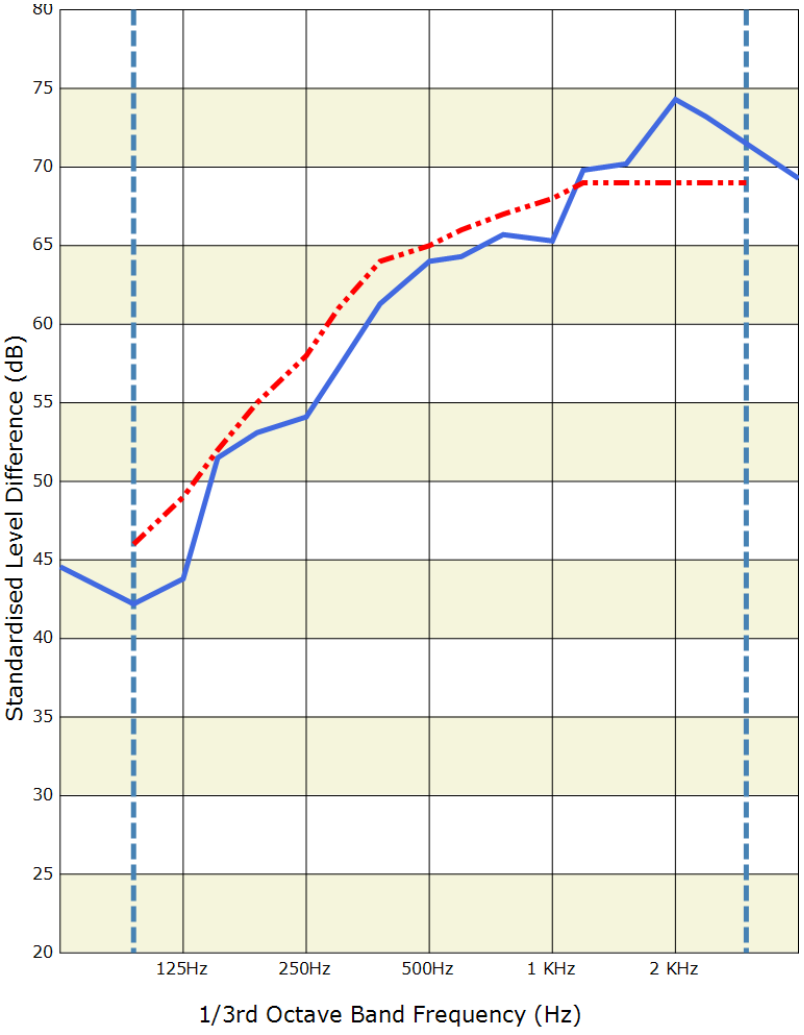
$D_{nT,w}$ (C; C_{tr}) [dB]: 65 (-2, -7) dB
$D_{nT,w}$+ C_{tr} [dB]: 58 dB
Minimum Pass Level [dB]: 43 dB

PASS
Adverse Aggregated Deviations [dB]: 28.5

Test Exceptions (if any): Source Room furnished, Receive Room furnished, 6dB Rule not met
