Drainage Verification Report

Land formerly Eastbrook Primary School, Southwick, BN42 4N

Lovell Partnerships

Ref: 11650
Date: March 2025

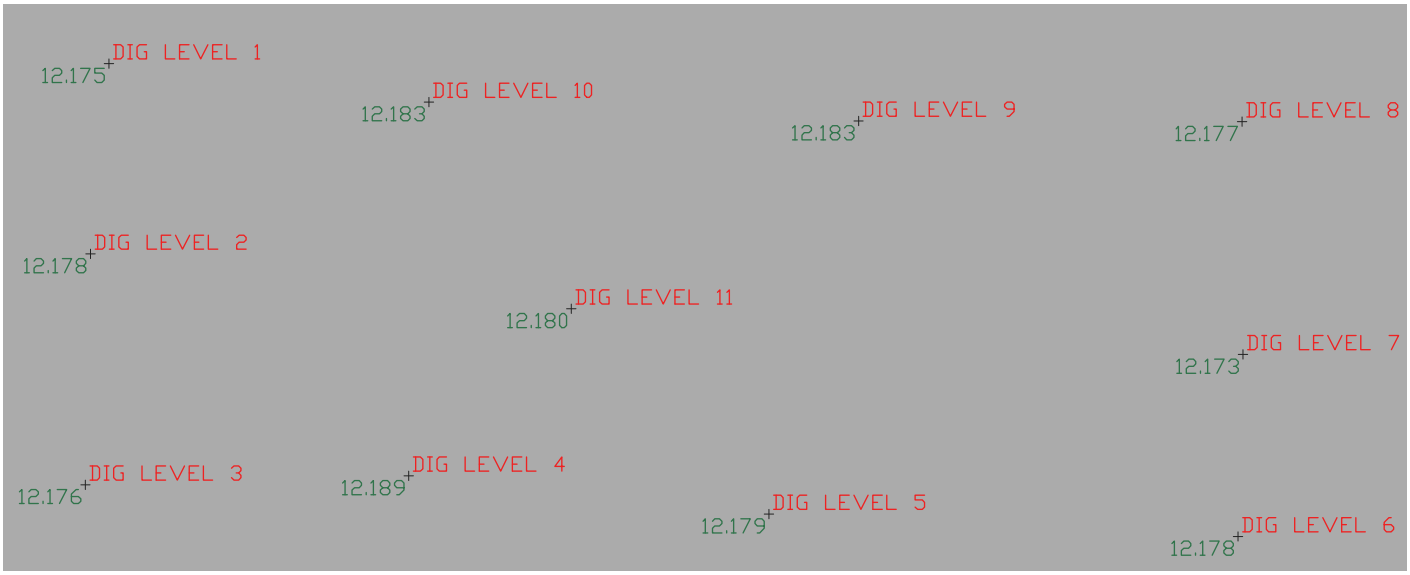
Checked Levels - Bottom of the Tank

Position	Eastings	Northing	Level
Dig Level 1	524783.753	105526.162	12.175
Dig Level 2	524783.368	105522.126	12.178
Dig Level 3	524783.257	105517.223	12.176
Dig Level 4	524790.114	105517.417	12.189
Dig Level 5	524797.759	105516.600	12.179
Dig Level 6	524807.708	105516.124	12.178
Dig Level 7	524807.807	105519.993	12.173
Dig Level 8	524807.795	105524.925	12.177
Dig Level 9	524799.658	105524.941	12.183
Dig Level 10	524790.544	105525.348	12.183
Dig Level 11	524793.564	105520.954	12.18

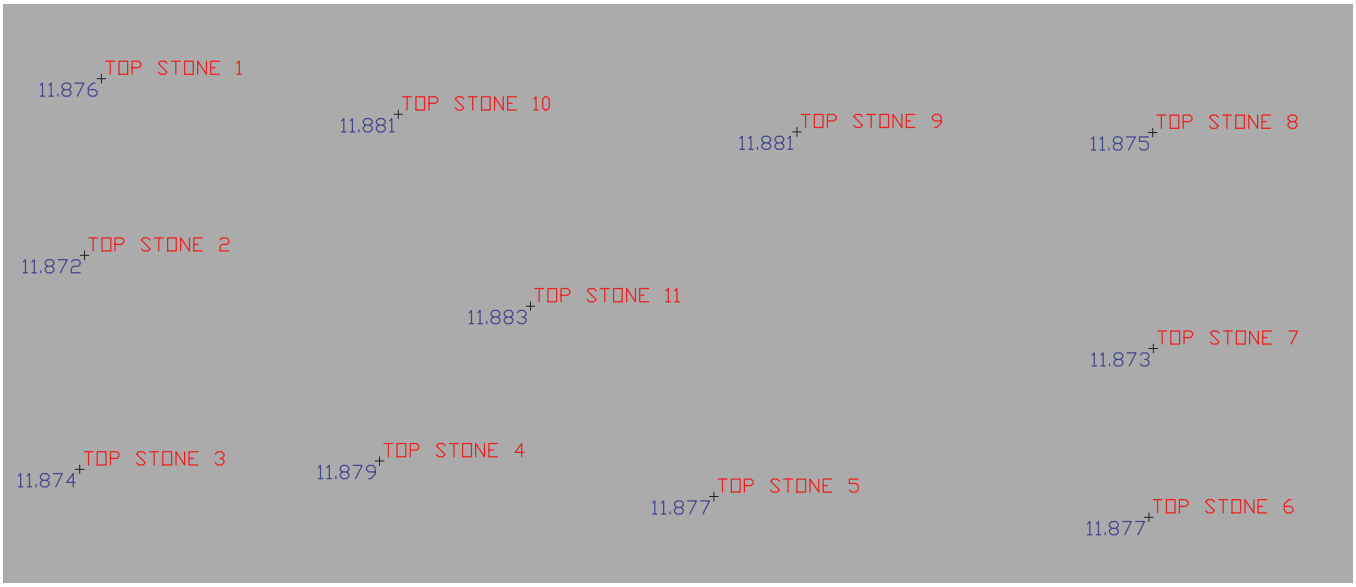
Checked Levels - Top of the Granular Base

Position	Eastings	Northing	Level
Top Stone 1	524783.751	105526.160	11.876
Top Stone 2	524783.363	105522.121	11.872
Top Stone 3	524783.254	105517.226	11.874
Top Stone 4	524790.111	105517.414	11.879
Top Stone 5	524797.756	105516.603	11.877
Top Stone 6	524807.705	105516.129	11.877
Top Stone 7	524807.809	105519.990	11.873
Top Stone 8	524807.792	105524.927	11.875
Top Stone 9	524799.655	105524.944	11.881
Top Stone 10	524790.541	105525.345	11.881
Top Stone 11	524793.562	105520.958	11.883

Design Level = 11.875m

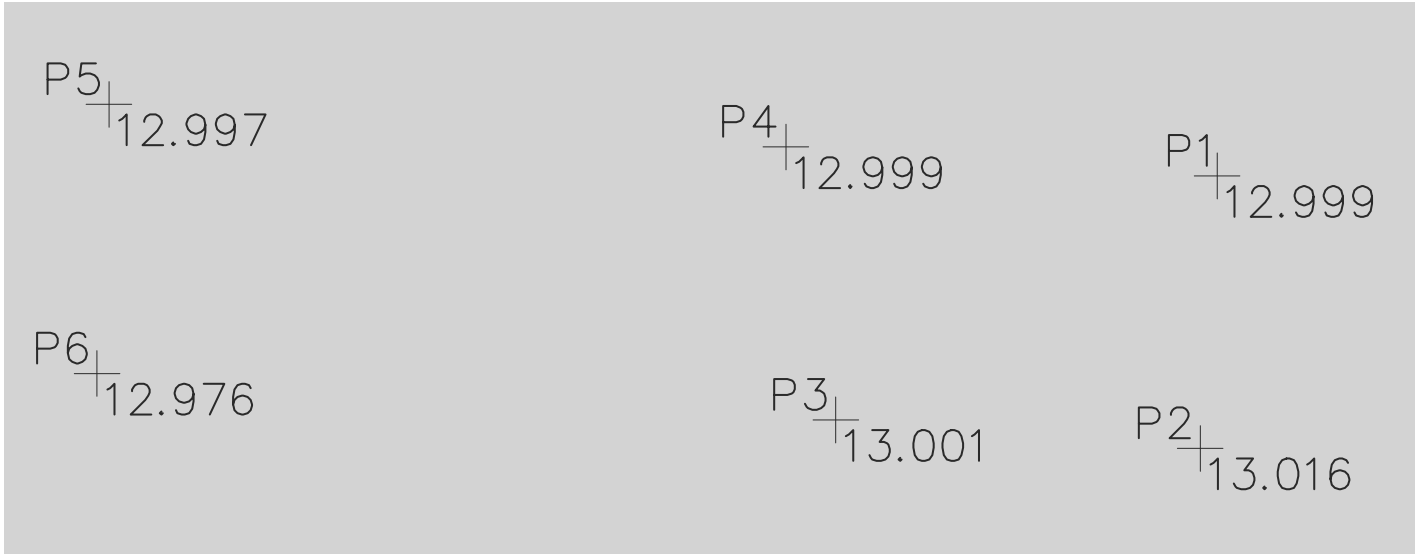
Checked Levels - Top of the Crates

Position	Easting	Northing	Level
P1	524816.346	105523.563	12.999
P2	524815.852	105515.580	13.016
P3	524805.171	105516.414	13.001
P4	524803.711	105524.410	12.999
P5	524783.877	105525.661	12.997
P6	524783.526	105517.771	12.976

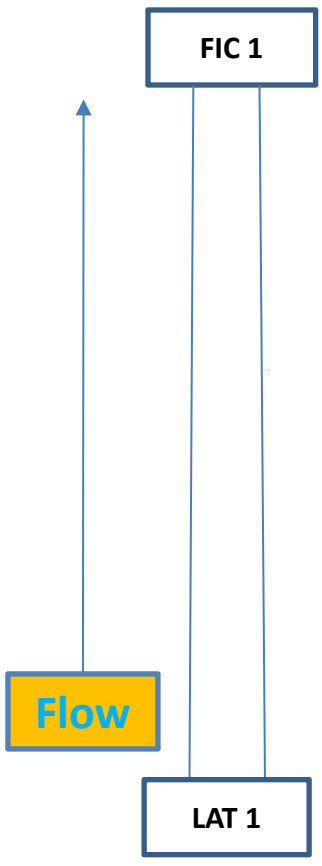
Position	Code	Observation
0.0M	ST	Start Of Survey
0.0M	WL	Water Level 0 %
0.9M	LR	Line Turns Right
1.7M	LL	Line Turns Left
5.9M	LU	Line Turns Up

REM ; THERE ARE NO DEFECTS WITH THIS SECTION OF PIPE

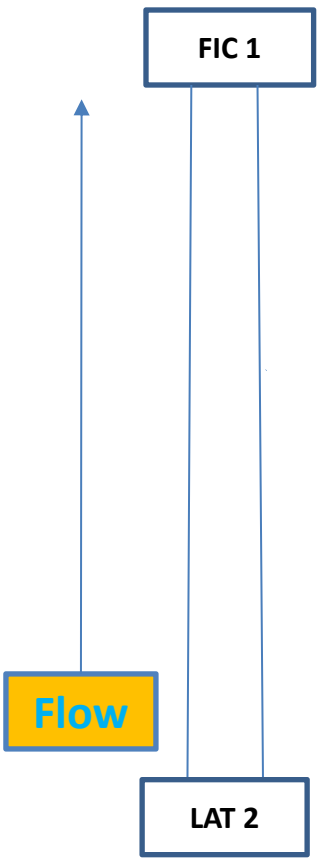
Position	Code	Observation
0.0M	ST	Start Of Survey
0.0M	WL	Water Level 0 %
7.9M	JN	Line Drops In From The Right
10.0M	LU	Line Turns Up

REM ; THERE ARE NO DEFECTS WITH THIS SECTION OF PIPE

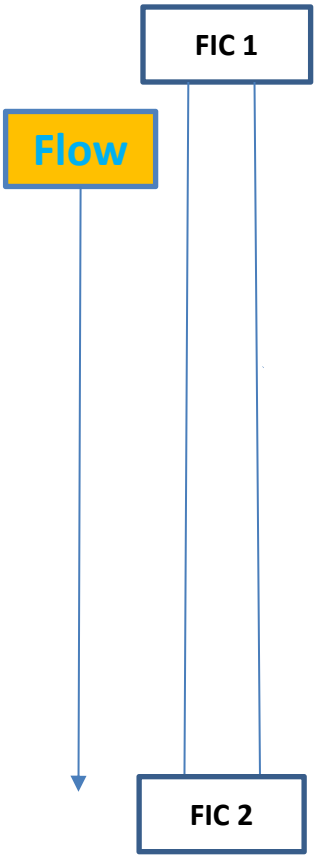
1.4M	MH	Camera Enters Manhole FIC 2

REM ; THERE ARE NO DEFECTS WITH THIS SECTION OF PIPE

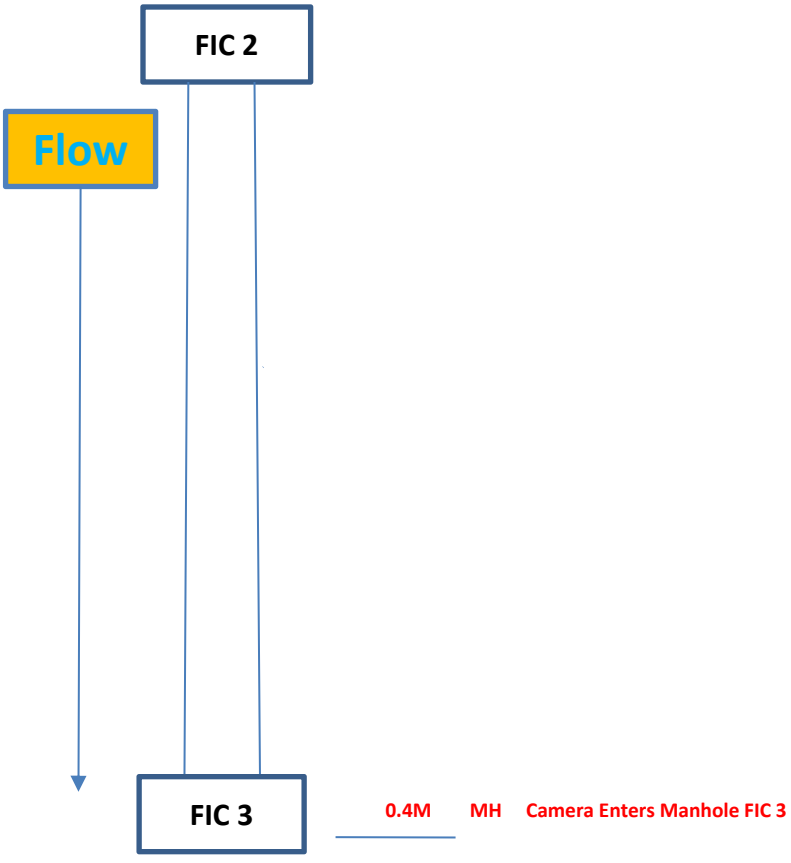
0.4M	MH	Camera Enters Manhole FIC 3

REM ; THERE ARE NO DEFECTS WITH THIS SECTION OF PIPE

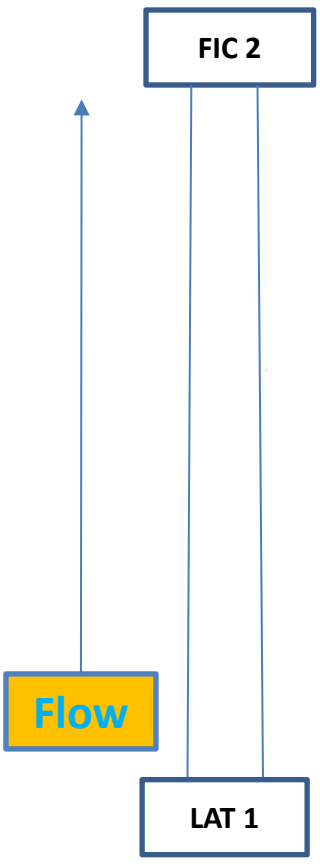
7.0M	JN	Line Drops In From The Left
7.9M	LU	Line Turns Up

REM ; THERE ARE NO DEFECTS WITH THIS SECTION OF PIPE

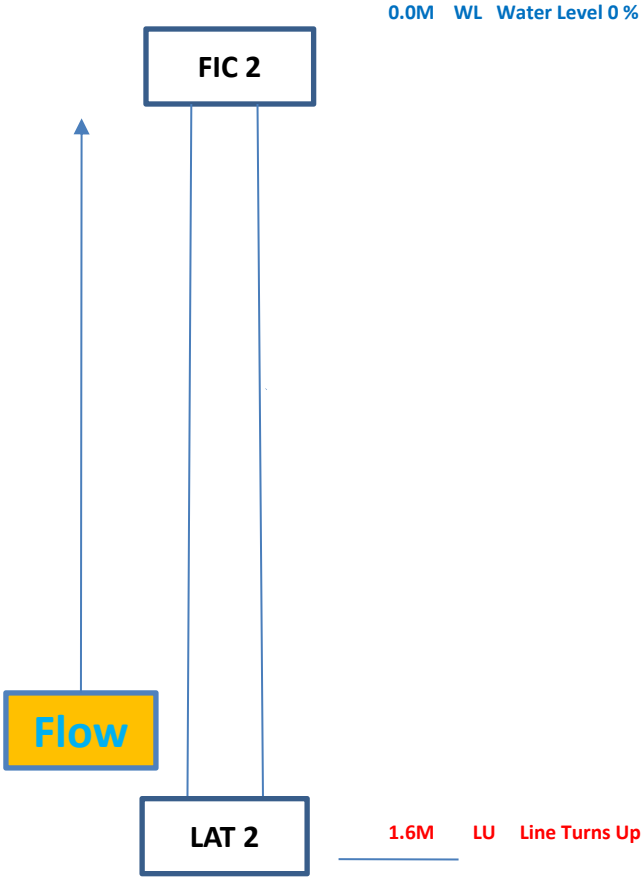
1.6M	LU	Line Turns Up

REM ; THERE ARE NO DEFECTS WITH THIS SECTION OF PIPE

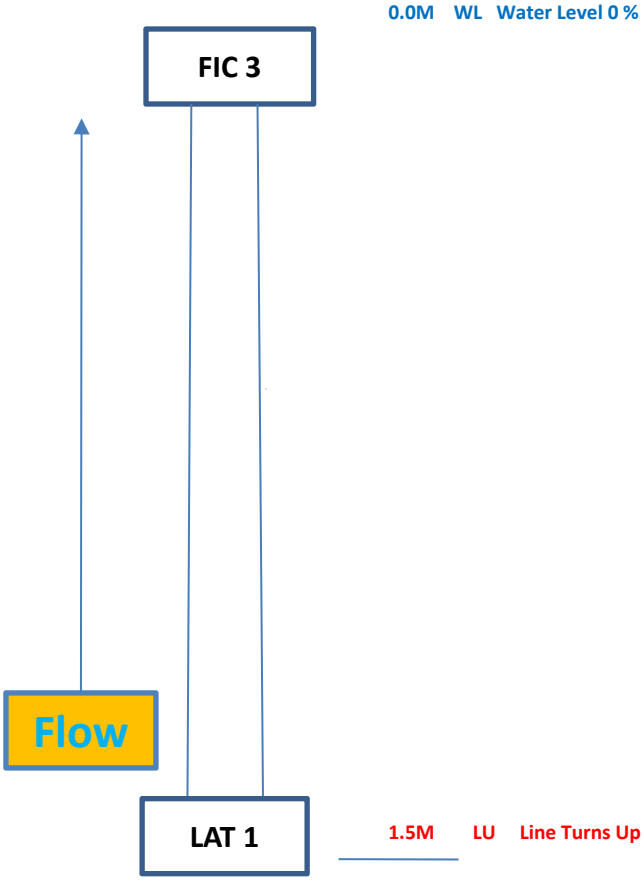
1.5M	LU	Line Turns Up

REM ; THERE ARE NO DEFECTS WITH THIS SECTION OF PIPE

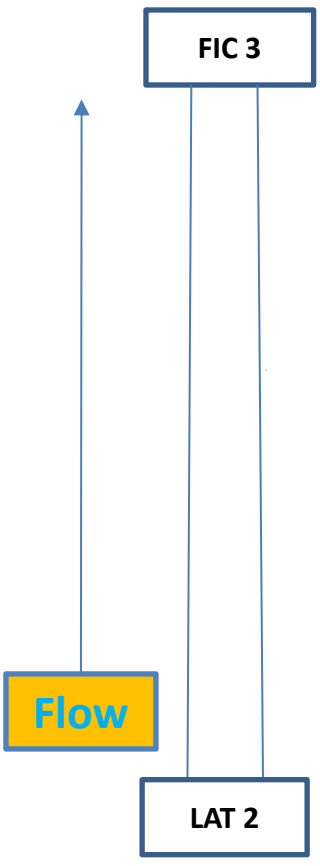
6.7M	JN	Line Drops In From The Right
8.0M	LU	Line Turns Up

REM ; THERE ARE NO DEFECTS WITH THIS SECTION OF PIPE

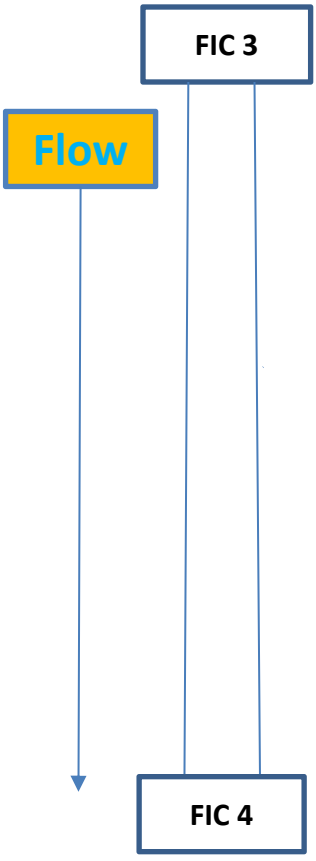
2.8M	MH	Camera Enters Manhole FIC 4

REM ; THERE ARE NO DEFECTS WITH THIS SECTION OF PIPE

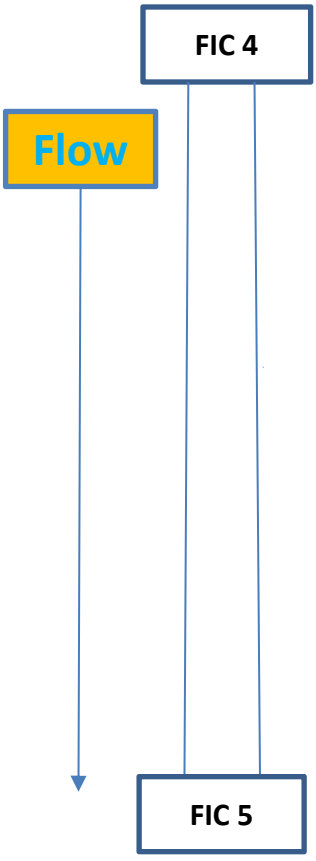
3.5M	MH	Camera Enters Manhole FIC 5

REM ; THERE ARE NO DEFECTS WITH THIS SECTION OF PIPE

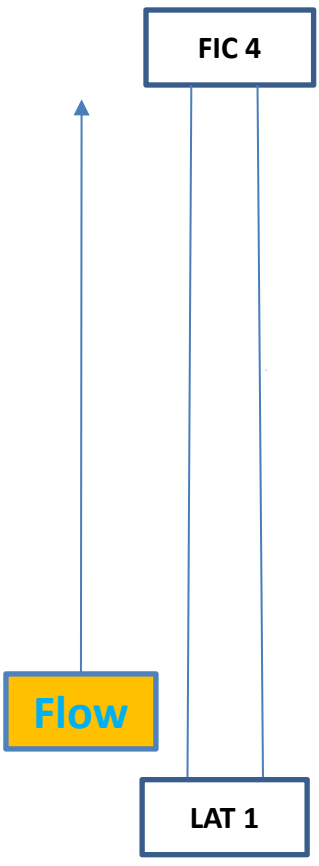
9.0M	JN	Line Drops In From The Left
10.1M	LU	Line Turns Up

REM ; THERE ARE NO DEFECTS WITH THIS SECTION OF PIPE

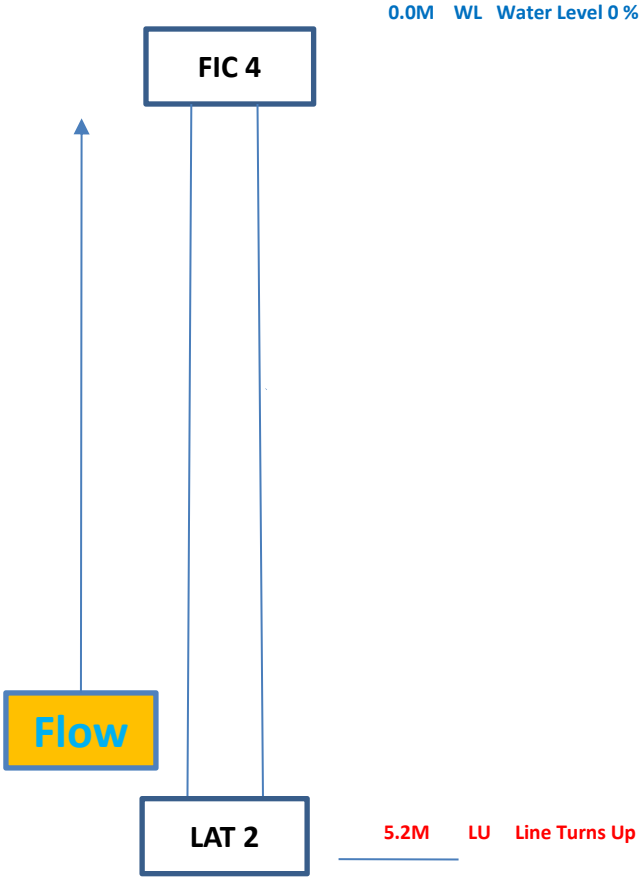
5.2M	LU	Line Turns Up

REM ; THERE ARE NO DEFECTS WITH THIS SECTION OF PIPE

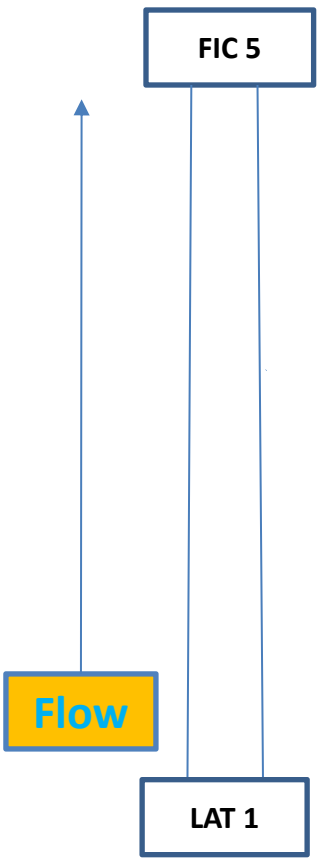
5.0M	LU	Line Turns Up

REM ; THERE ARE NO DEFECTS WITH THIS SECTION OF PIPE

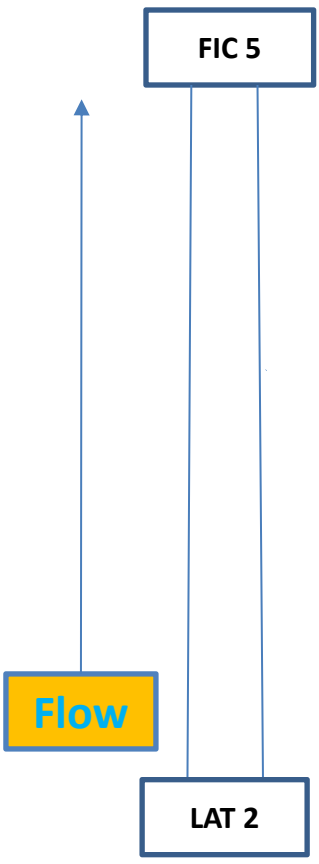
8.3M	JN	Line Drops In From The Right
10.0M	LU	Line Turns Up

REM ; THERE ARE NO DEFECTS WITH THIS SECTION OF PIPE

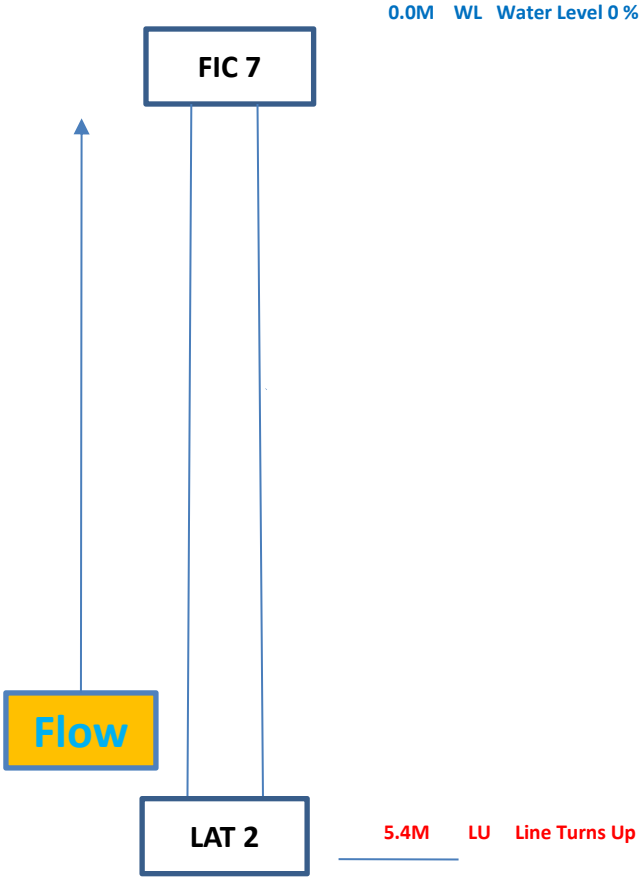
5.4M	LU	Line Turns Up

REM ; THERE ARE NO DEFECTS WITH THIS SECTION OF PIPE

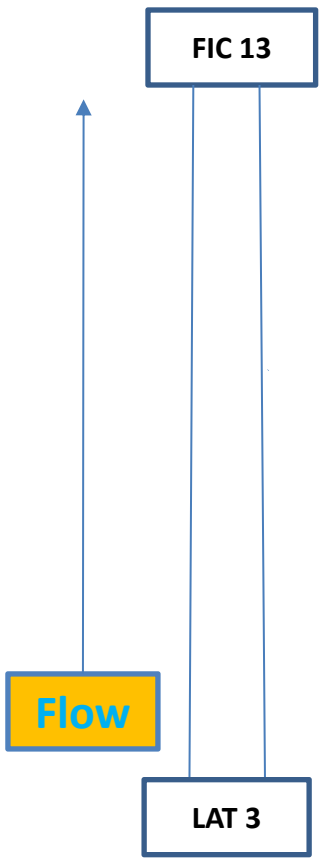
Position	Code	Observation
0.0M	ST	Start Of Survey
0.0M	WL	Water Level 0 %
2.2M	JN	Line Drops In From The Right
7.6M	LU	Line Turns Up

REM ; THERE ARE NO DEFECTS WITH THIS SECTION OF PIPE

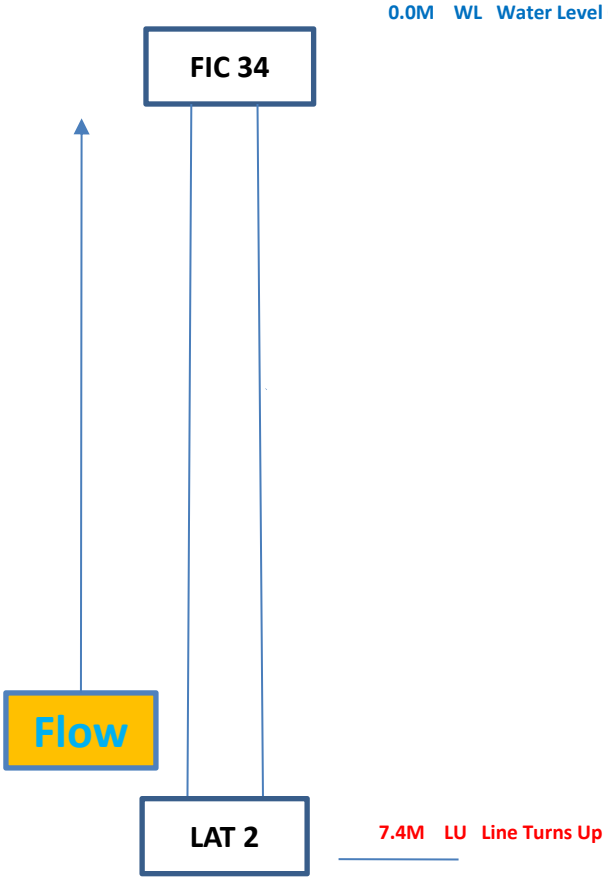
Position	Code	Observation
0.0M	ST	Start Of Survey
0.0M	WL	Water Level 0 %

7.4M	LU	Line Turns Up

REM ; THERE ARE NO DEFECTS WITH THIS SECTION OF PIPE

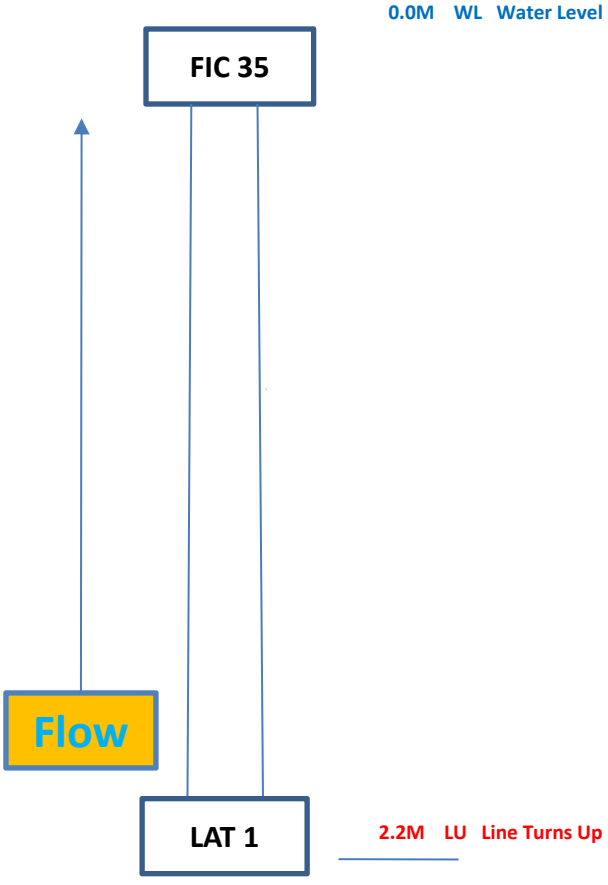
Position	Code	Observation
0.0M	ST	Start Of Survey
0.0M	WL	Water Level 0 %

REM ; THERE ARE NO DEFECTS WITH THIS SECTION OF PIPE

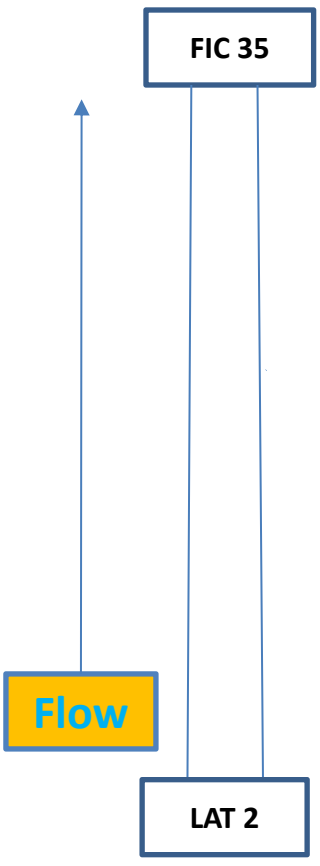
Position	Code	Observation
0.0M	ST	Start Of Survey
0.0M	WL	Water Level 0 %
0.1M	LD	Line Drops Down

5.3M	LU	Line Turns Up

REM ; THERE ARE NO DEFECTS WITH THIS SECTION OF PIPE

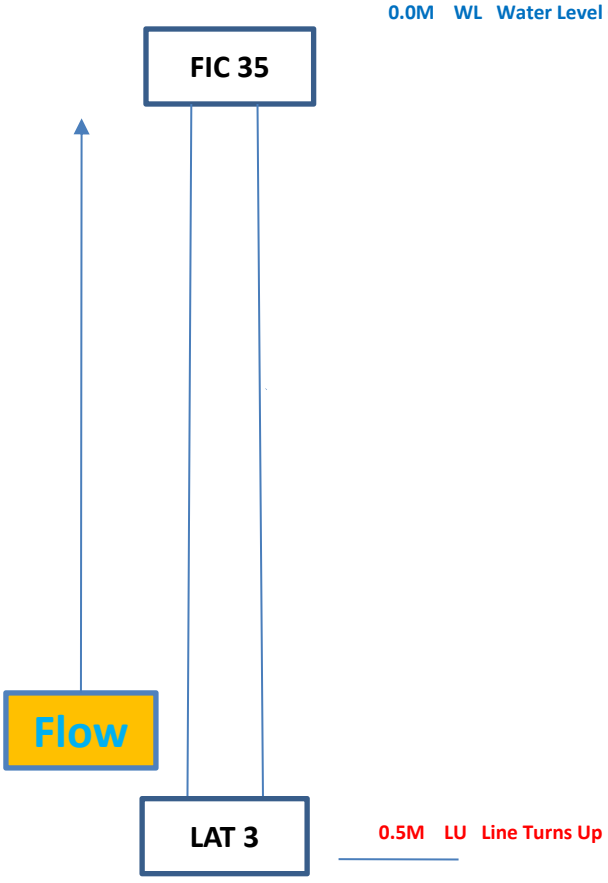
Position	Code	Observation
0.0M	ST	Start Of Survey
0.0M	WL	Water Level 0 %

REM ; THERE ARE NO DEFECTS WITH THIS SECTION OF PIPE

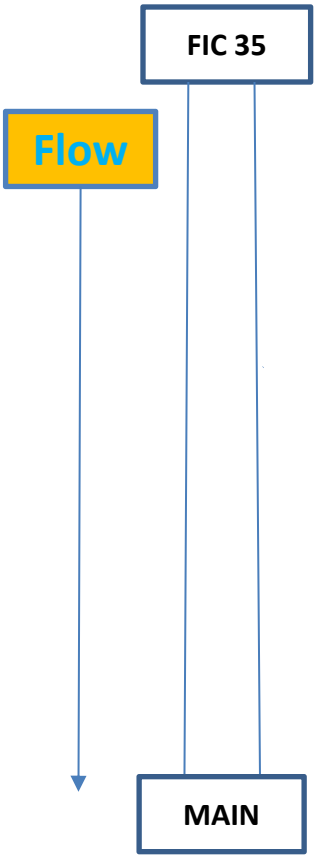
0.8M LD Line Drops Into Main

REM ; THERE ARE NO DEFECTS WITH THIS SECTION OF PIPE

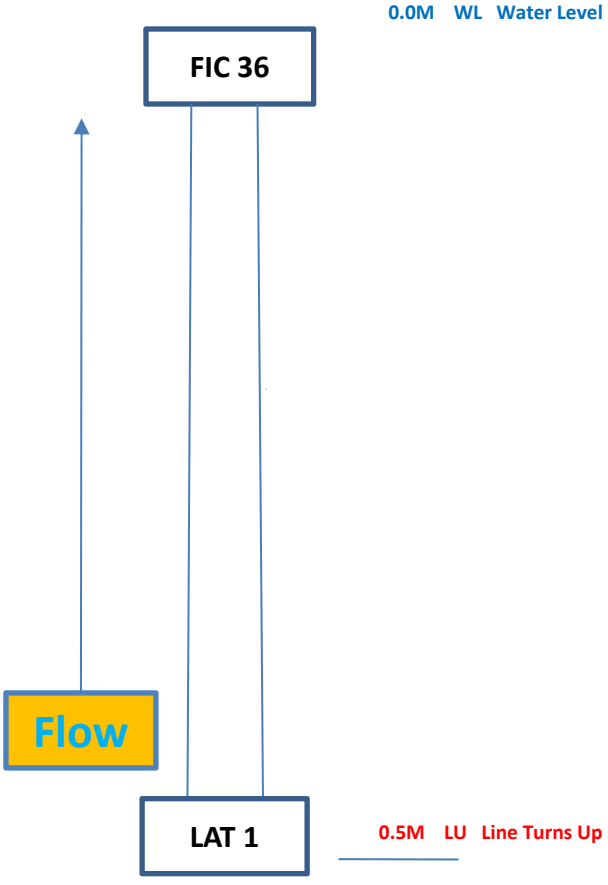
0.0M ST Start Of Survey
0.0M WL Water Level 0 %

REM ; THERE ARE NO DEFECTS WITH THIS SECTION OF PIPE

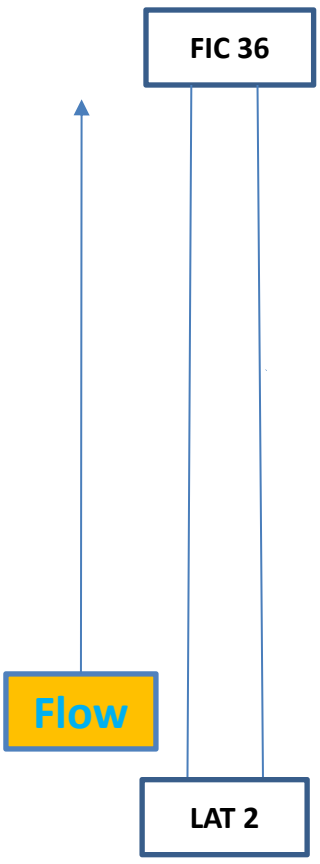
Position	Code	Observation
0.0M	ST	Start Of Survey
0.0M	WL	Water Level 0 %
0.1M	LD	Line Drops Down

5.5M	LU	Line Turns Up

REM ; THERE ARE NO DEFECTS WITH THIS SECTION OF PIPE

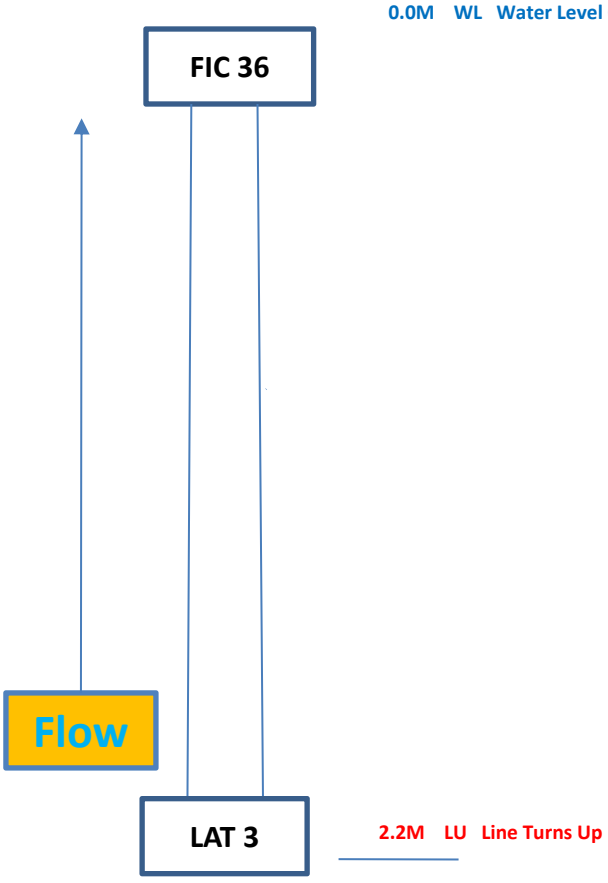
Position	Code	Observation
0.0M	ST	Start Of Survey
0.0M	WL	Water Level 0 %

REM ; THERE ARE NO DEFECTS WITH THIS SECTION OF PIPE

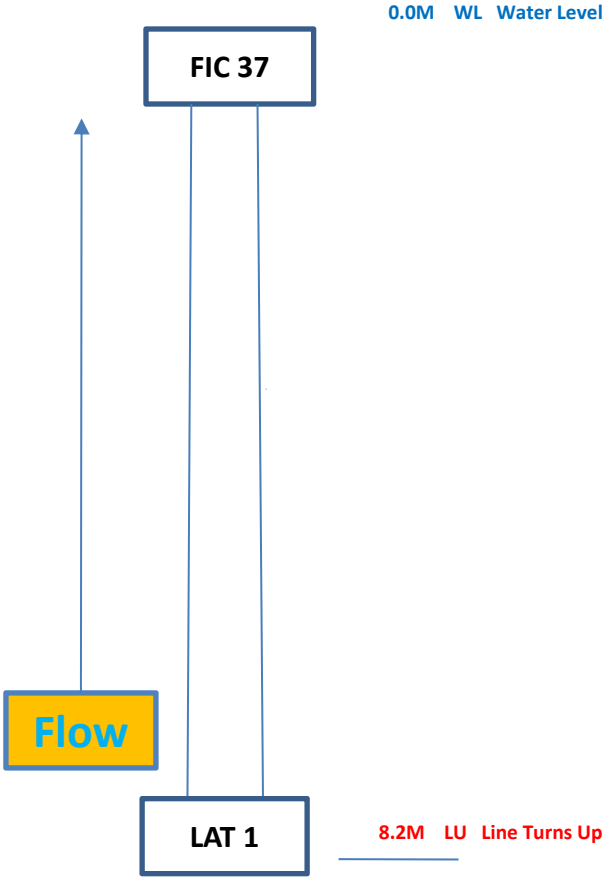
Position	Code	Observation
0.0M	ST	Start Of Survey
0.0M	WL	Water Level 0 %

REM ; THERE ARE NO DEFECTS WITH THIS SECTION OF PIPE

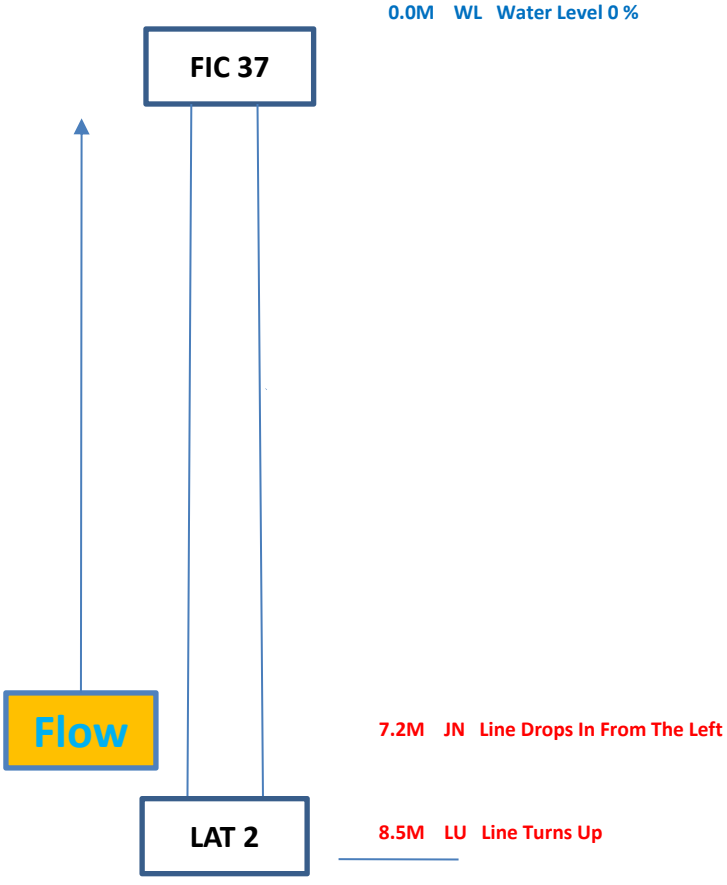
7.2M	JN	Line Drops In From The Left
8.5M	LU	Line Turns Up

REM ; THERE ARE NO DEFECTS WITH THIS SECTION OF PIPE

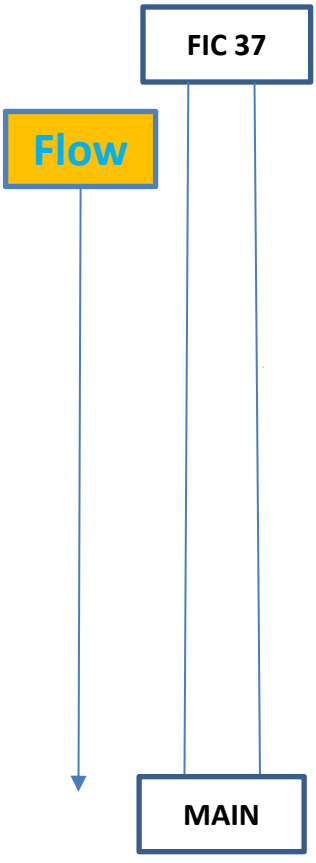
0.6M LD Line Drops Into Main

REM ; THERE ARE NO DEFECTS WITH THIS SECTION OF PIPE

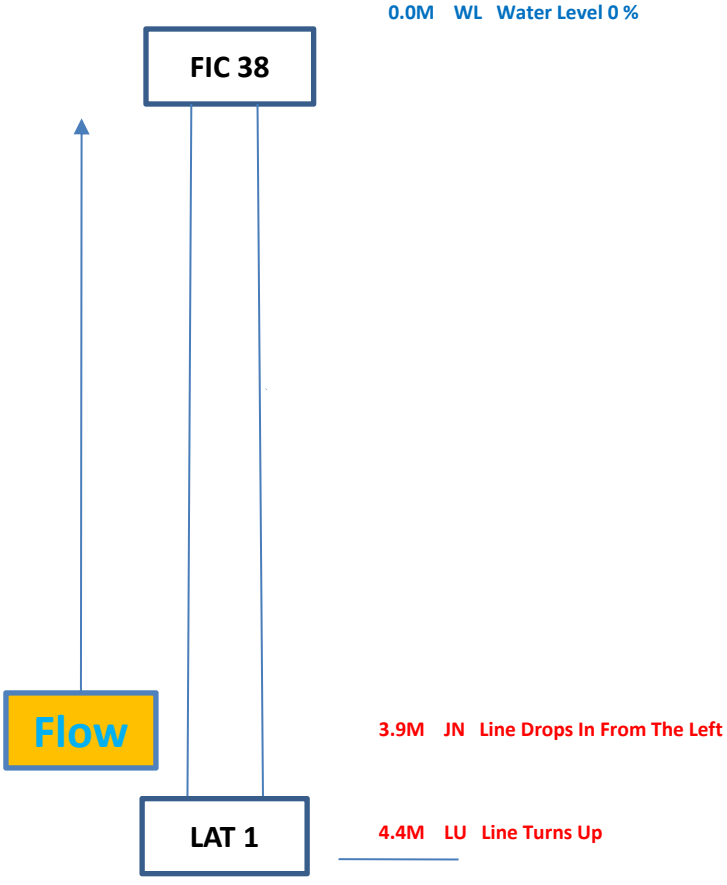
3.9M	JN	Line Drops In From The Left
4.4M	LU	Line Turns Up

REM ; THERE ARE NO DEFECTS WITH THIS SECTION OF PIPE

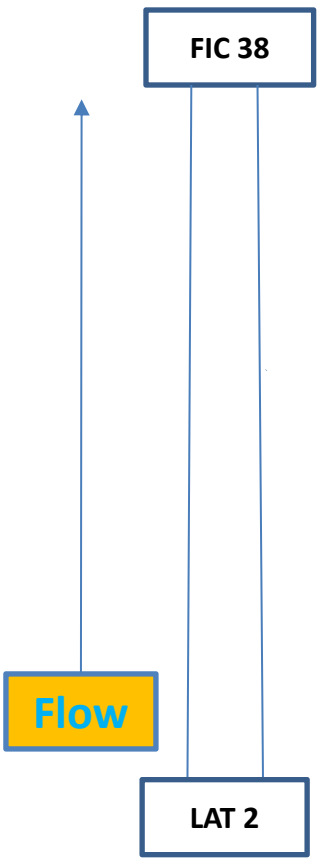
8.2M	JN	Line Drops In From The Left
10.4M	LU	Line Turns Up And Is Capped Off

REM ; THERE ARE NO DEFECTS WITH THIS SECTION OF PIPE

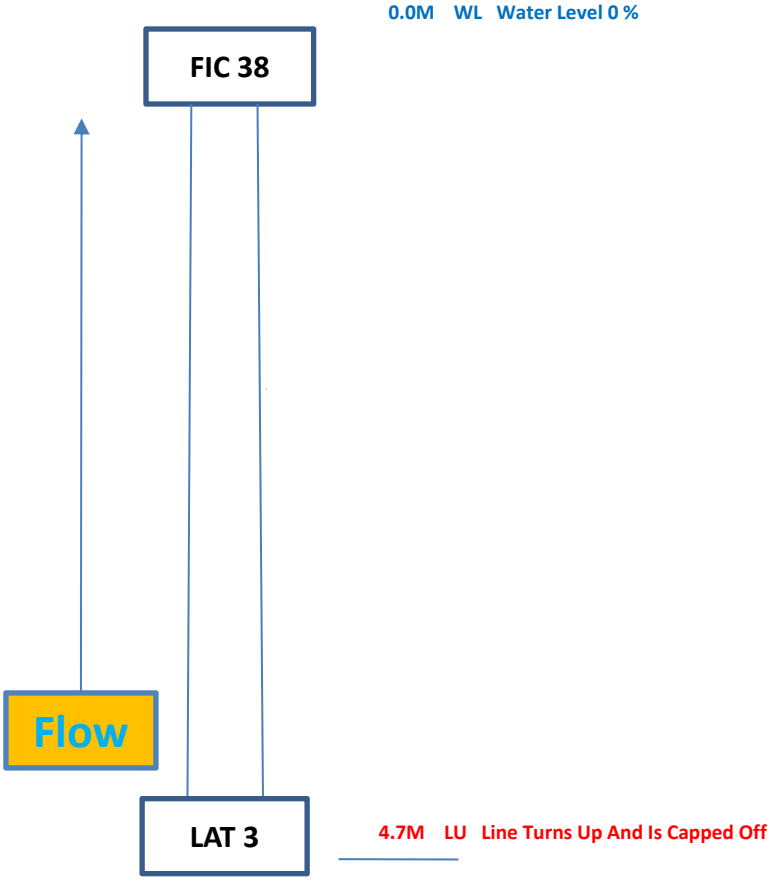
0.0M ST Start Of Survey
0.0M WL Water Level 0 %

REM ; THERE ARE NO DEFECTS WITH THIS SECTION OF PIPE

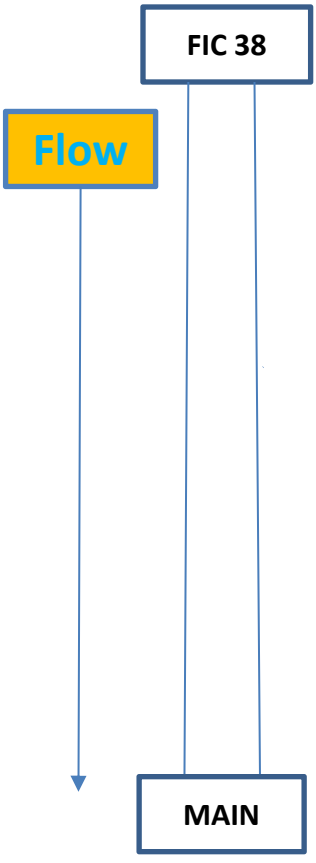
1.2M LD Line Drops Into Main

REM ; THERE ARE NO DEFECTS WITH THIS SECTION OF PIPE

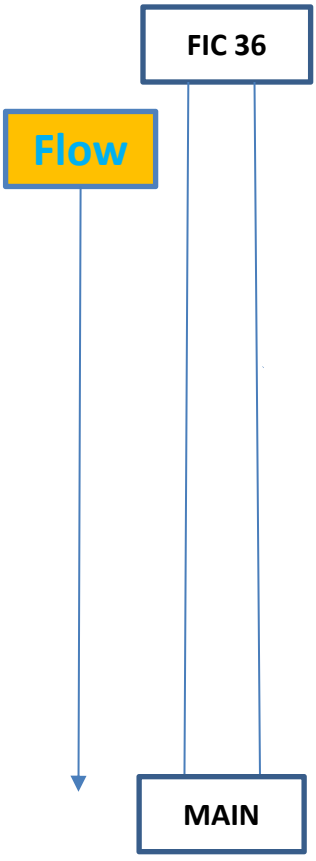
0.7M LD Line Drops Into Main

REM ; THERE ARE NO DEFECTS WITH THIS SECTION OF PIPE

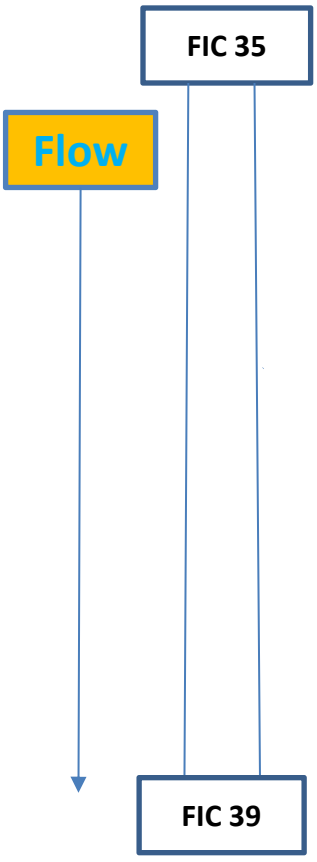
0.0M ST Start Of Survey
0.0M WL Water Level 0 %
1.1M LL Line Turns Left
2.4M JN L;ine Drops In From The Left From FIC 35
3.6M JN Line Drops In From The Left From FIC 36
6.4M JN Line Drops In From The Left From FIC 37
14.7M JN Line Drops In From The Left From FIC 38
19.6M MH Camera Enters Manhole FIC 39

REM ; THERE ARE NO DEFECTS WITH THIS SECTION OF PIPE

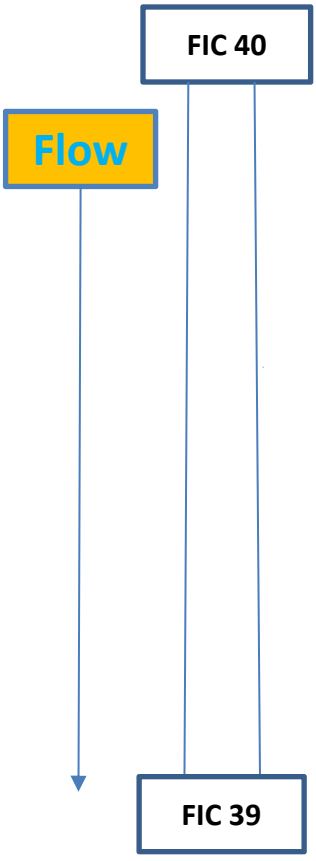
5.8M MH Camera Enters Manhole FIC 39

REM ; THERE ARE NO DEFECTS WITH THIS SECTION OF PIPE

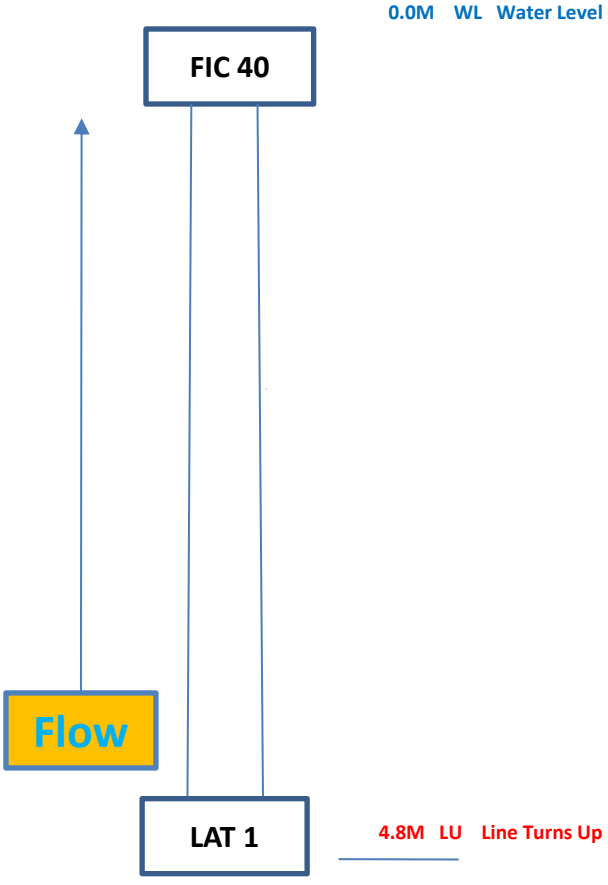
4.8M	LU	Line Turns Up

REM ; THERE ARE NO DEFECTS WITH THIS SECTION OF PIPE

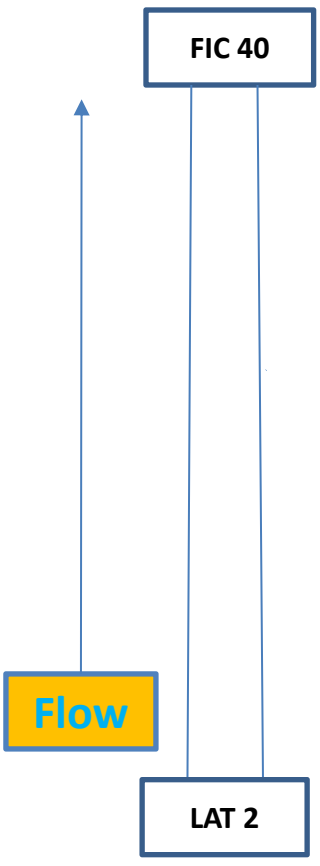
6.8M JN L;ine Drops In From The Right

9.8M LU Line Turns Up

REM ; THERE ARE NO DEFECTS WITH THIS SECTION OF PIPE

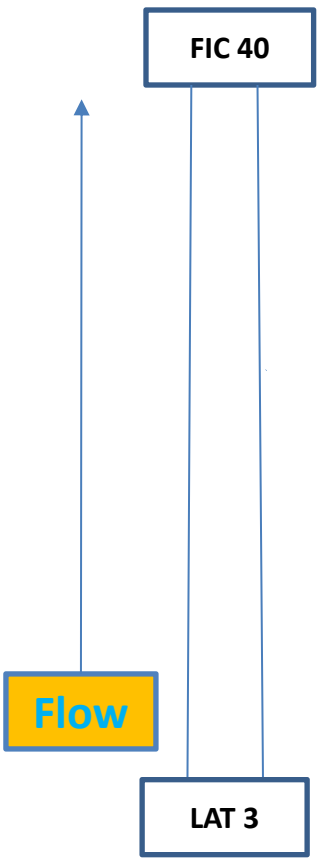
4.4M	JN	Line Drops In From The Right
5.0M	LU	Line Turns Up

REM ; THERE ARE NO DEFECTS WITH THIS SECTION OF PIPE

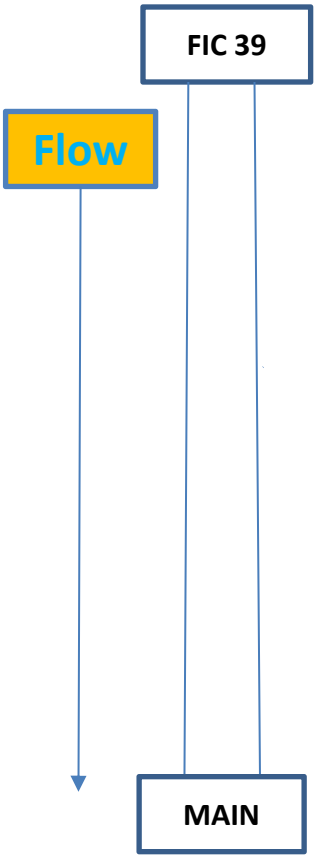
Position	Code	Observation
0.0M	ST	Start Of Survey
0.0M	WL	Water Level 0 %
4.8M	MC	Pipe Changes To Clay
6.7M	LD	Line Drops Into Main

REM ; THERE ARE NO DEFECTS WITH THIS SECTION OF PIPE

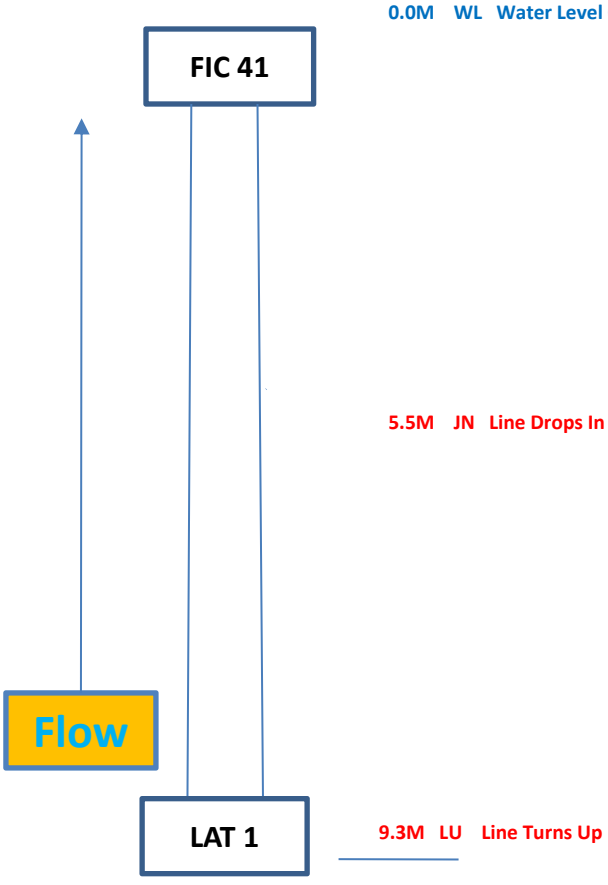
5.5M JN Line Drops In From The Left

9.3M LU Line Turns Up

REM ; THERE ARE NO DEFECTS WITH THIS SECTION OF PIPE

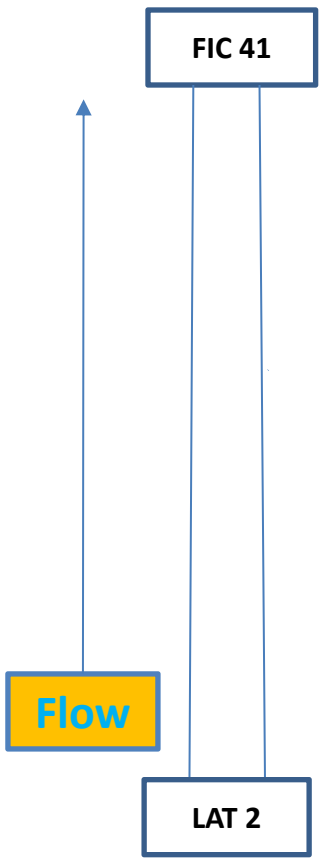
Position	Code	Observation
0.0M	ST	Start Of Survey
0.0M	WL	Water Level 0 %
5.5M	JN	Line Drops In From The Left
9.3M	LU	Line Turns Up

REM ; THERE ARE NO DEFECTS WITH THIS SECTION OF PIPE

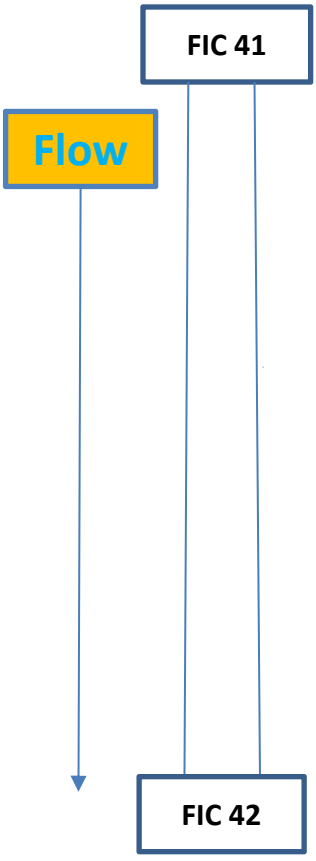
1.7M	MH	Camera Enters Manhole FIC 42

REM ; THERE ARE NO DEFECTS IN THIS SECTION OF PIPE

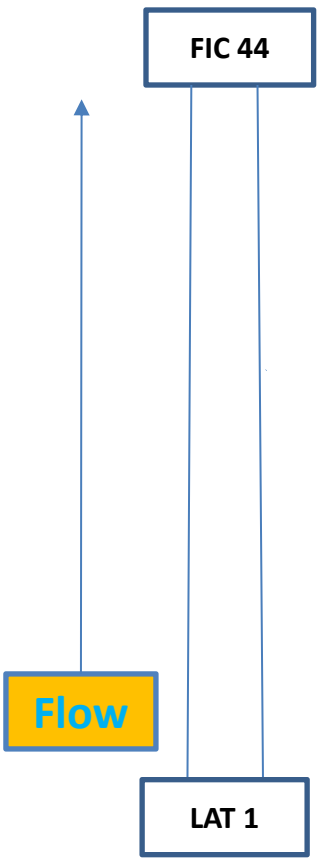
Position	Code	Observation
0.0M	ST	Start Of Survey
0.0M	WL	Water Level 0 %
5.5M	JN	Line Drops In From The Left
8.8M	LU	Line Turns Up

REM ; THERE ARE NO DEFECTS WITH THIS SECTION OF PIPE

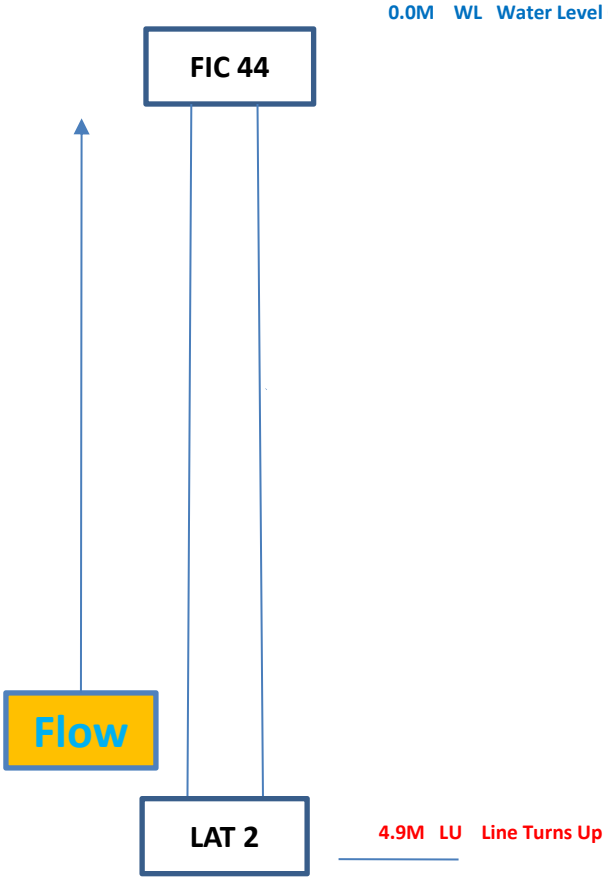
4.9M	LU	Line Turns Up

REM ; THERE ARE NO DEFECTS WITH THIS SECTION OF PIPE

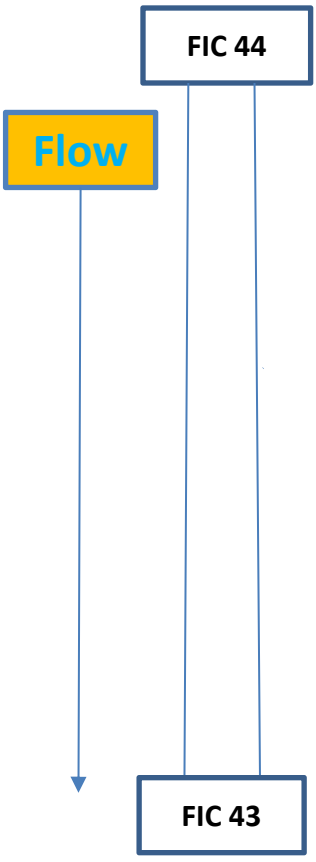
1.7M MH Camera Enters Manhole FIC 43

REM ; THERE ARE NO DEFECTS IN THIS SECTION OF PIPE

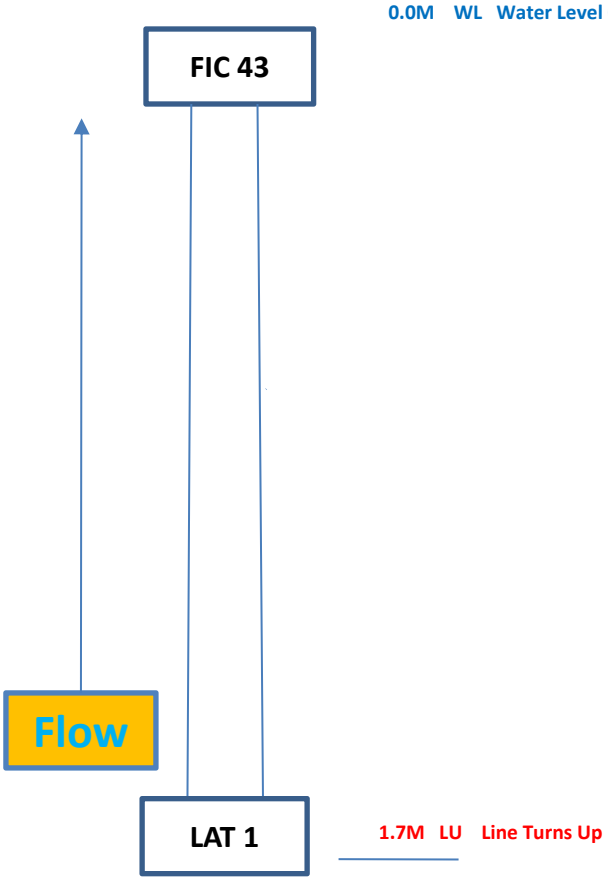
1.7M	LU	Line Turns Up

REM ; THERE ARE NO DEFECTS WITH THIS SECTION OF PIPE

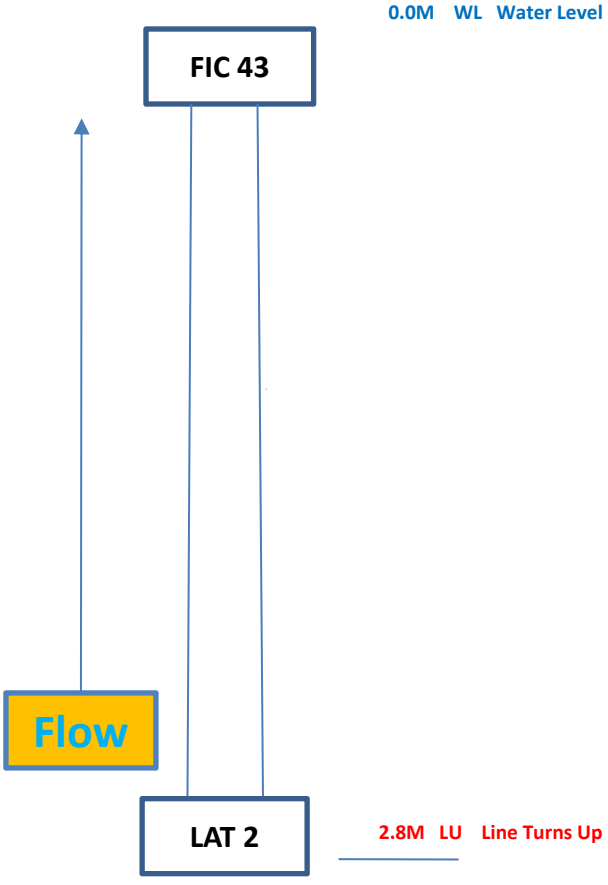
2.8M	LU	Line Turns Up

REM ; THERE ARE NO DEFECTS WITH THIS SECTION OF PIPE

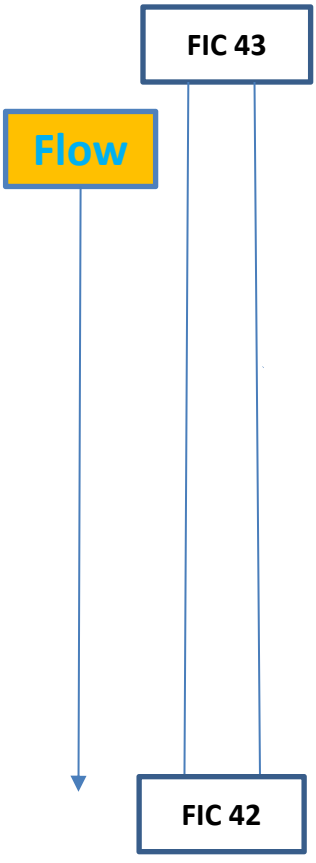
0.2M MH Camera Enters Manhole FIC 42

REM ; THERE ARE NO DEFECTS IN THIS SECTION OF PIPE
