Drainage Verification Report

Land formerly Eastbrook Primary School, Southwick, BN42 4N

Lovell Partnerships

Ref: 11650
Date: March 2025

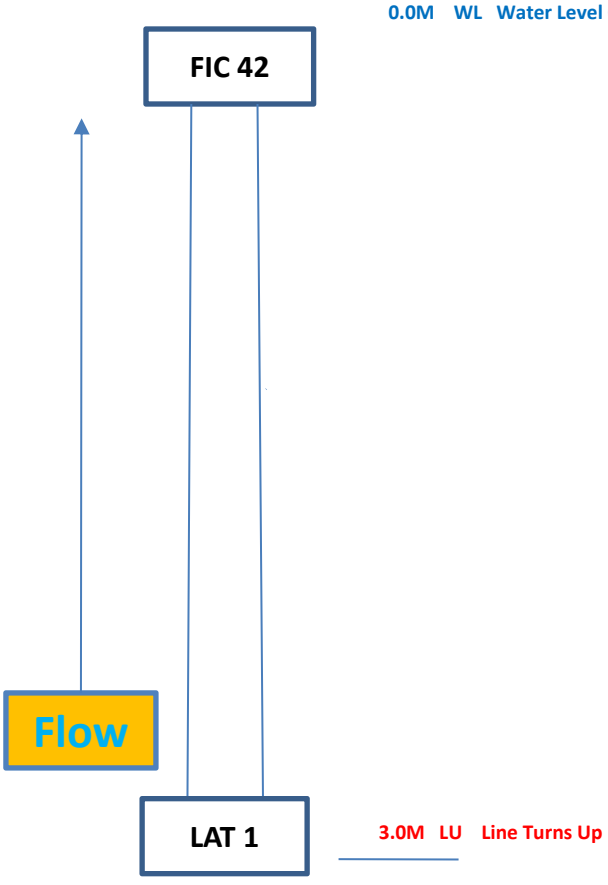
0.0M ST Start Of Survey
0.0M WL Water Level 0 %

REM ; THERE ARE NO DEFECTS WITH THIS SECTION OF PIPE

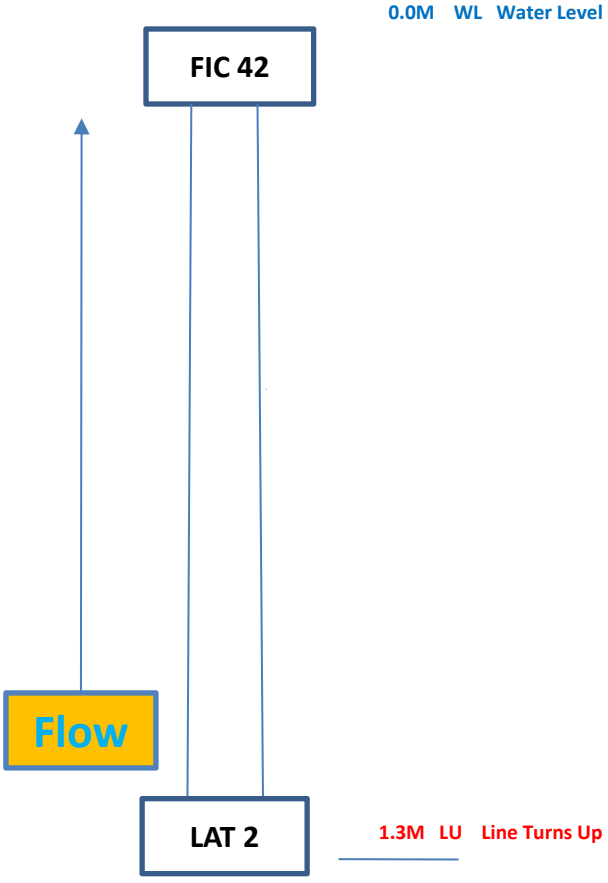
0.0M ST Start Of Survey
0.0M WL Water Level 0 %

REM ; THERE ARE NO DEFECTS WITH THIS SECTION OF PIPE

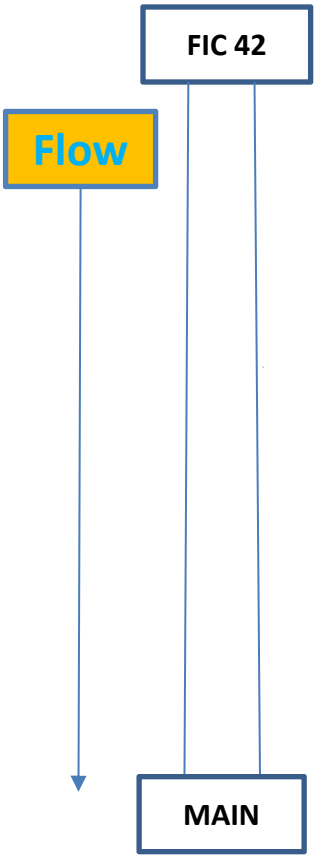
Position	Code	Observation
0.0M	ST	Start Of Survey
0.0M	WL	Water Level 0 %
4.4M	MC	Pipe Changes To Clay
7.8M	LD	Line Drops Into Main

REM ; THERE ARE NO DEFECTS WITH THIS SECTION OF PIPE

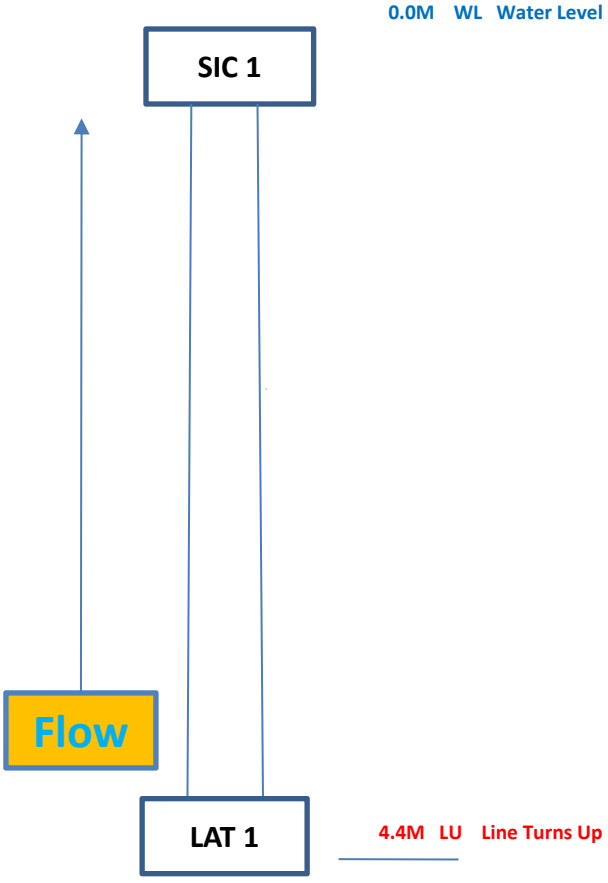
4.4M	LU	Line Turns Up

REM ; THERE ARE NO DEFECTS WITH THIS SECTION OF PIPE.

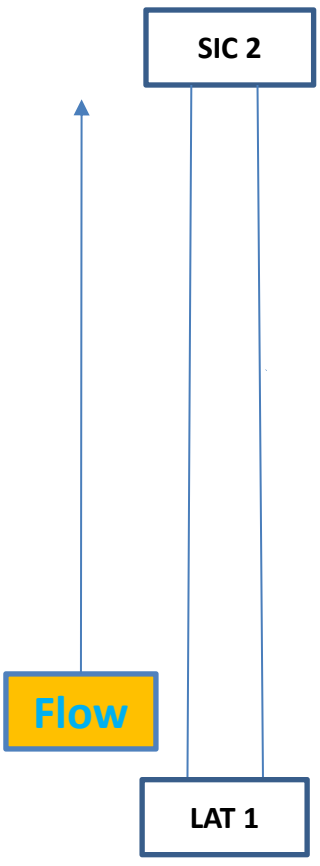
Position	Code	Observation
0.0M	ST	Start Of Survey
0.0M	WL	Water Level 0 %
5.1M	JN	Line Drops In From The Right
5.7M	JN	Line Drops In From The Right
6.7M	LR	Line Turns Right
9.4M	LU	Line Turns Up

REM ; THERE ARE NO DEFECTS WITH THIS SECTION OF PIPE.

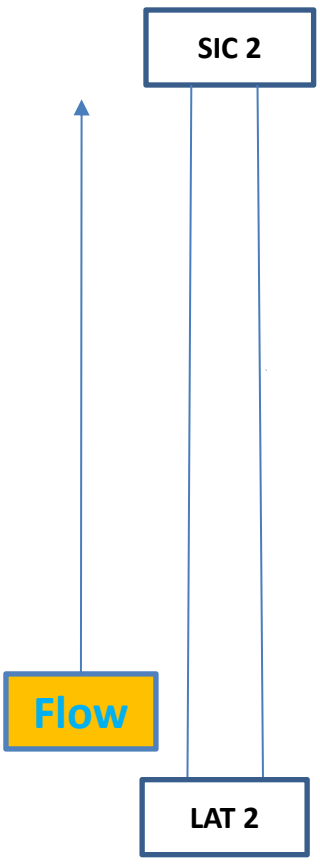
Position	Code	Observation
0.0M	ST	Start Of Survey
0.0M	WL	Water Level 0 %
4.8M	JN	Line Drops In From The Left
8.4M	JN	Line Drops In From The Right
9.3M	JN	Line Drops In From The Left
10.1M	LU	Line Turns Up To Rodding Eye

REM ; THERE ARE NO DEFECTS WITH THIS SECTION OF PIPE.

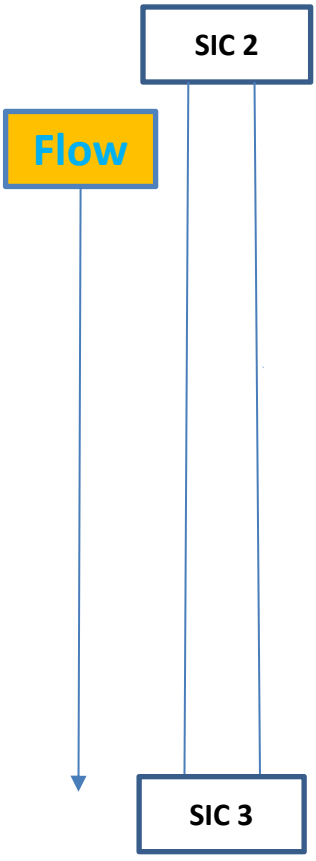
4.2M MH Camera Enters Manhole SIC 3

REM ; THERE ARE NO DEFECTS WITH THIS SECTION OF PIPE

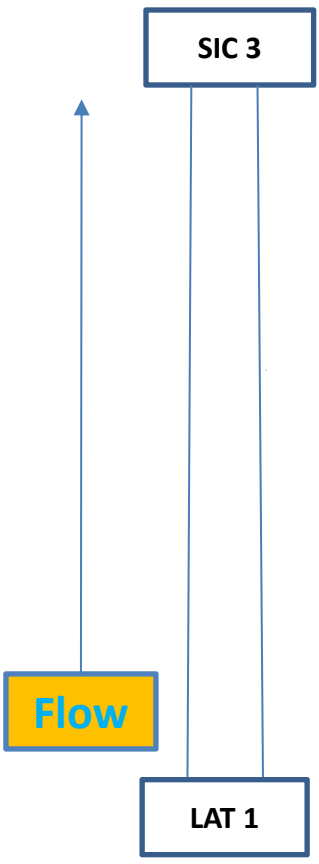
1.2M CR Camera Stops At Crate System

REM ; THERE ARE NO DEFECTS WITH THIS SECTION OF PIPE.

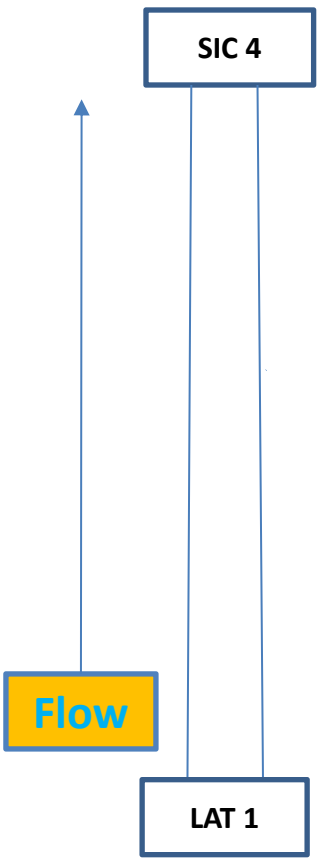
0.4M	CR	Camera Stops At Crate System

REM ; THERE ARE NO DEFECTS WITH THIS SECTION OF PIPE.

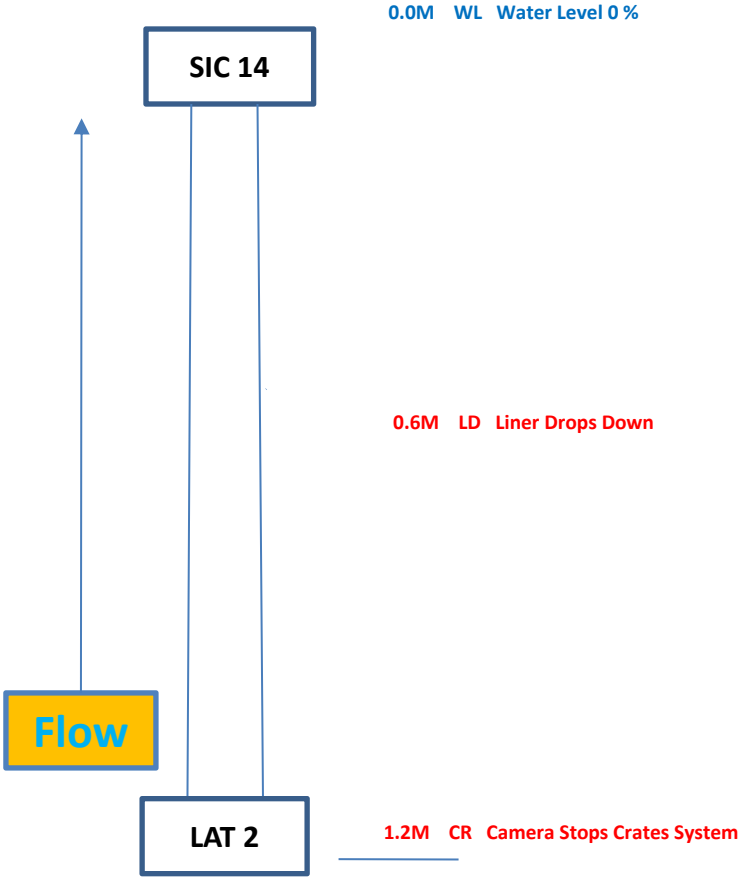
Position	Code	Observation
0.0M	ST	Start Of Survey
0.0M	WL	Water Level 0 %
0.6M	LD	Liner Drops Down
1.2M	CR	Camera Stops Crates System

REM ; THERE ARE NO DEFECTS WITH THIS SECTION OF PIPE.

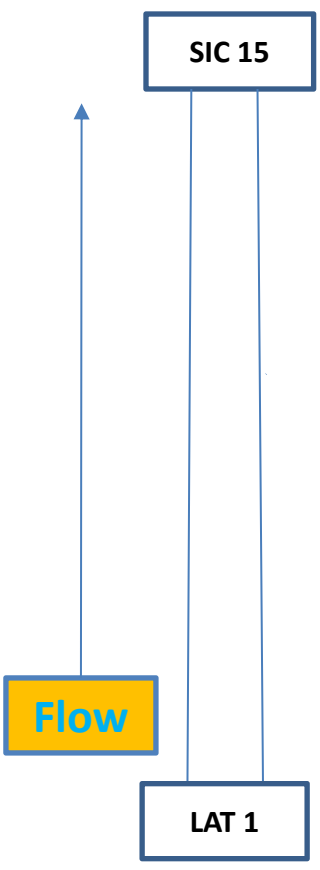
Position	Code	Observation
0.0M	ST	Start Of Survey
0.0M	WL	Water Level 0 %
1.4M	JN	Line Drops In From The Right
1.6M	JN	Line Drops In From The Left
4.0M	LR	Line Turns Right
7.3M	LU	Line Turns Up

REM ; THERE ARE NO DEFECTS WITH THIS SECTION OF PIPE

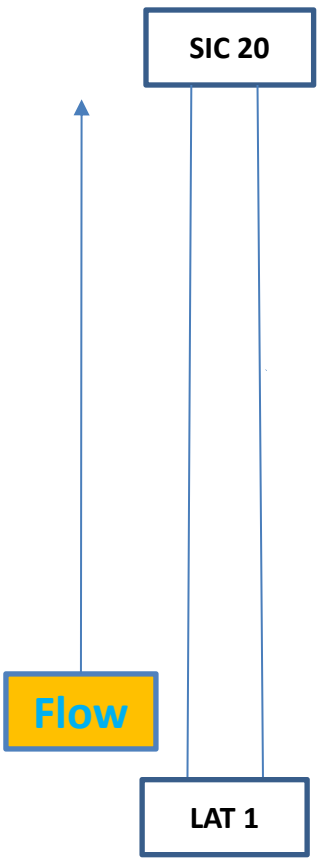
Position	Code	Observation
0.0M	ST	Start Of Survey
0.0M	WL	Water Level 0 %
9.5M	JN	Line Drops In From The Right
10.5M	JN	Line Drops In From The Right
12.8M	WL	Water Level 10 %
13.0M	JN	Line Drops In From Above

REM ; THERE ARE NO DEFECTS WITH THIS SECTION OF PIPE

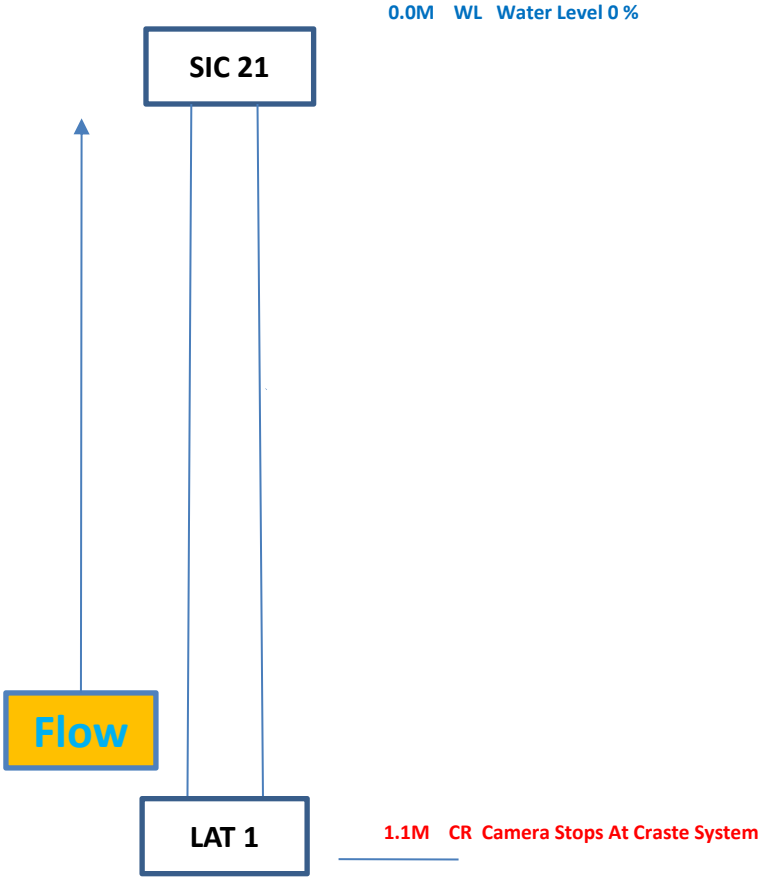
0.0M ST Start Of Survey
0.0M WL Water Level 0 %

1.1M CR Camera Stops At Craste System

REM ; THERE ARE NO DEFECTS IN THIS SECTION OF PIPE

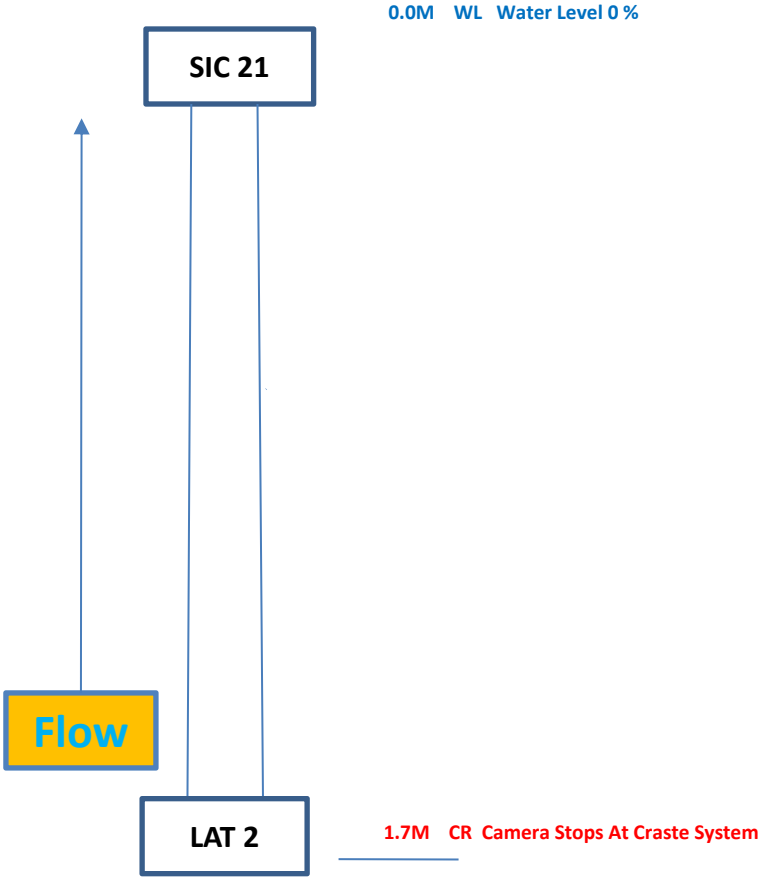
0.0M ST Start Of Survey
0.0M WL Water Level 0 %

REM ; THERE ARE NO DEFECTS IN THIS SECTION OF PIPE

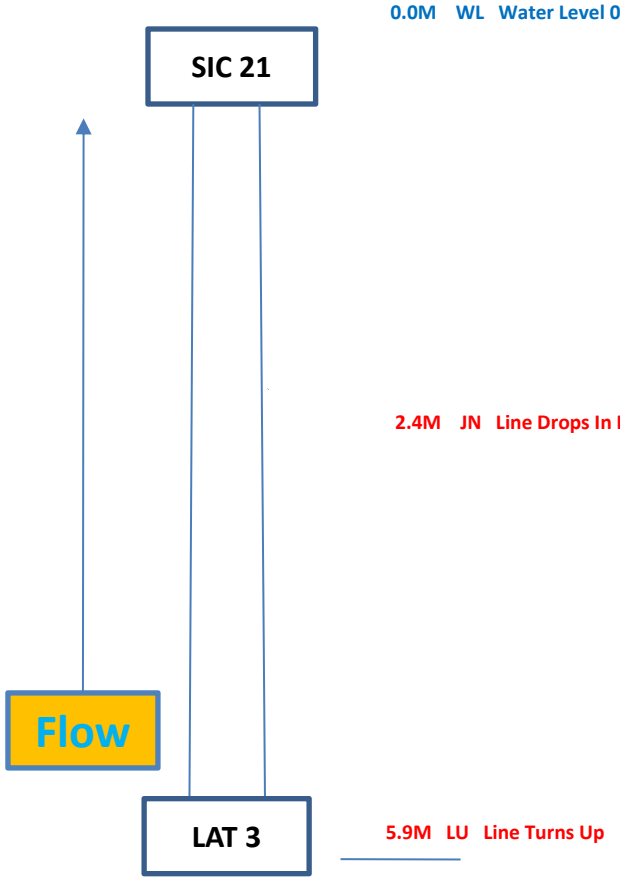
0.0M ST Start Of Survey
0.0M WL Water Level 0 %

2.4M JN Line Drops In From The Right

5.9M LU Line Turns Up

REM ; THERE ARE NO DEFECTS IN THIS SECTION OF PIPE

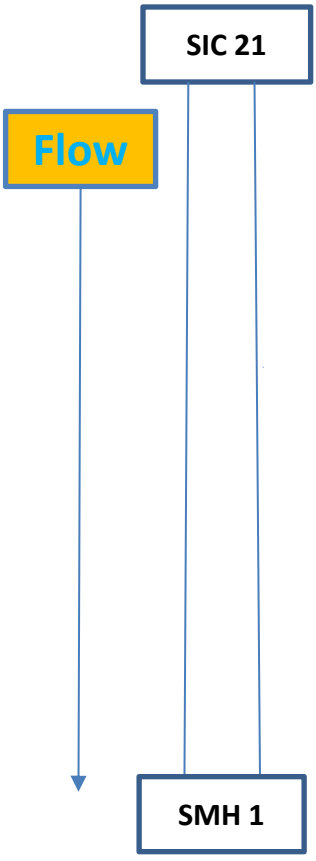
Position	Code	Observation
0.0M	ST	Start Of Survey
0.0M	WL	Water Level 0 %

7.6M	MH	Camera Enters Manhole SMH 1

REM ; THERE ARE NO DEFECTS IN THIS SECTION OF PIPE

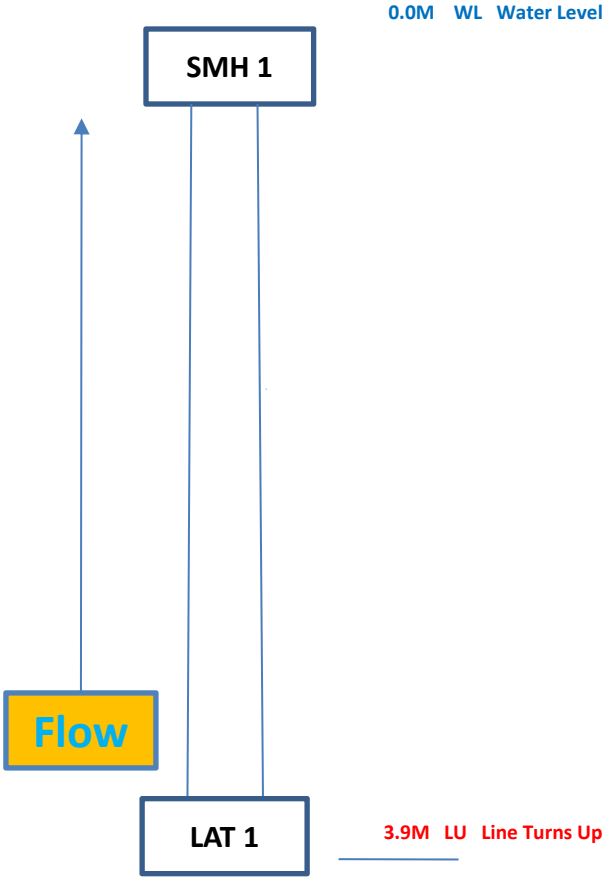
Position	Code	Observation
0.0M	ST	Start Of Survey
0.0M	WL	Water Level 0 %

3.9M	LU	Line Turns Up

REM ; THERE ARE NO DEFECTS IN THIS SECTION OF PIPE

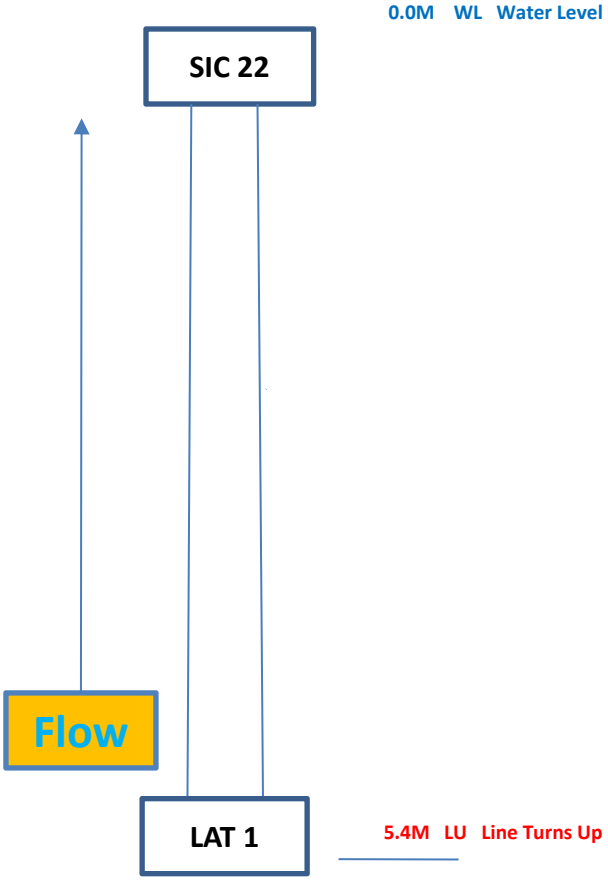
Position	Code	Observation
0.0M	ST	Start Of Survey
0.0M	WL	Water Level 0 %

5.4M	LU	Line Turns Up

REM ; THERE ARE NO DEFECTS IN THIS SECTION OF PIPE

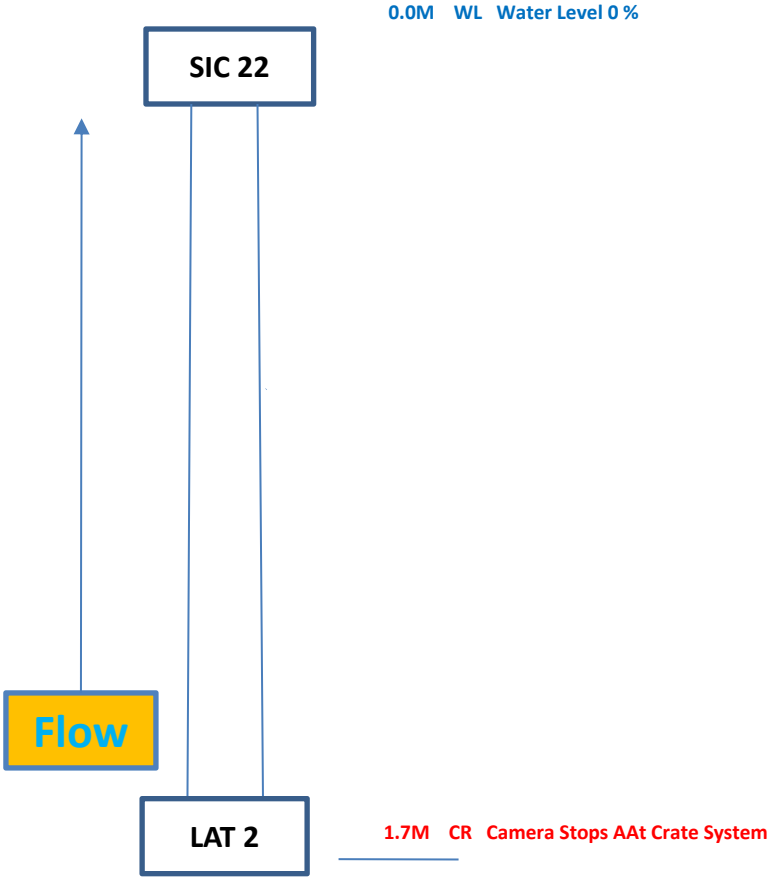
Position	Code	Observation
0.0M	ST	Start Of Survey
0.0M	WL	Water Level 0 %

1.7M	CR	Camera Stops AAt Crate System

REM ; THERE ARE NO DEFECTS IN THIS SECTION OF PIPE

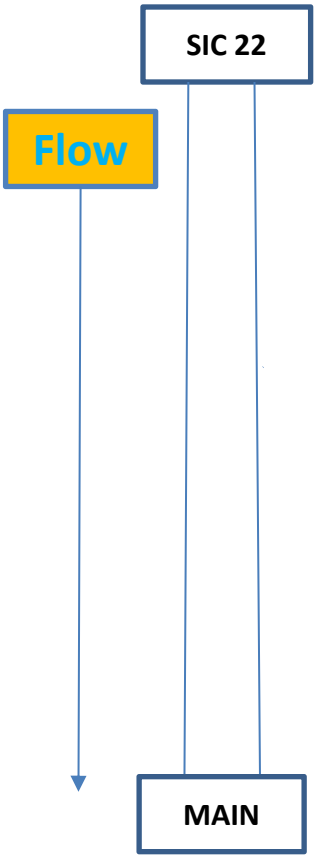
Position	Code	Observation
0.0M	ST	Start Of Survey
0.0M	WL	Water Level 0 %

2.9M LD Line Drops Into Main

REM ; THERE ARE NO DEFECTS WITH THIS SECTION OF PIPE
