17th August 2026

Ref: A12064-2/260721/L1

RE: Adur Civic Centre, Ham Road, Shoreham by Sea, West Sussex, BN43 9SA - Validation of Clean Cover System within the southeast soft landscaping areas

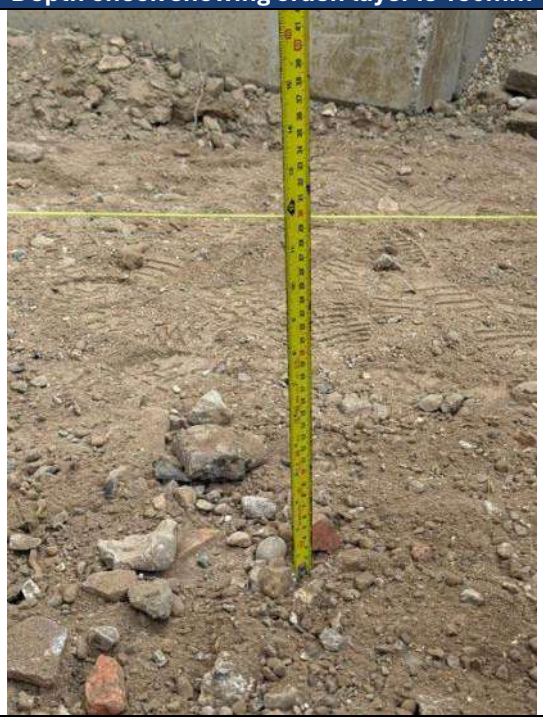
Depth Check showing the 450mm excavation

Depth check showing crush layer is 150mm

Crush Stockpile
