Part E – Sound Insulation Testing Compliance Report

Report Reference Number: 58021

Test Date: 13/12/2024

This report describes the test procedure and the results obtained from the pre-completion sound insulation testing at
125B Lyndhurst Road, Worthing, BN11 2DE.

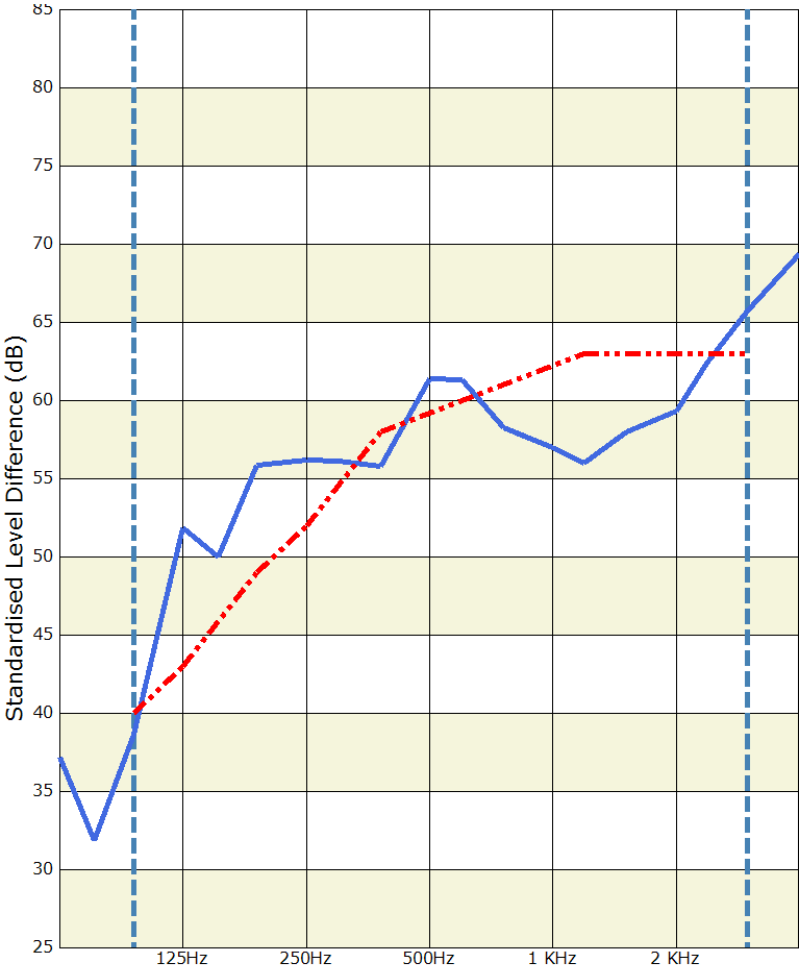
$D_{nT,w}$ (C; C_{tr}) [dB]: 59 (-1, -4) dB
$D_{nT,w}$+ C_{tr} [dB]: 55 dB
Minimum Pass Level [dB]: 43 dB

PASS
Adverse Aggregated Deviations [dB]: 27.5

Test Exceptions (if any): Source Room furnished, 6dB Rule not met

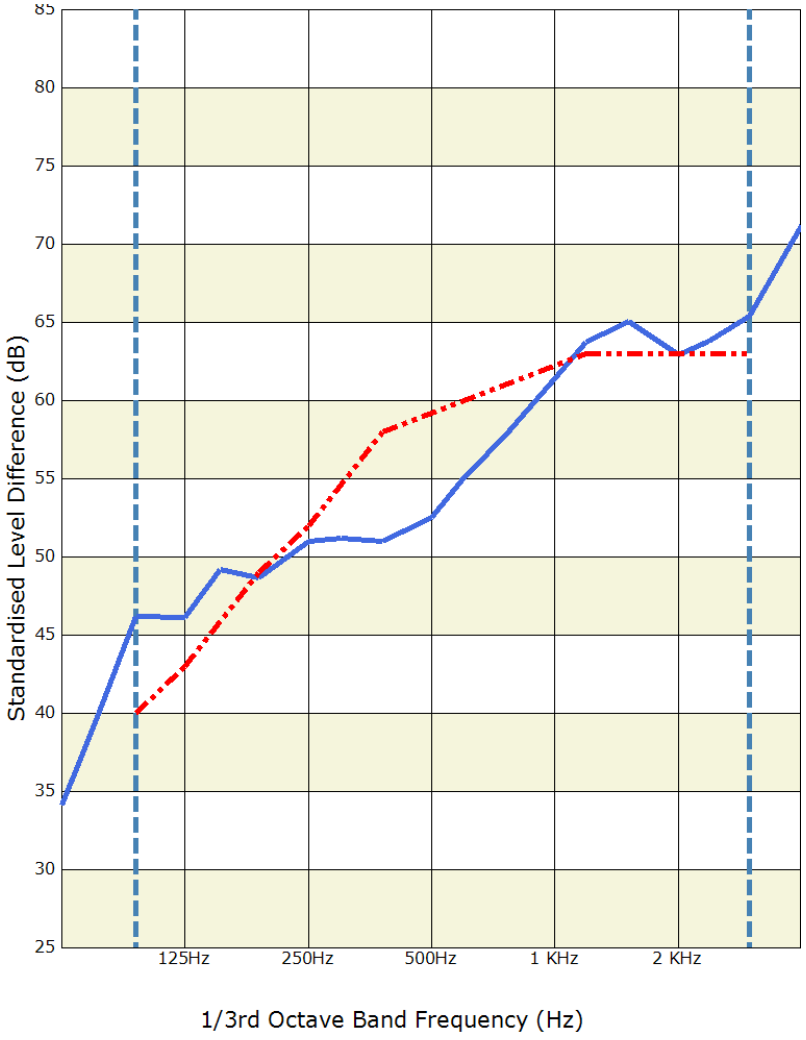
$D_{nT,w}$ (C; C_{tr}) [dB]: 59 (-1, -4) dB
$D_{nT,w}$+ C_{tr} [dB]: 55 dB
Minimum Pass Level [dB]: 43 dB

PASS
Adverse Aggregated Deviations [dB]: 27.4

Test Exceptions (if any): Source Room furnished, 6dB Rule not met
