## Verification Report

Plots 66-67 and 107-109

Barrington Road, Worthing

September 2025

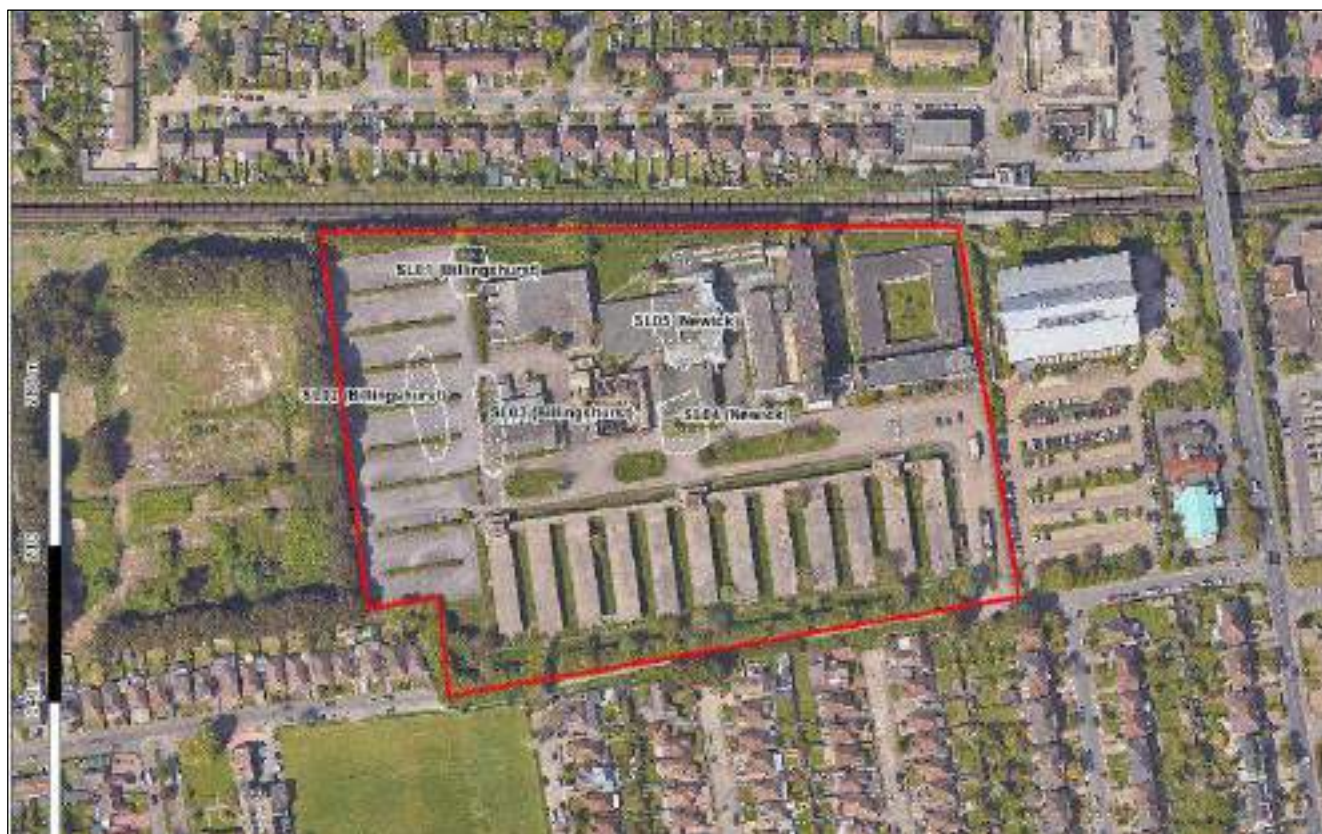
Fig 1 A Stockpile Location

Sampling was evenly distributed across the extent of the stockpiles. Generally sampling was undertaken following the principles of ISO 18400-104:2018 *Soil quality – Sampling - Part 104: Strategies*. Laboratory testing was undertaken on all samples collected for a general suite of organic and inorganic contaminants, as well as asbestos. Laboratory test results are presented within Appendix B. The stockpile location plan is shown below.
