## Verification Report

Plots 54, 57-62 Residential Development

Barrington Road, Worthing

March 2025

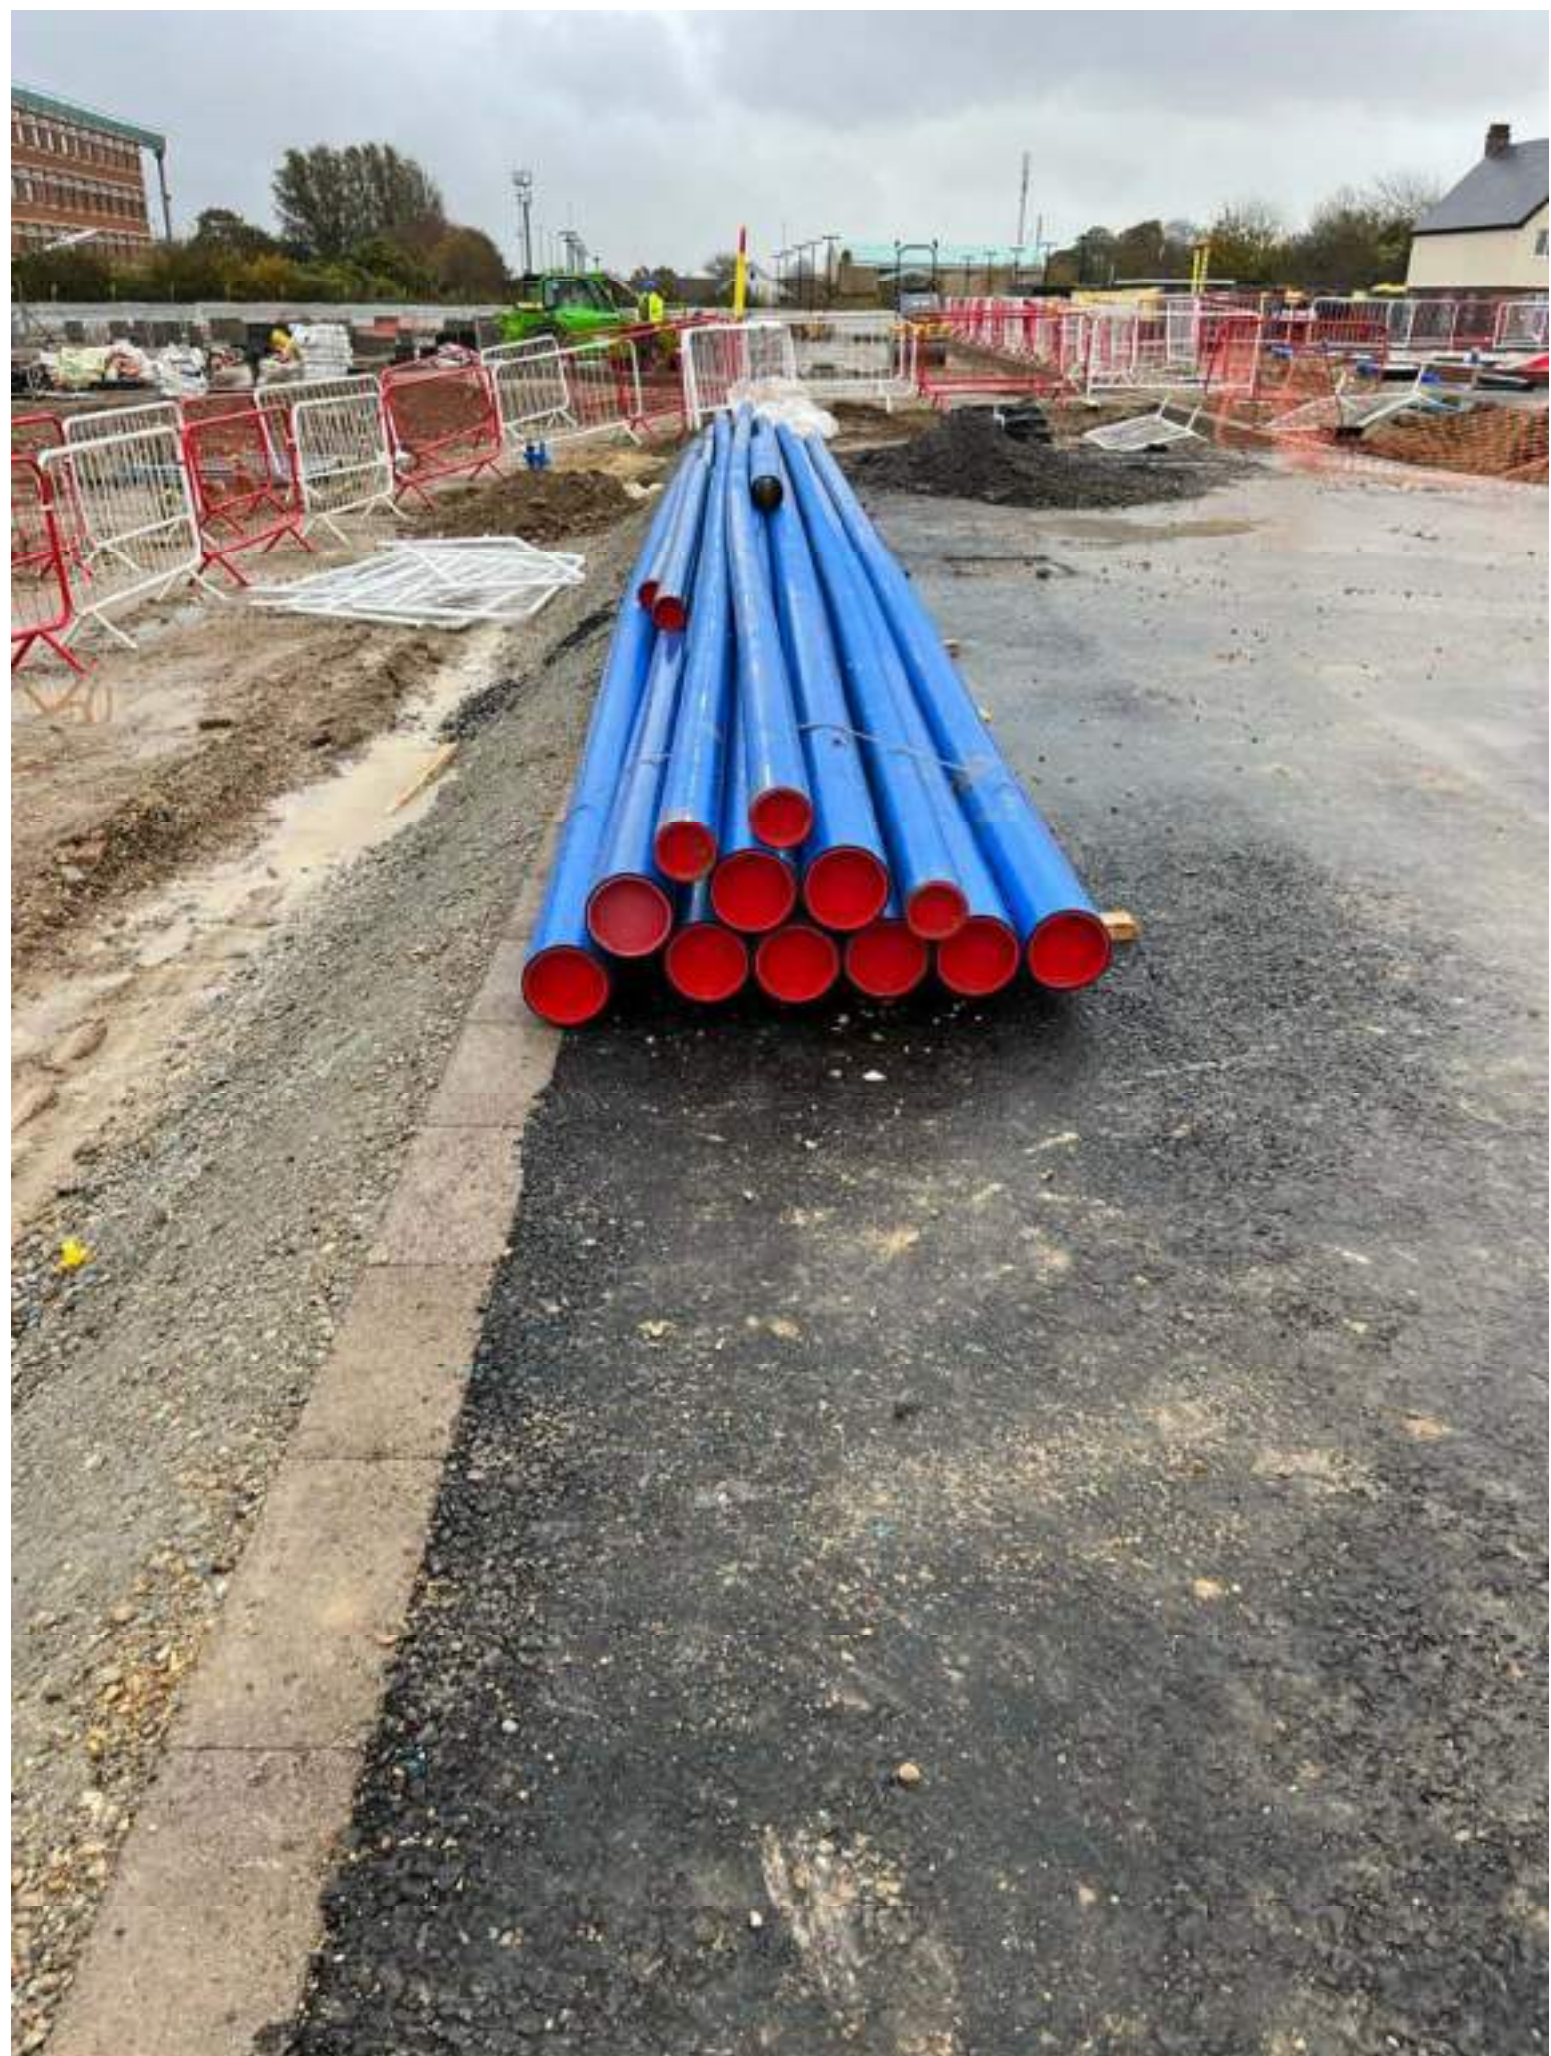
PLOT 40

- 4.3.3 The photographs do not show any evidence of significant hydrocarbon contamination in areas of PE pipework, and protective barrier pipe can be identified by a thick brown line along blue pipework in the relevant plots. It should be noted that an oily sheen can be seen on perched water in one of the trenches exposing the protective barrier pipe, supporting the use of the pipe in this area.
