## Verification Report

Plots 74-77, 80-82, 91-93 Residential Development

Barrington Road, Worthing

Site: Barrington Road, Worthing  
Document Title: Verification Report  
Document no.: STV5959-R27-Rev\_A  
Date: April 2026  
Client: Bellway Homes Ltd (South London)  
Issuing office: Soiltechnics Ltd  
Cedar Barn, White Lodge, Walgrave, Northampton. NN6 9PY  
Tel: 01604 781 877 E-mail: [mail@soiltechnics.net](mailto:mail@soiltechnics.net)

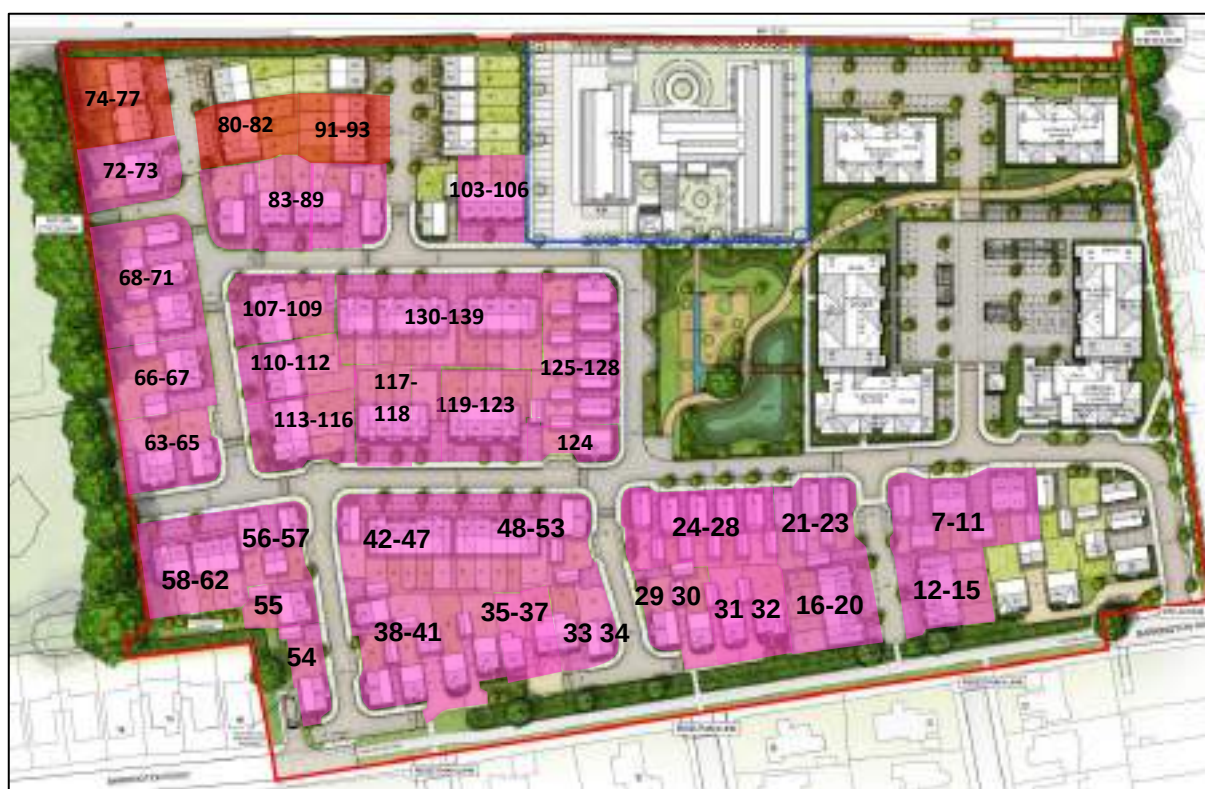
Figure 1-A: Proposed Layout and Plots In Scope

- 1.1.1 The site is located at the former HM Revenues And Customs complex at Barrington Road, Worthing, BH12 4SD.
- 1.1.2 The redevelopment of the site comprises the demolition of the former HMRC buildings and construction of a residential development comprising a mixture of houses, apartments and a care home. Plans of the existing and proposed site layout are provided within Appendix A. This comprises of 139 residential plots, 4 blocks of flats, and a care home.
- 1.1.3 The development is controlled under the Worthing Borough Council planning regime, under the planning application number AWDM/0605/22.
- 1.1.4 This Verification Report is for the verification of all remedial requirements associated with Plots 74-77, 80-82, and 91-93 only. A proposed development plan is included below, with the plots covered highlighted in red, plots verified under previous reports are shown in pink.

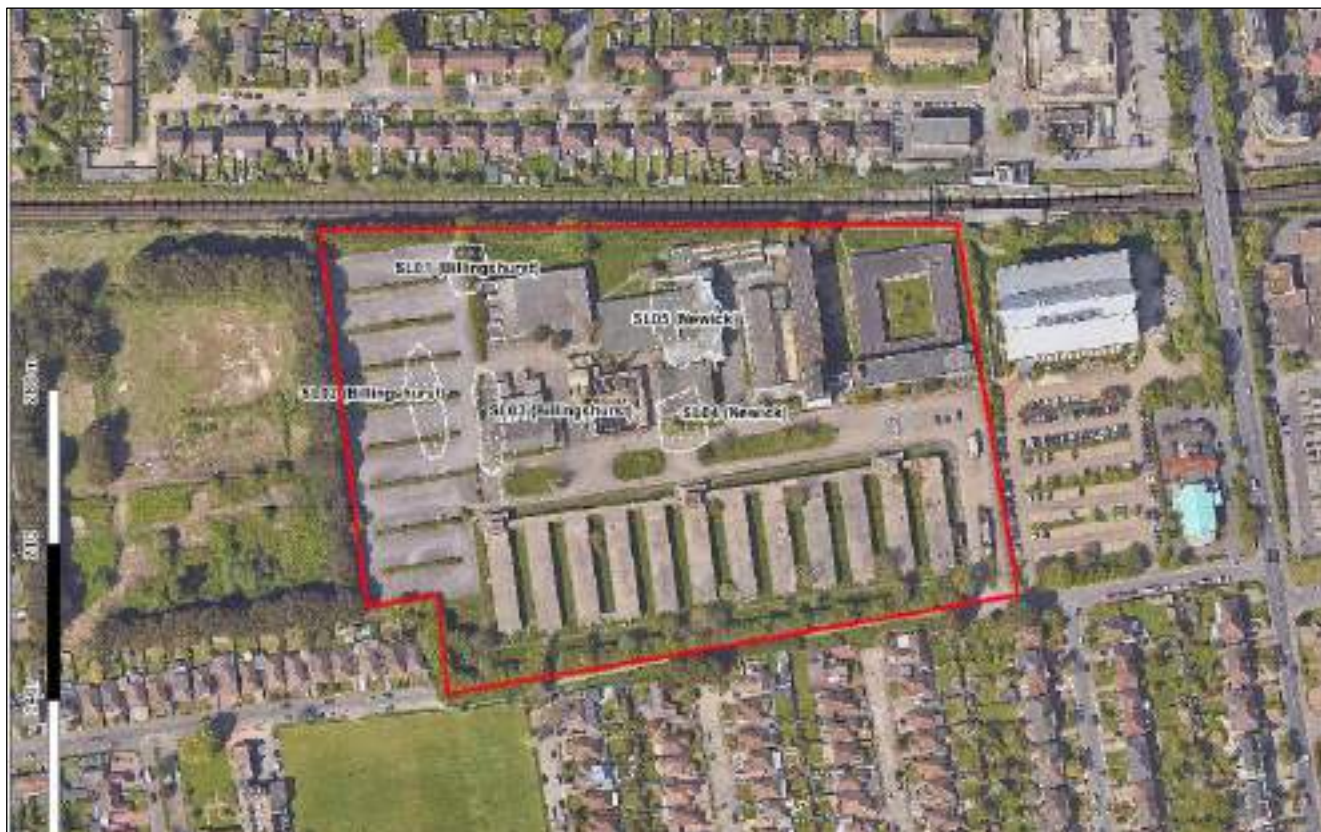
Fig 1 A Stockpile Location

Sampling was evenly distributed across the extent of the stockpiles. Generally sampling was undertaken following the principles of ISO 18400-104:2018 *Soil quality – Sampling - Part 104: Strategies*. Laboratory testing was undertaken on all samples collected for a general suite of organic and inorganic contaminants, as well as asbestos. Laboratory test results are presented within Appendix B. The stockpile location plan is shown below.
