**Lloyds Bank**

**41-43 South St, Worthing BN11 3AU**  
**Wind & Watertight**

# Scope of Works

27<sup>TH</sup> NOVEMBER 2025

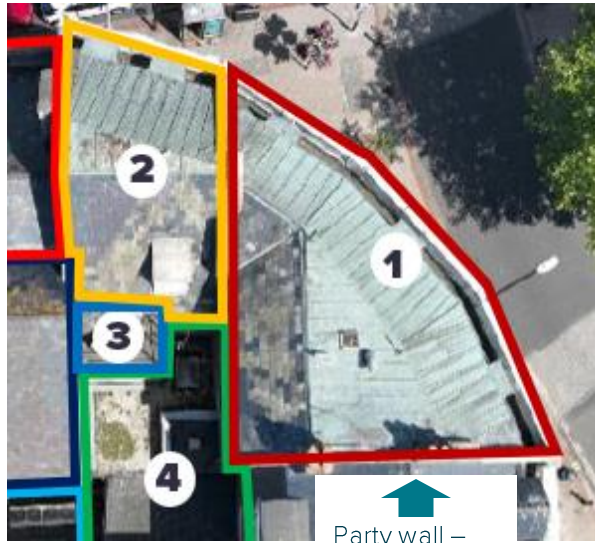
# Roof 1

Party wall –  
parapet wall.

- Repair / refix dislodged, missing or damaged roof slate to match existing.
- Survey condition of copper / asphalt flat sections & flashings at ridge level.
  - Repair existing copper if required.
  - Repair / install new flashings to roof plant exhaust sections.
- Party wall. Review
  - Cracked render finish to determine requirements.
  - Assess parapet coping stone to confirm details / requirement to make W&WT.
- Remove vegetation & accumulated debris from front elevation box gutter / surround area.
- Paint finish has failed to upper section of parapet stone to front elevation.
  - Prepare & decorate.
- Remove moss & vegetation from parapet etc. repoint and make good as necessary.
- Replace leaf guards in box gutter outlets.
- Clear gutters and downpipes.

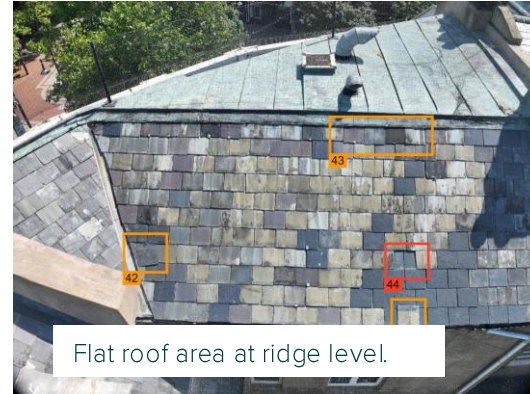
Flat roof area at ridge level.

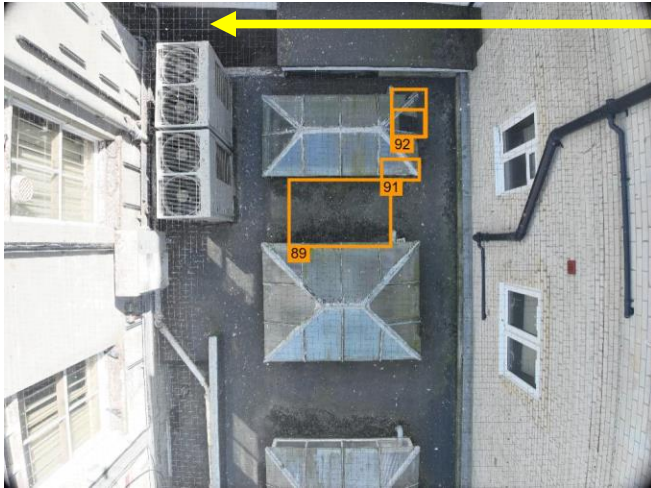
# Roof area 5.

Recessed roof extending into a void beneath residential property.

- Patch repair roof surface including flashings to walls
- Remove 3No. Corroded and damaged lantern lights complete.
  - Install new box construction over existing openings, suitably flashed to existing roof surface.
- Remove vegetation and debris from roof surface.
- Refix single ACU which has been dislodged from support base.
- Wall face beneath Roof 5. Remove, repair and replace defective render where cracking is evident.
- Remove foam and install suitable, recognised wall infill detail surround to incoming cable trays.
- Clear bird guano from window sills.
- Ensure existing bird mesh is complete and inaccessible by birds. Mitie

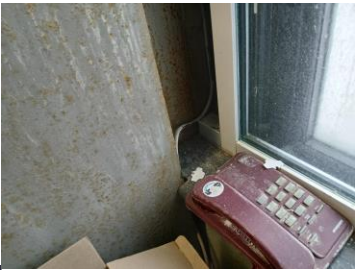
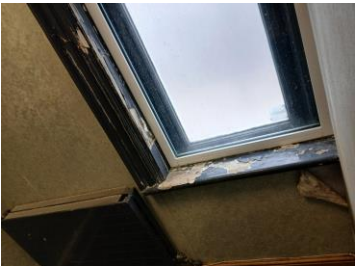
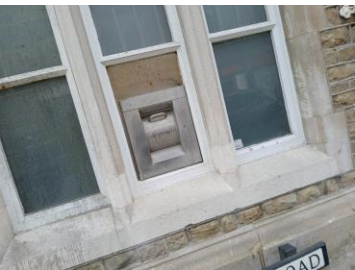
Admin room. Existing night safe is no longer used and redundant.  
The understanding is that it is acting as a cold bridge and introducing condensation to the surround structure.

Alternative source of ingress could be the flashing over the ground level shopfront.  
Survey required to determine remedial works.  
Bird spikes to be replaced alongside this work.

Wates would recommend that this to be removed in due course.
