## Damp and Timber Report

Date of Survey: 18/12/2025

Site address: The Old Scantling's, 26 Church Street, Shoreham by Sea, BN43 5DQ

Surveyor: Matilda Jacobs-Milburn

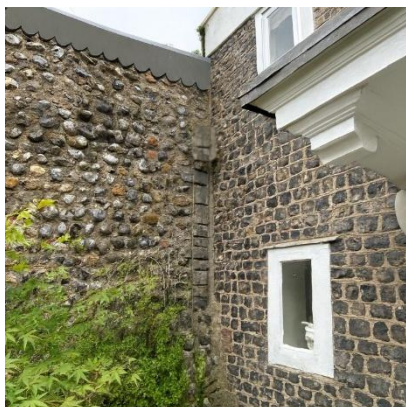
The partition garden wall between The Old Scantlings and the neighbouring property shows signs of long-term moisture ingress, with cracks, undulations, and vegetation growth indicating saturation. Rainwater currently pools on the top surface, allowing moisture to soak into the wall and become trapped within the masonry.

To prevent further water penetration and allow the wall to begin drying, the following work is recommended:

- Dress the top of the wall with lead sheeting to create a continuous, waterproof capping.
- The lead should be chased securely into both The Old Scantlings and the neighbouring property's wall, forming a smooth and watertight junction along the entire length of the wall top.
- The lead should overhang approximately 0.5 to 1 metre on each side to direct rainwater clear of the wall faces.
- The finished edge of the lead should be slightly flicked outwards, ensuring that rainwater is propelled away from the wall rather than running down its surface.

- The visible edge may be finished with a scalloped or other decorative detail to create a neat and sympathetic appearance in keeping with the historic setting of the property.
