Flood Risk & SuDS Assessment

51-63 Southview Road, Southwick BN42 4TS

S. D. Holdings Ltd
4A Southview Road
Southwick
West Sussex
BN42 4TU
Ref: 12383
Date: January 2026

GTA Civils & Transport Ltd
Maple House
192 – 198 London Road
Burgess Hill
West Sussex
RH15 9RD
Tel: 01444 871444

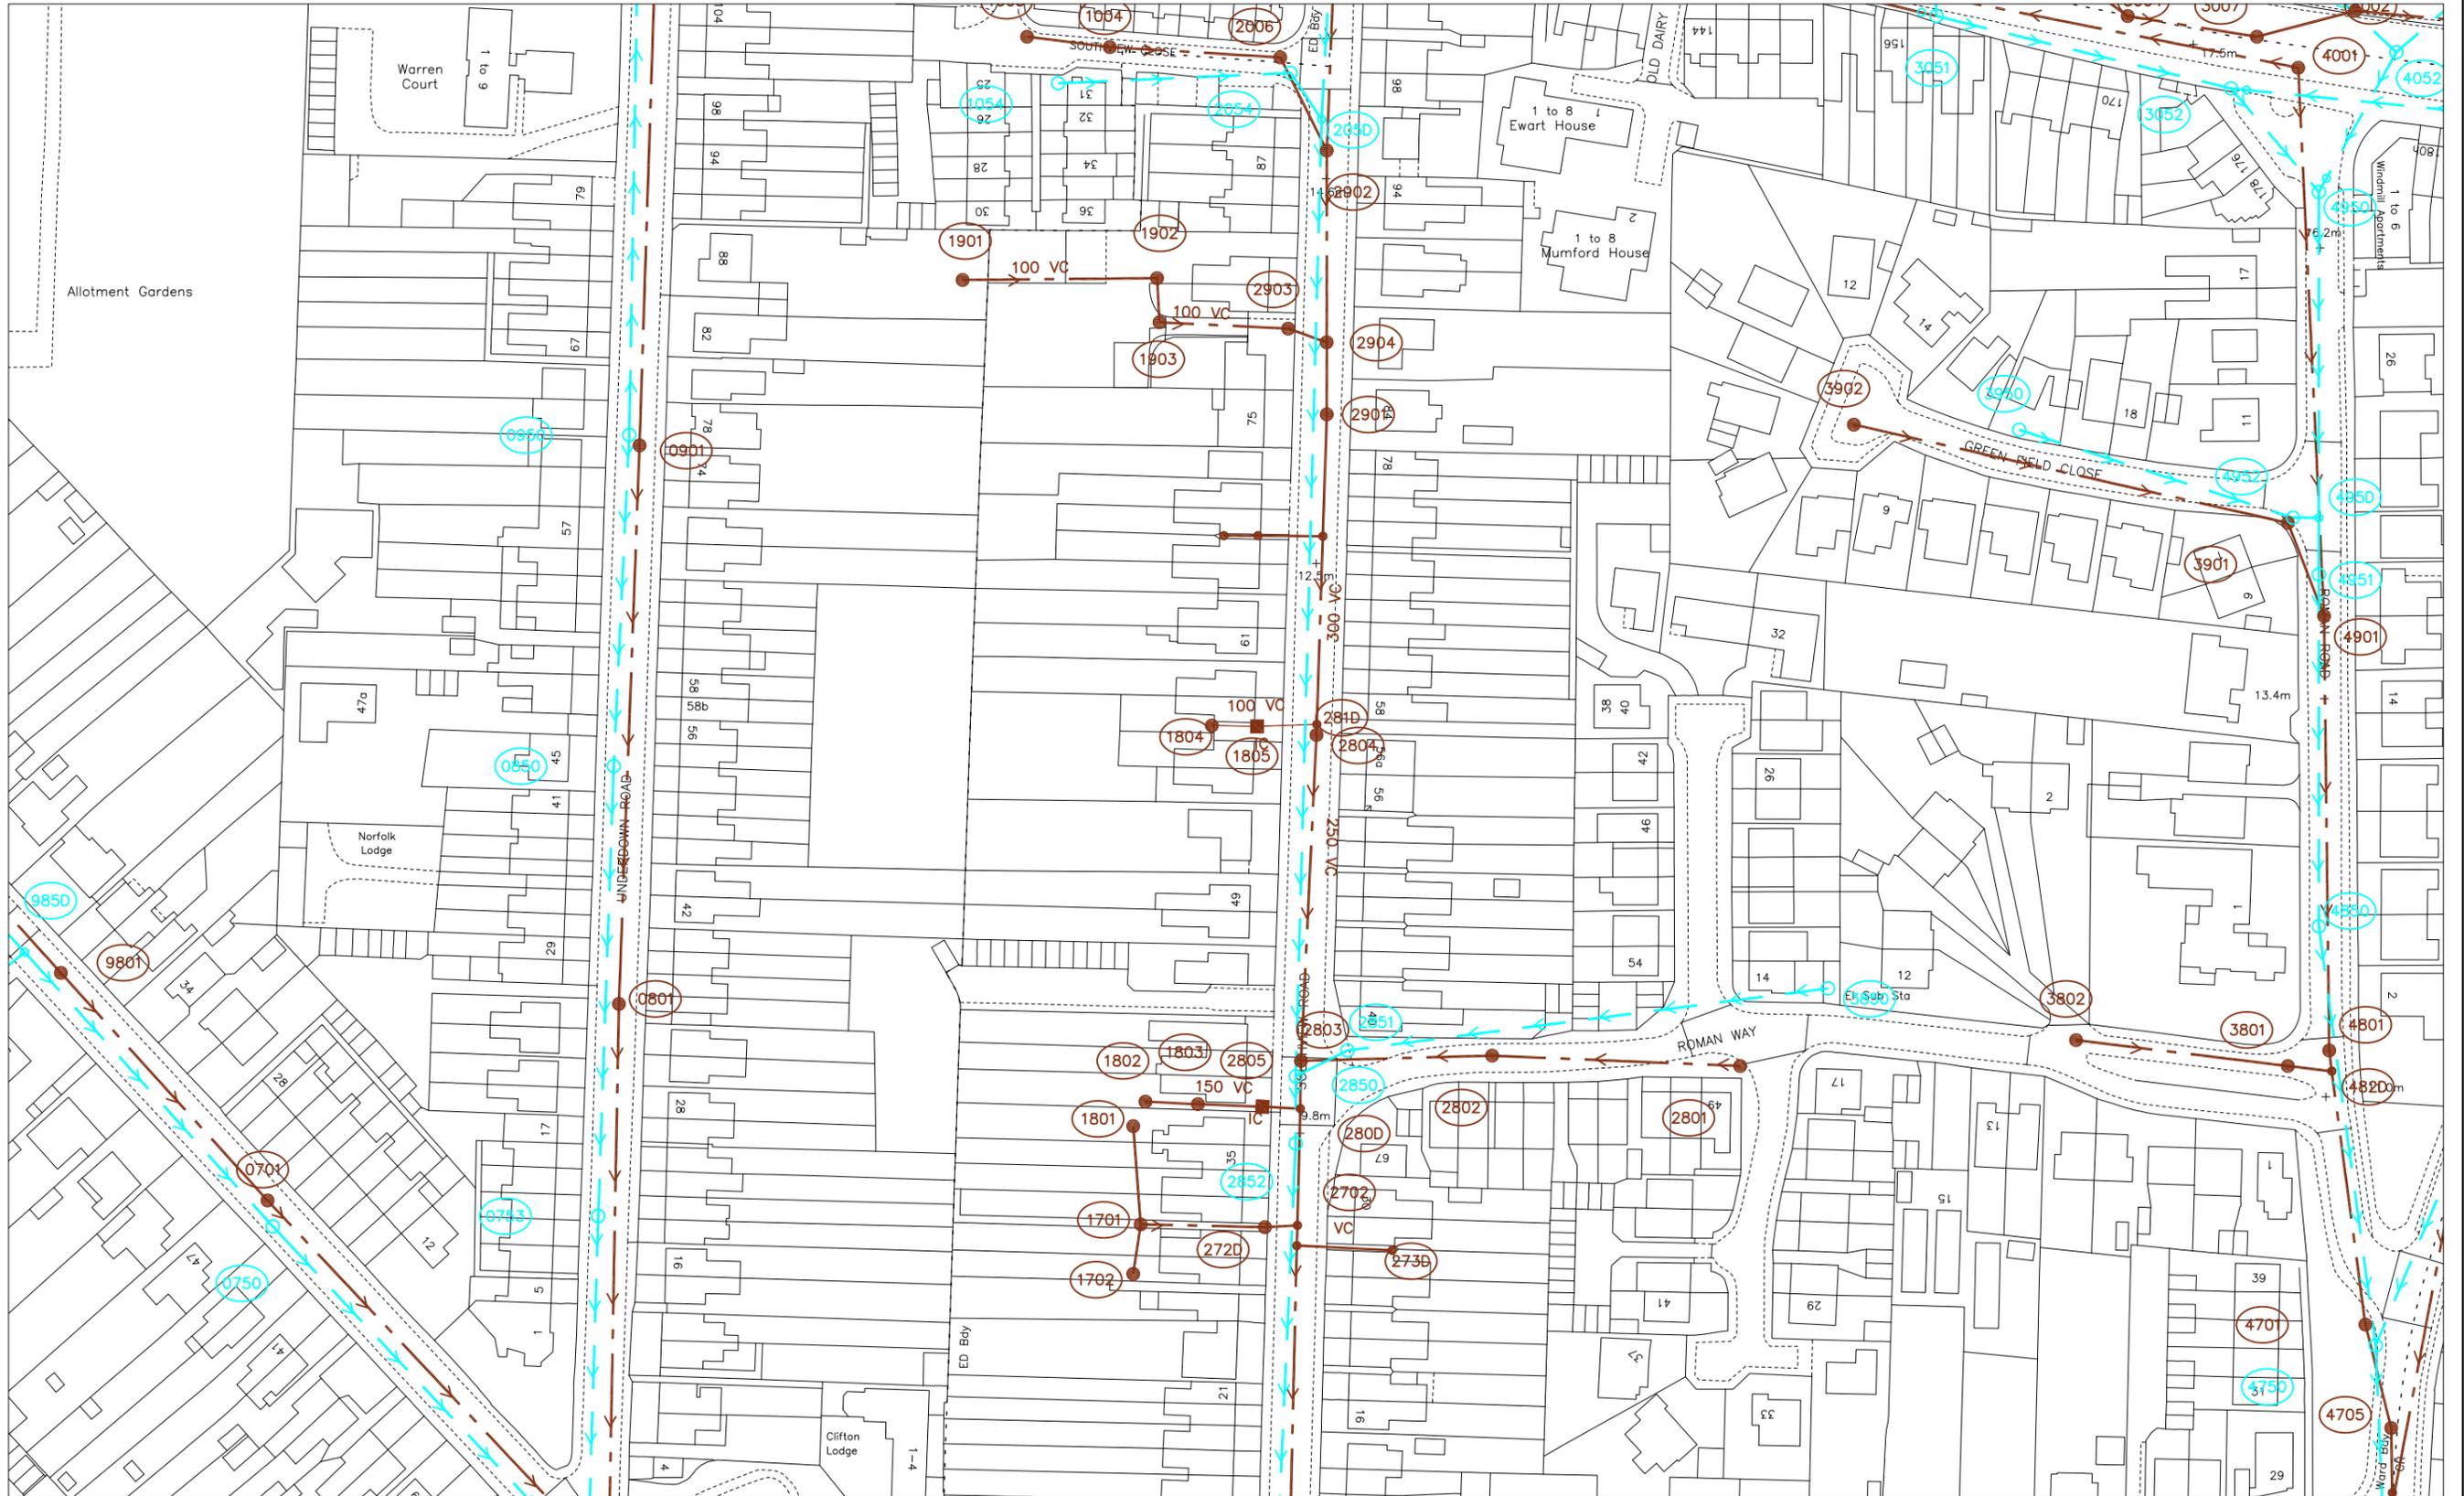
SEWER RECORDS PAGE 1 OF 2

O.S. REF. TQ2405NW	Drawn by: gujskew	The positions of pipes shown on this plan are believed to be correct, but Southern Water Services Ltd accept no responsibility in the event of inaccuracy. The actual positions should be determined on site. WARNING: BAC pipes are constructed of Bonded Asbestos Cement WARNING: Unknown (UNK) materials may include Bonded Asbestos Cement

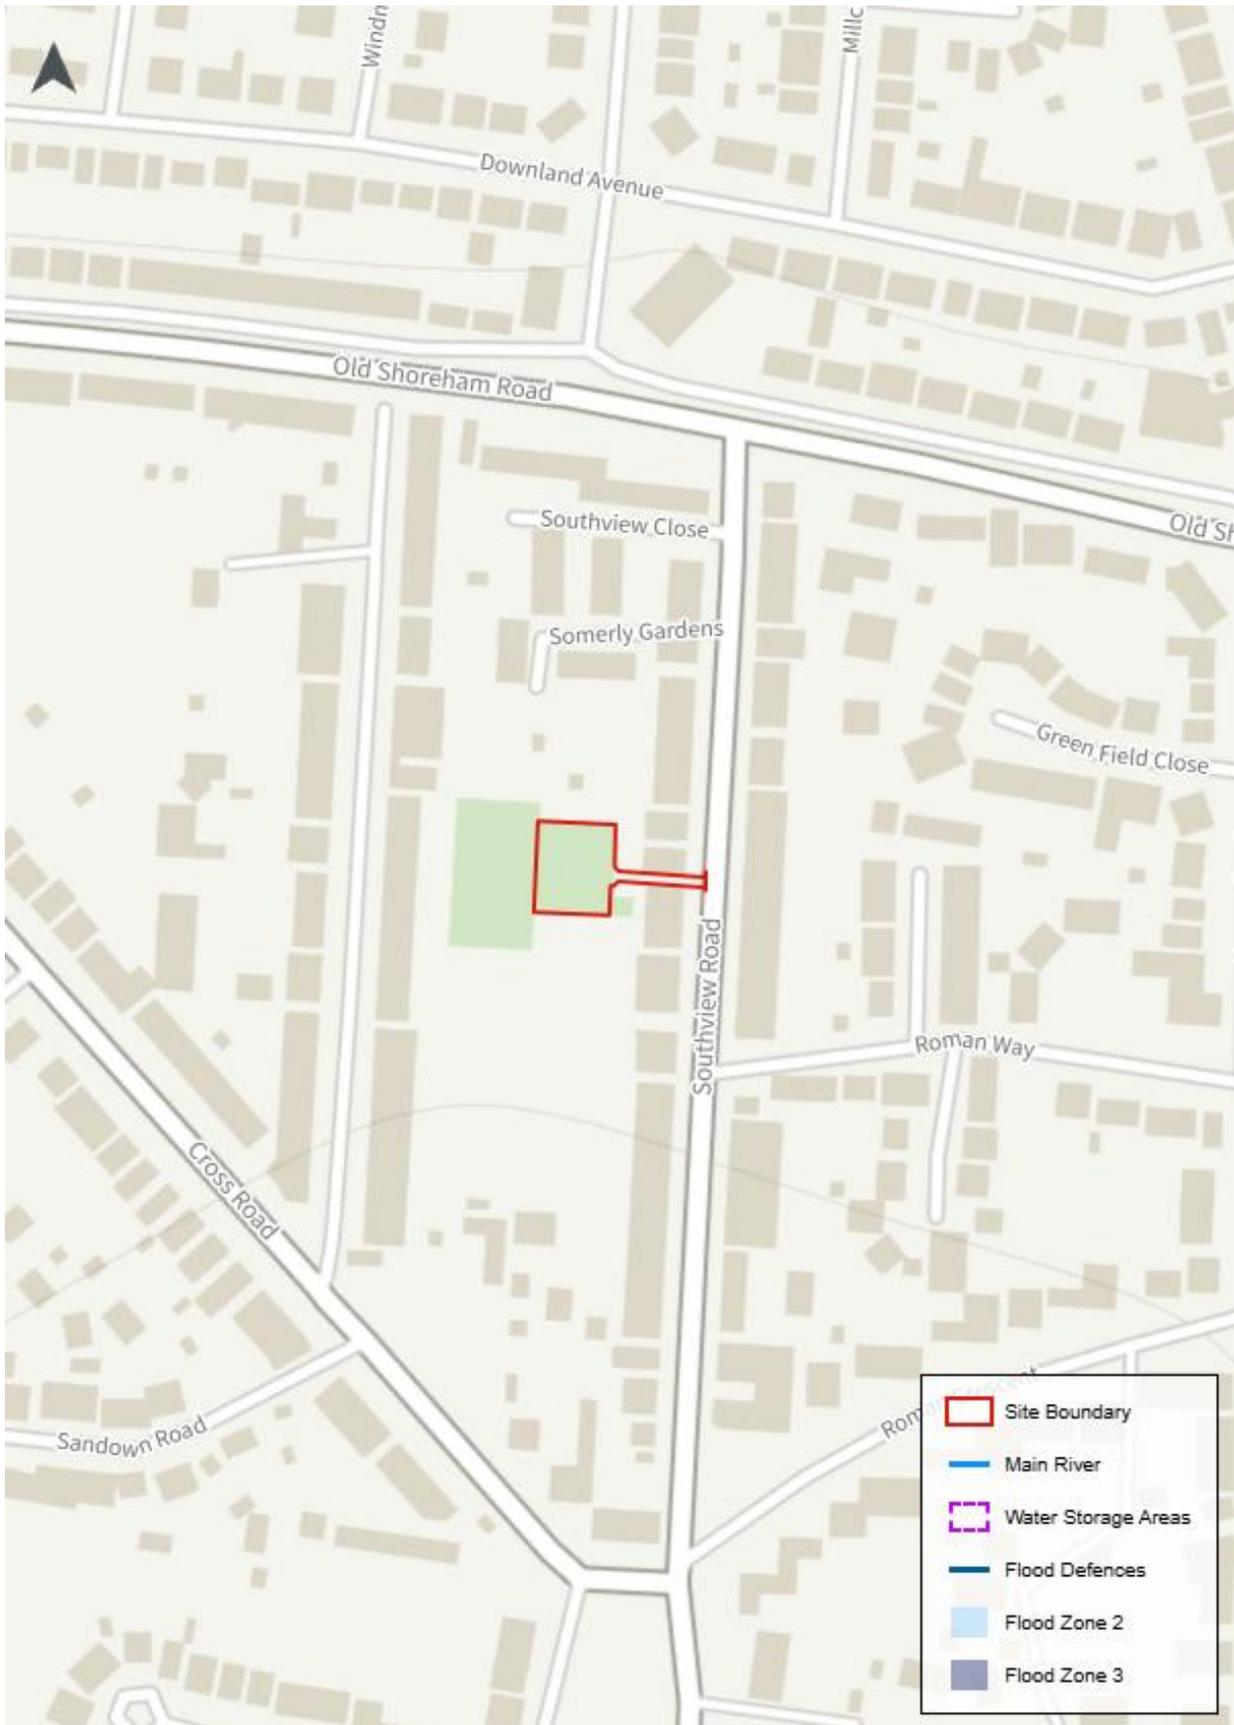
Environment Agency Flood Map for Planning

The site is located in fluvial Flood Zone 1

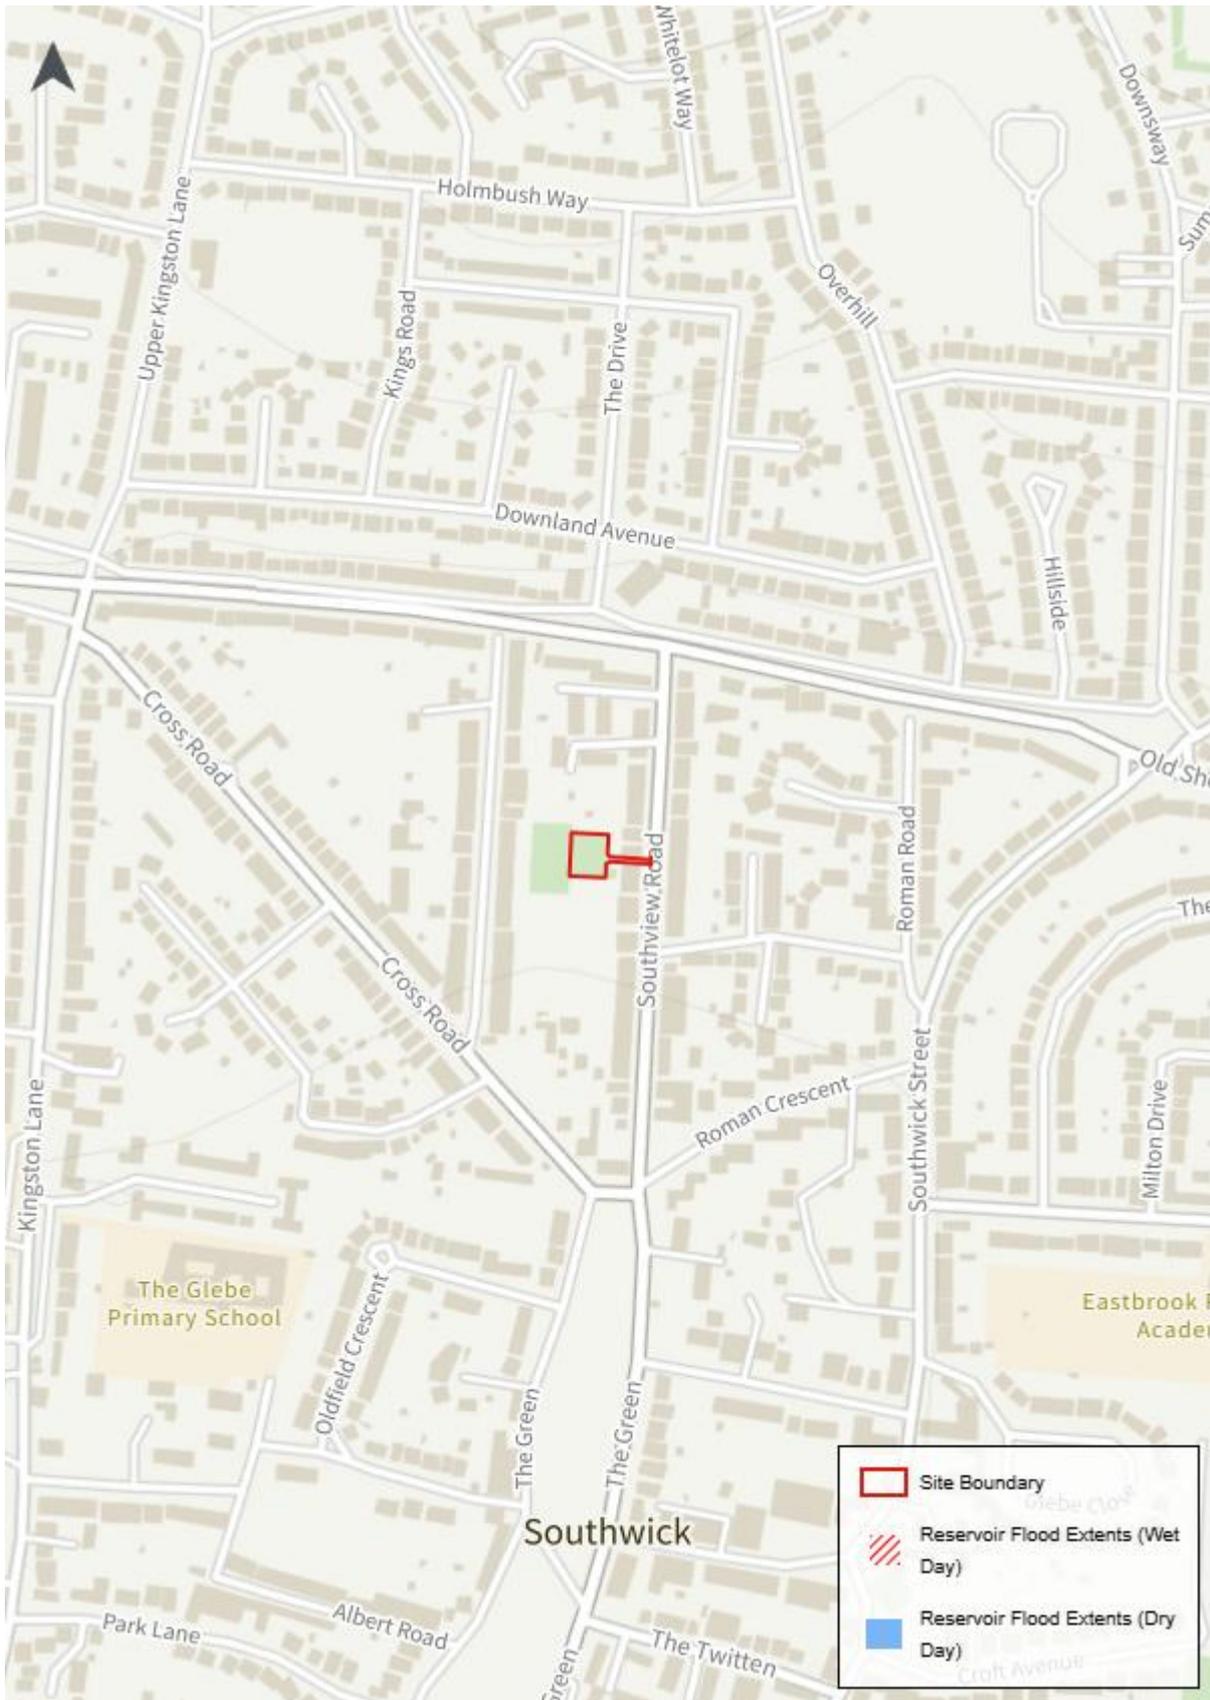
Environment Agency Flood Risk from Reservoirs

The site is clear from the risk of flooding from this source

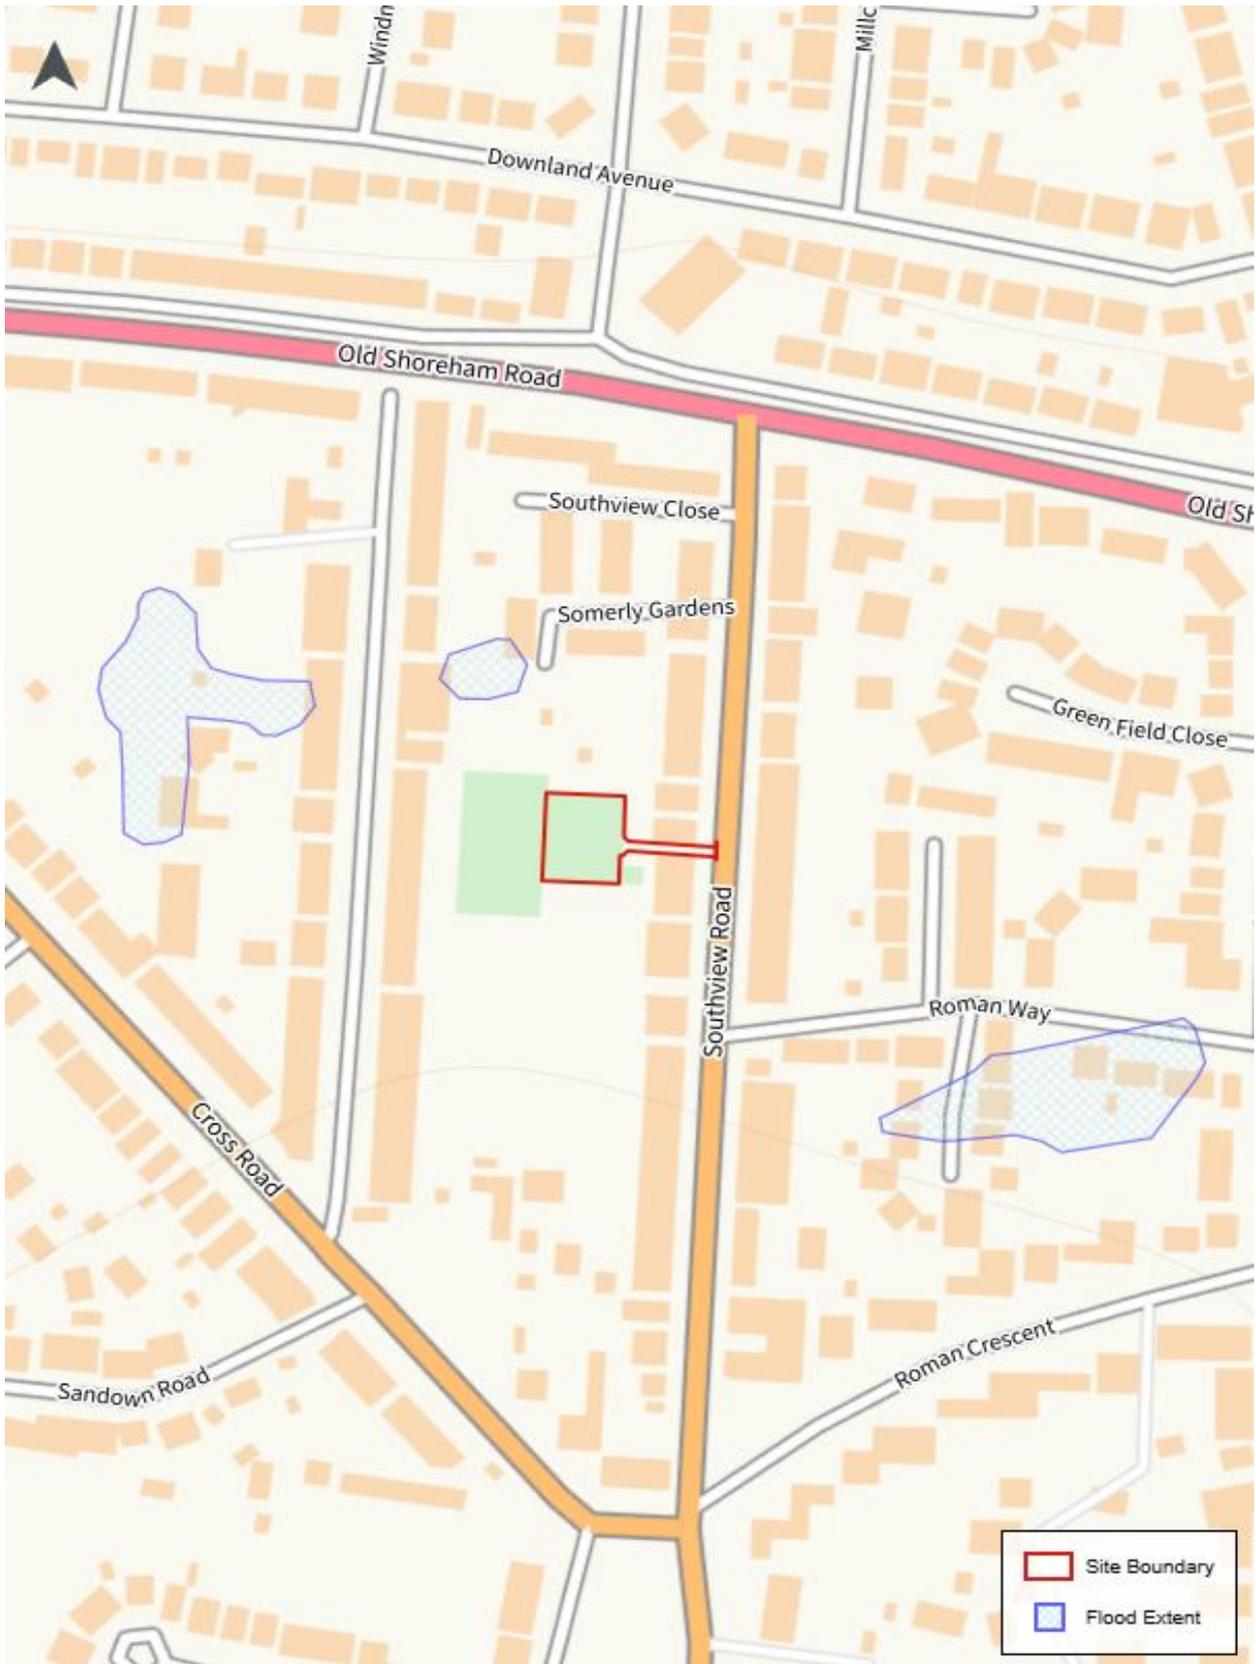
DEFRA Historical Flooding Map

Neither this site nor anywhere in the vicinity has been affected by flooding in the past

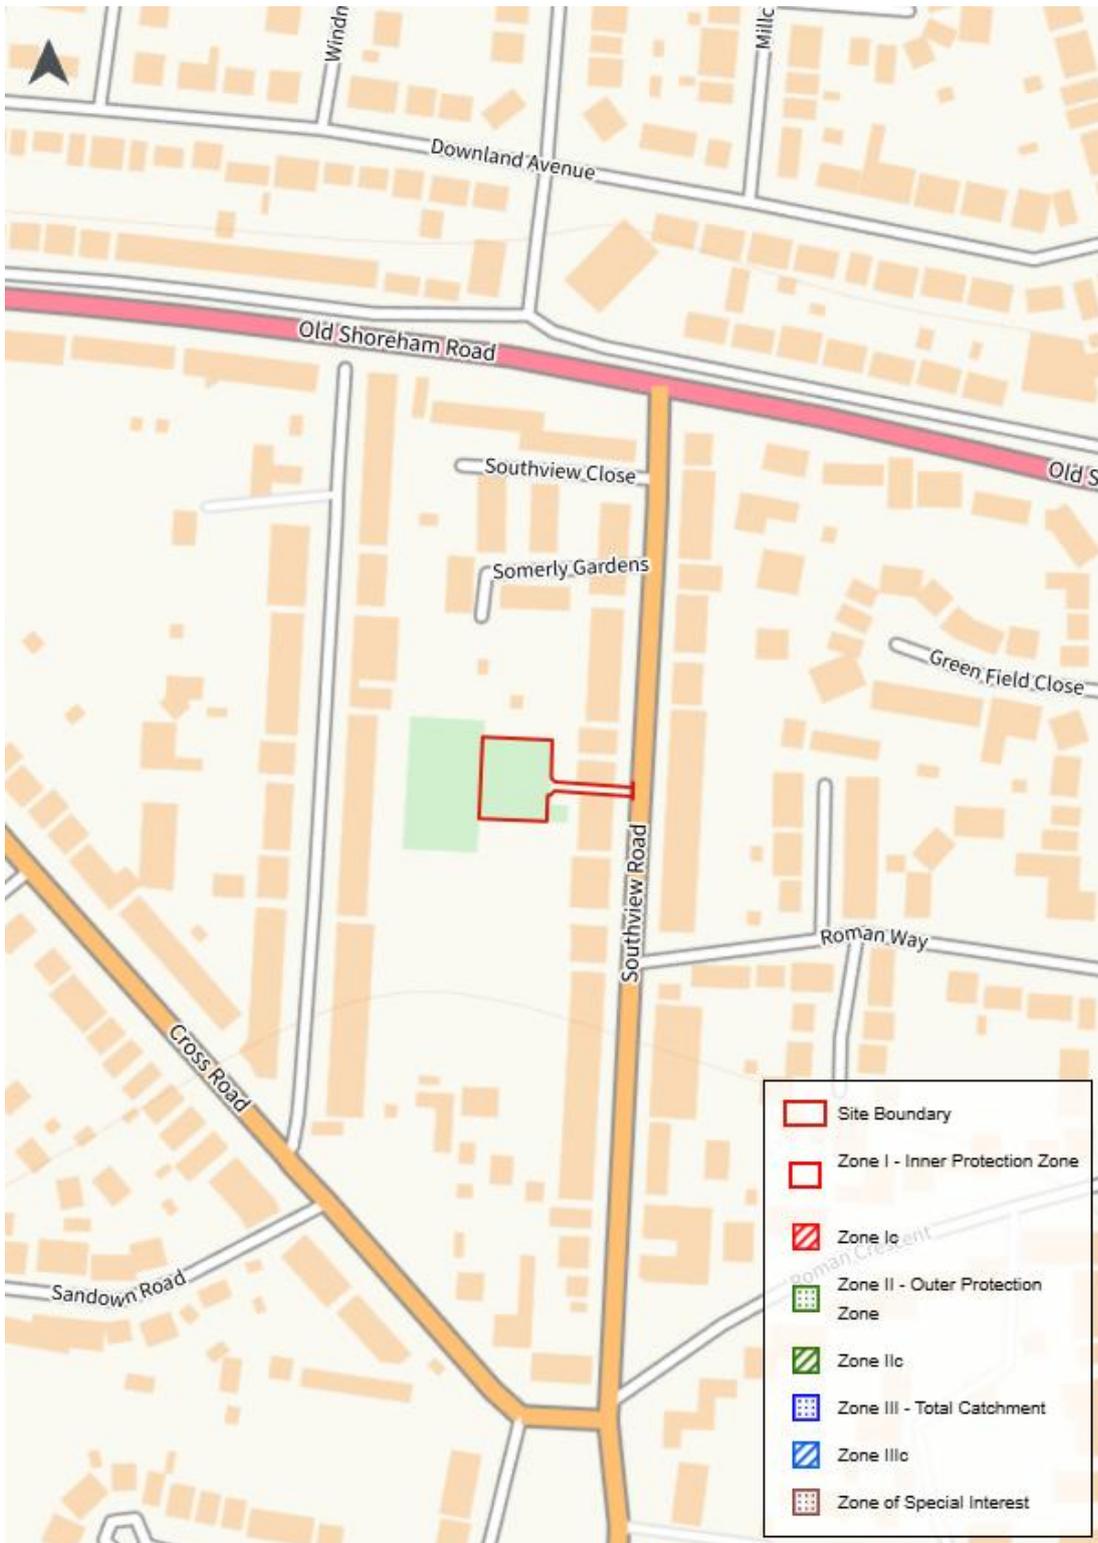
Environment Agency Groundwater Source Protection Zones Map

The site is removed from the nearest Groundwater Source Protection Zone

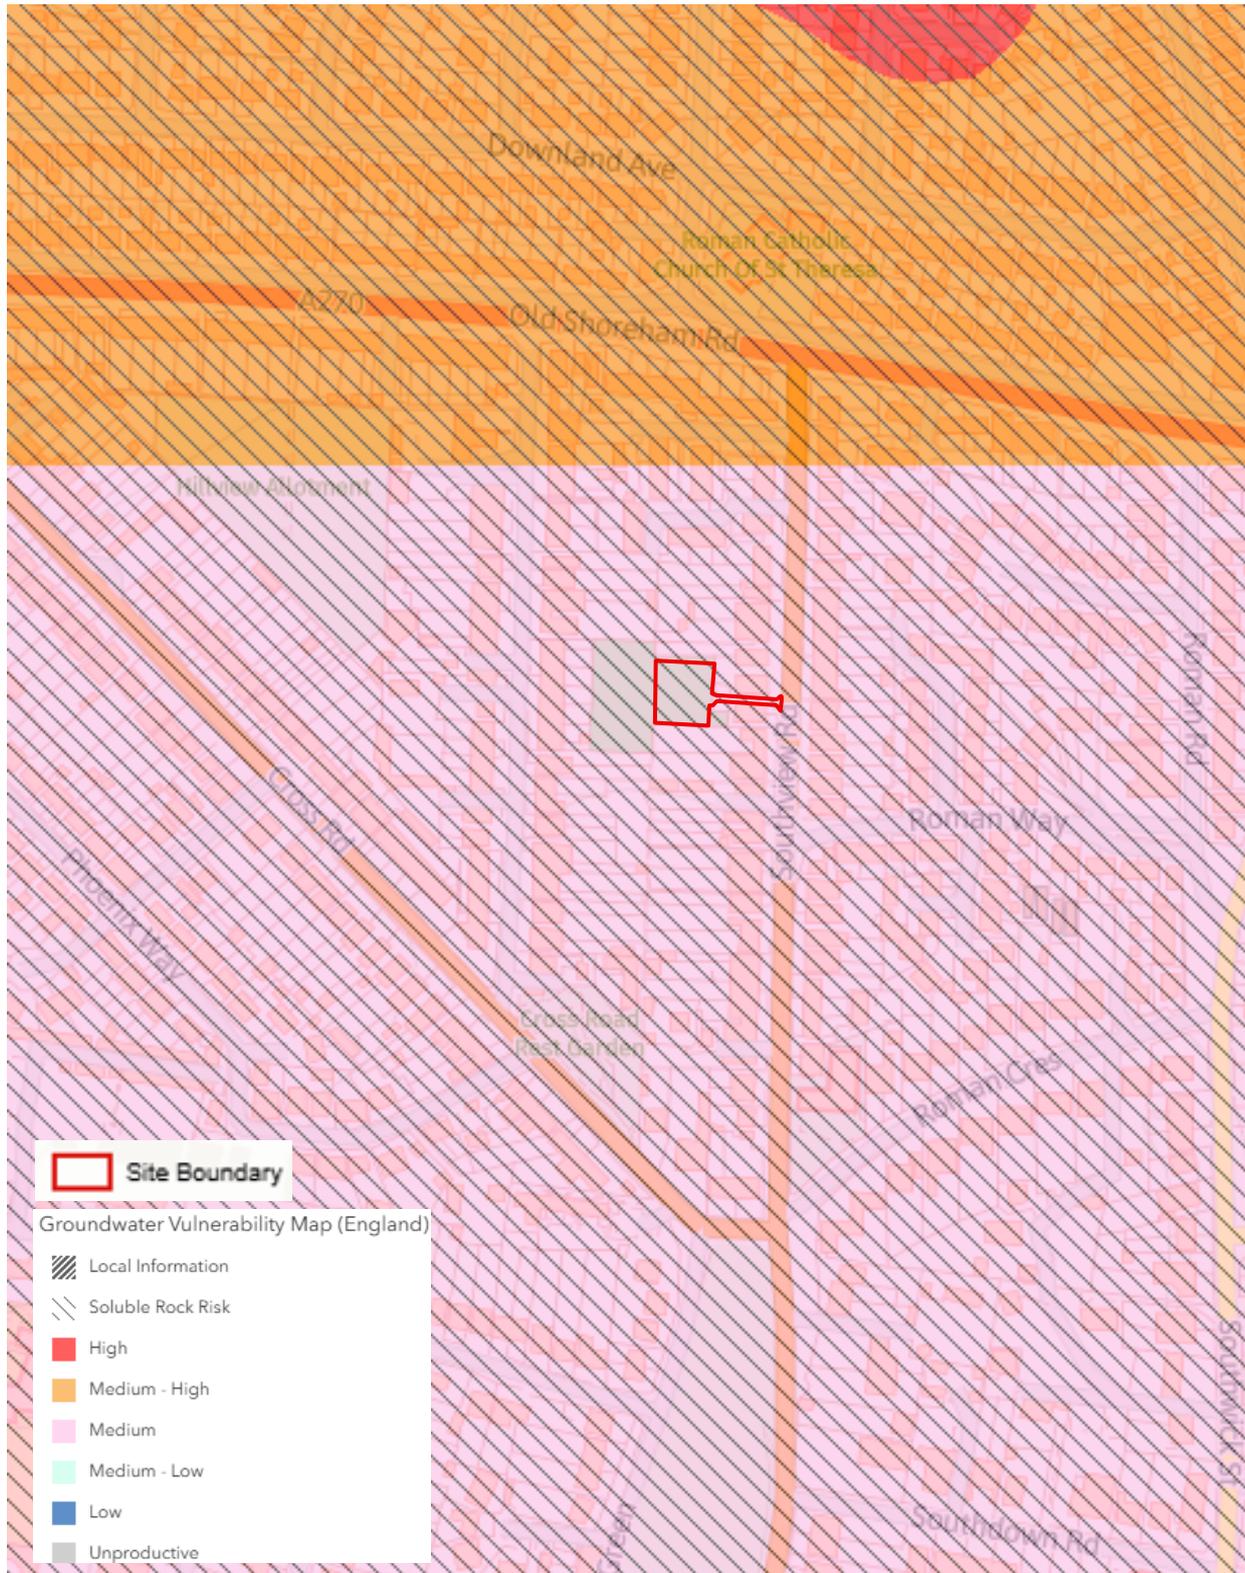
Environment Agency Groundwater Vulnerability Zones Map

The site overlies a Medium Groundwater Vulnerability Zone

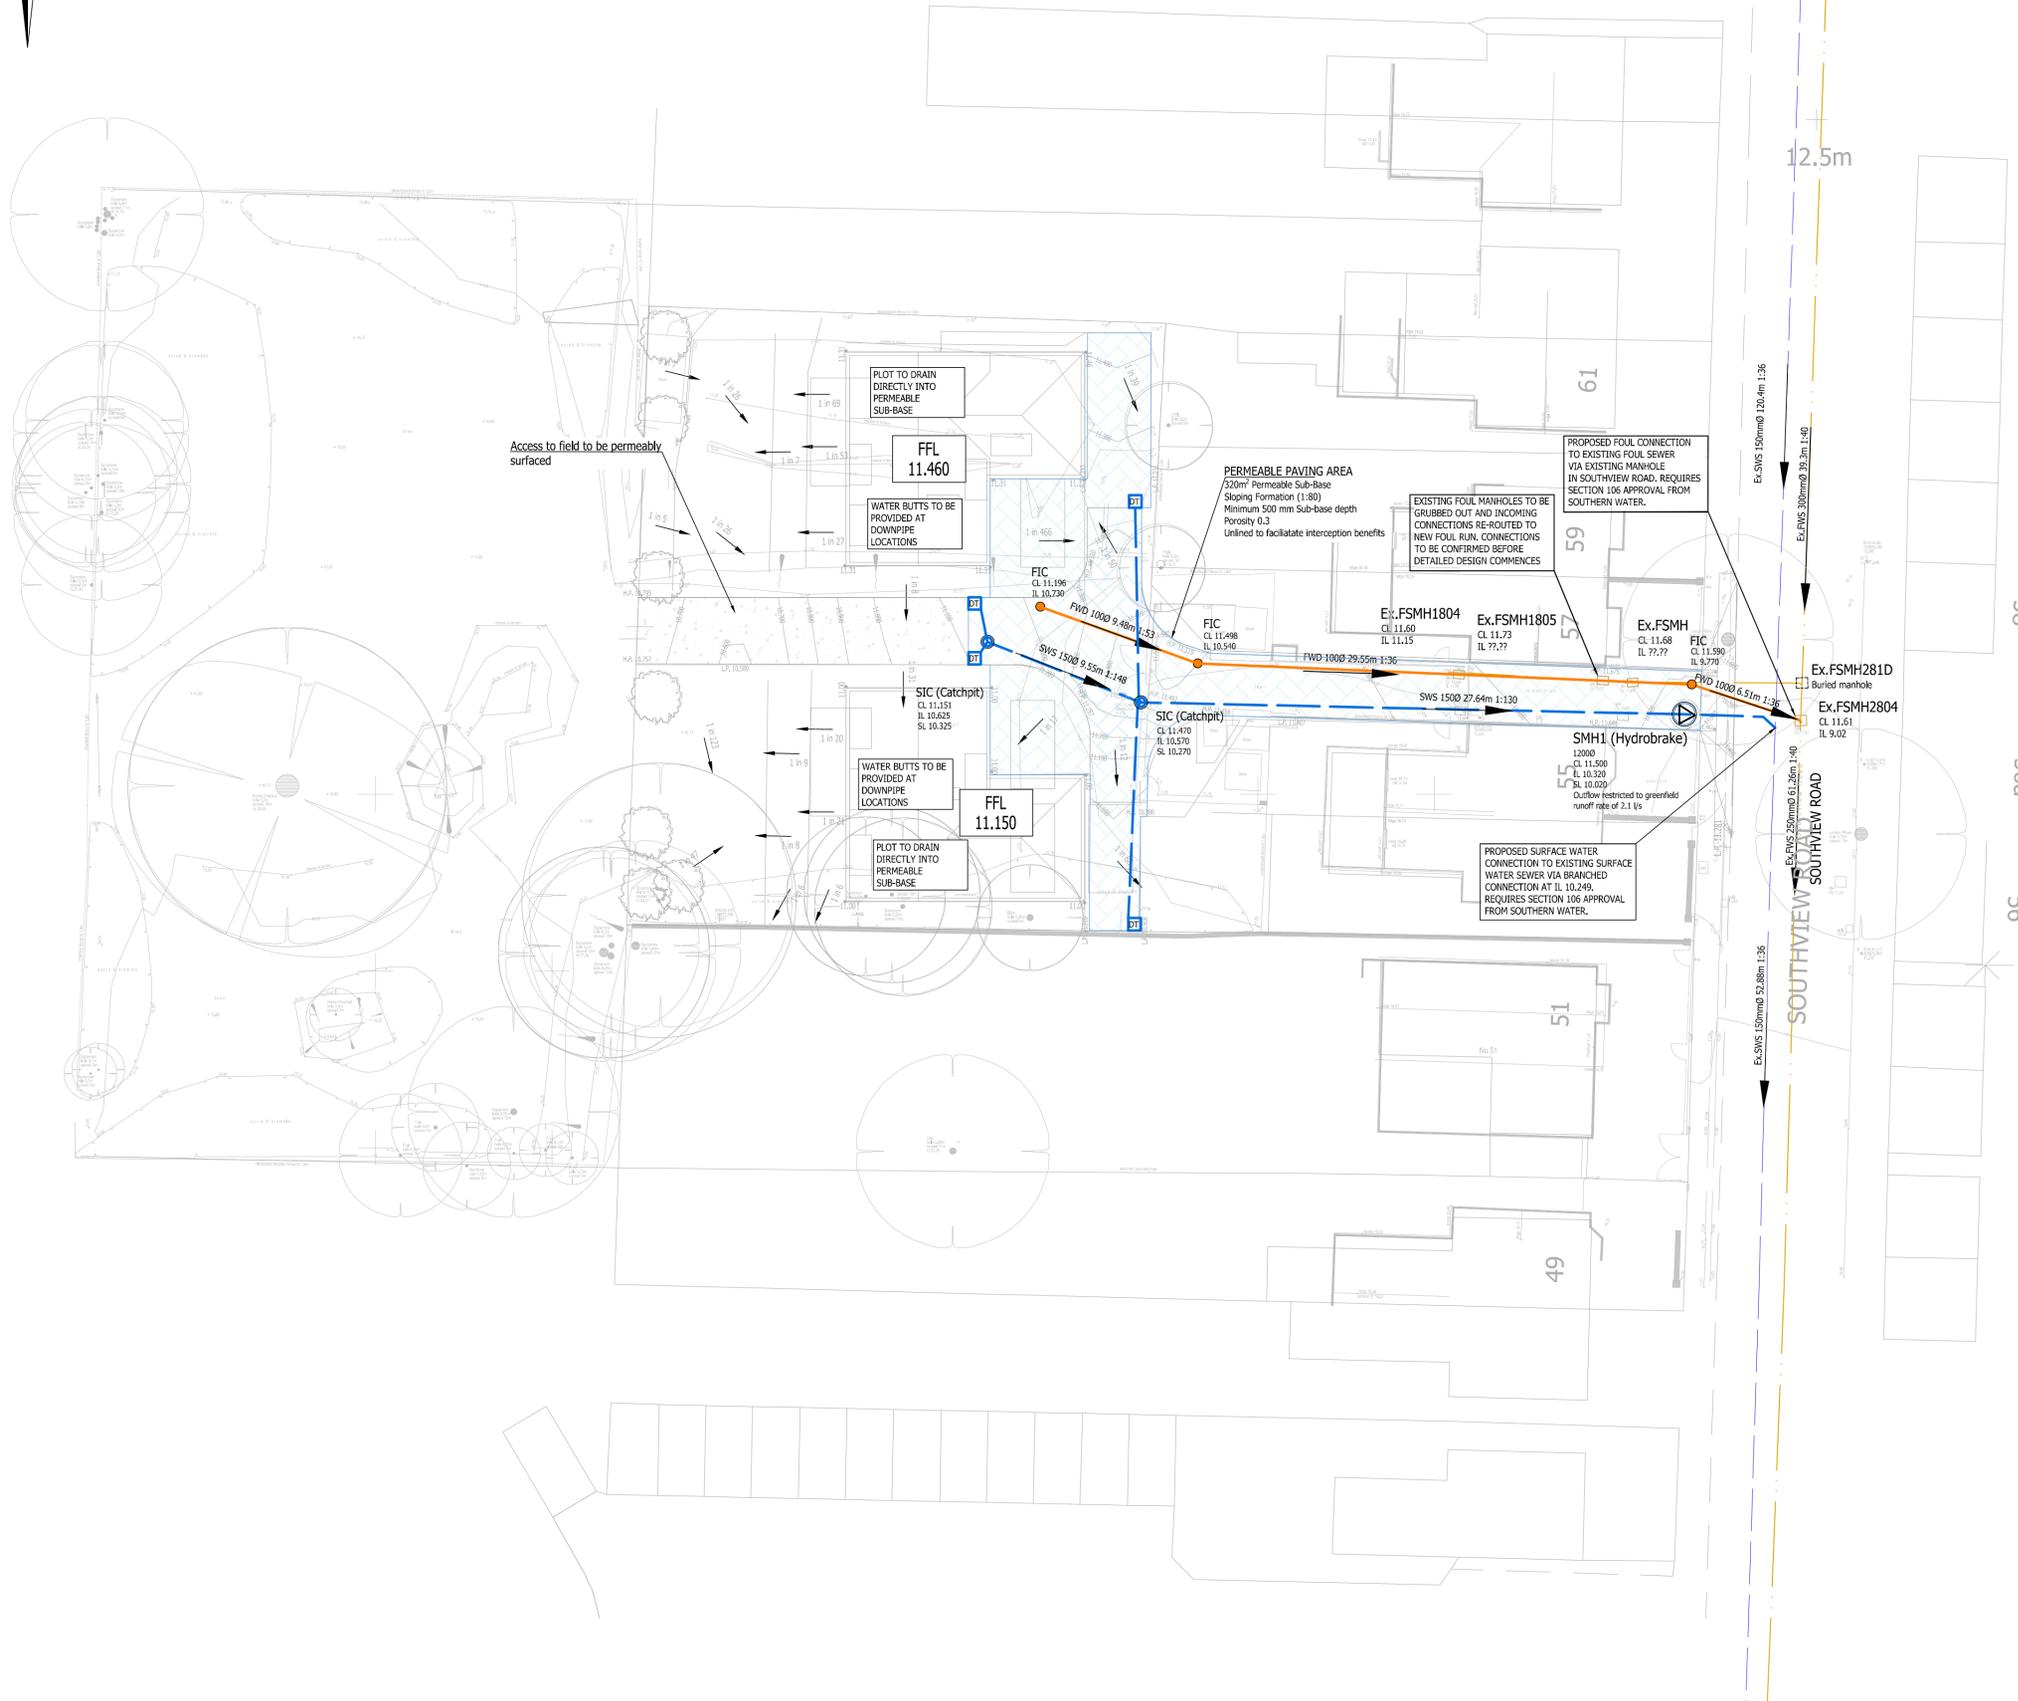
Proposed Drainage Strategy Layout

- RAINWATER STORAGE DESIGN BASED ON 1 IN 100 YR STORM + 45%.
- APPROVAL TO BE GAINED FROM SOUTHERN WATER FOR CONNECTIONS TO FOUL AND SURFACE WATER SEWERS.
- CONTRACTOR TO ALLOW FOR NEW FOUL AND SURFACE WATER SEWER CONNECTIONS INTO SOUTHVIEW ROAD.
- INVERT LEVEL OF STORM SEWER AT PROPOSED POINT OF CONNECTION HAS BEEN INTERPOLATED FROM SEWER RECORDS. CONTRACTOR TO CONFIRM SEWER'S INVERT LEVEL AS EARLY AS POSSIBLE TO INFORM DETAILED DESIGN.

Status	PRELIMINARY			
Client	S.D. HOLDINGS LTD			
Architect	CIRCLE25 DESIGN			
Project	LAND TO REAR OF 53-61 SOUTHVIEW ROAD, SOUTHWICK			
Title	SITE DRAINAGE			
Date	FEBRUARY 2023	Scale @ A1	1:200	
Clients Ref.	Project Ref. 12383

3.9 The water will be treated by the sub-base granular fill. The filtration qualities of coarse fill are excellent and, in this way, the quality - cleanliness - of water as it joins the sewer will be high. Table 26.2 of CIRIA’s SuDS Manual shows that residential developments have pollution hazard indices as follows (overleaf):

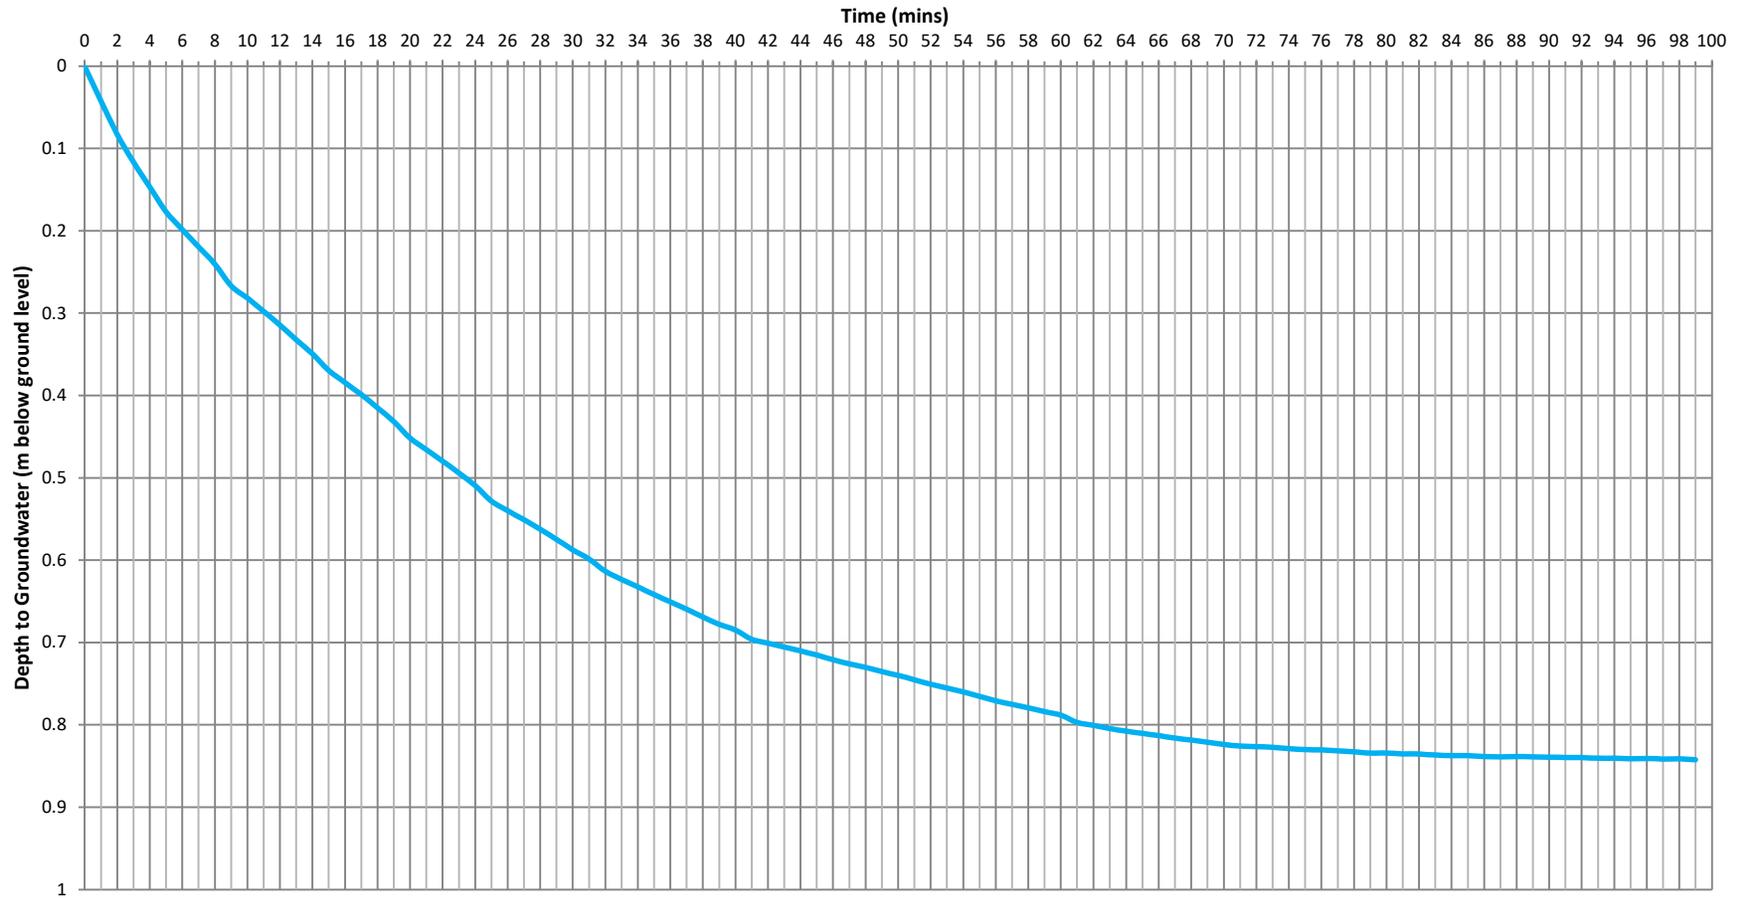
Report No. P14278

Groundwater Monitoring Results - TP105 Test 4
