Project  
**1094SM St Marys**

Discharge of Conditions  
CONDITION 09: Materials

## CONDITION 09: MATERIALS DETAIL

**Ref: AWDM/0082/26**

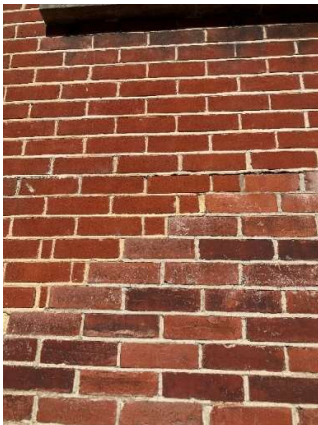
*Area of brickwork repair to New Road stair showing highlighting tonal variation in original Edwardian brickwork (lower portion).*

The existing unpainted brickwork to the New Road elevation has been repaired and remodelled in a number of areas. Brickwork original to the Edwardian construction comprises bricks of uneven plane, creasing and texture laid to imperial courses (305 - 310mm per four courses) using bricks that are 65-67mm high and 220 -230mm long. Mortar joints vary in character (possibly reflecting areas of repair) but are generally

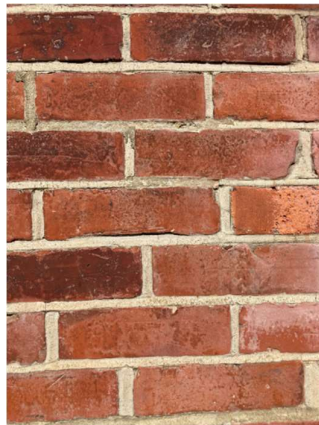
*Typical area of original Edwardian brickwork.*

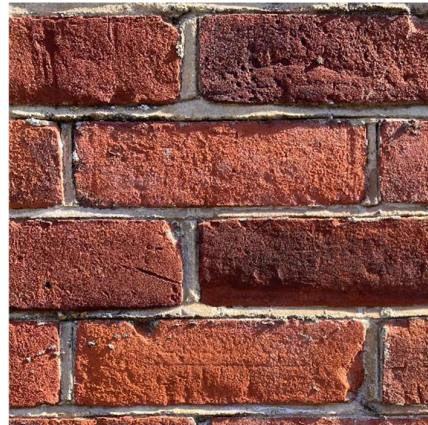
*Obliquely illuminated Edwardian brickwork showing undulations and surface texture.*

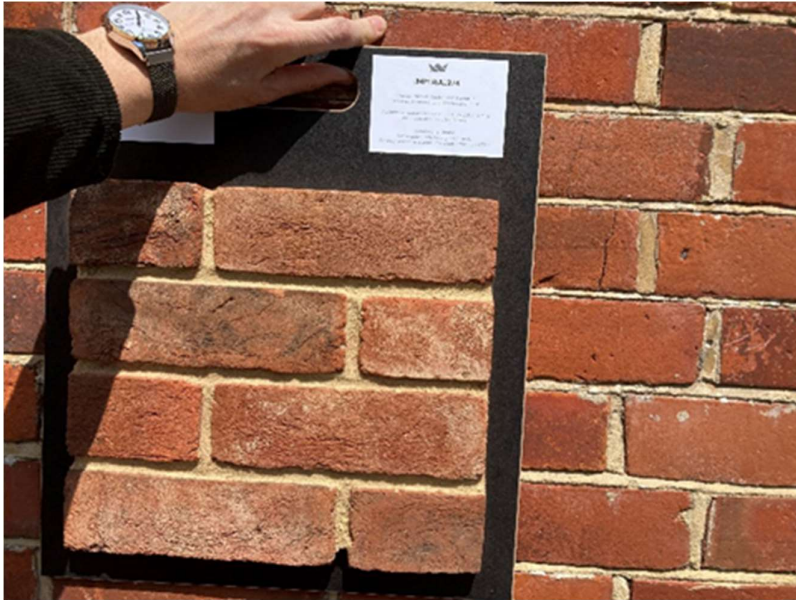
*Imperial Bricks  
Reclamation Weathered  
Soft Red (Handmade):  
View of sample board  
held against existing  
brickwork*

Where possible, it is intended that bricks from the demolished sections to the rear of the existing building will be reused. Elsewhere, Imperial Bricks' Reclamation Weathered Soft Red (Handmade) is considered a good match

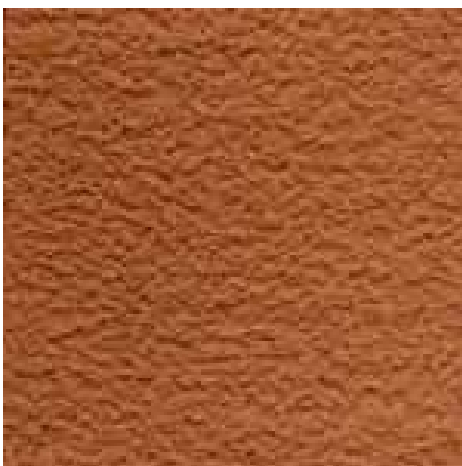
*SAS Render Systems Prorend silicone-based masonry  
paint, colour: 'brick'*

The brick work render and stucco façade to house 5 on East Street is currently painted a magnolia type colour. This has trapped water in the surface of the bricks causing them to spall quite badly. It is proposed that the existing paint coatings be removed, the

damaged brickwork repaired, and that the façade be repainted using a silicone based paint (giving greater vapour permeability) in a single brick tone colour.

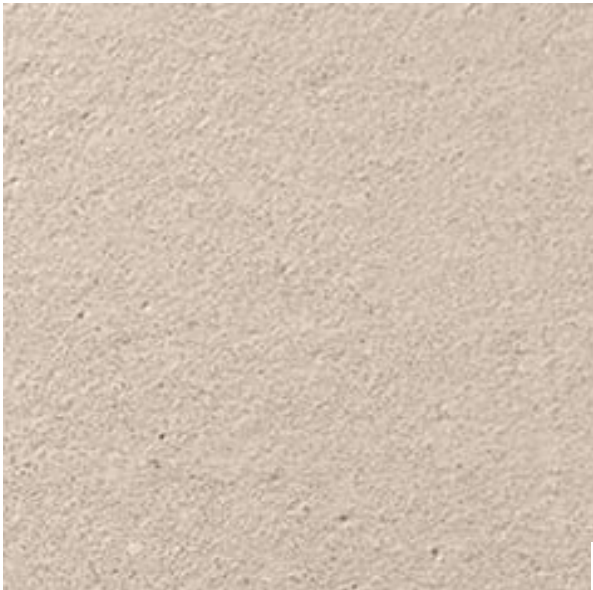
*Cornerstone Promix Medium Topcoat (Trowel Finish)*

The existing external finish to the upper storey of the East Street Building comprises painted pebbledash which is not original to the building's construction. It is proposed that, along with the reinstatement of the original lancet windows, this later finish will be removed and replaced with a smooth finish lime render with a scored ashlar pattern.

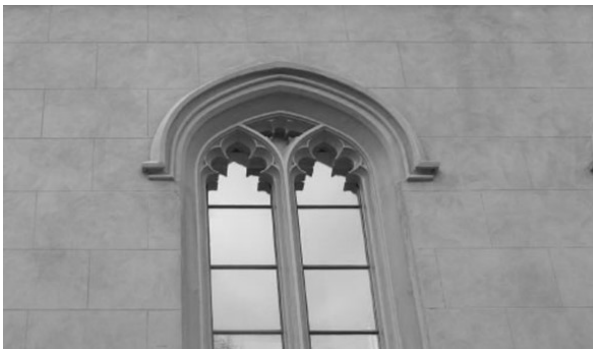
*Example of scored render with scored ashlar pattern*

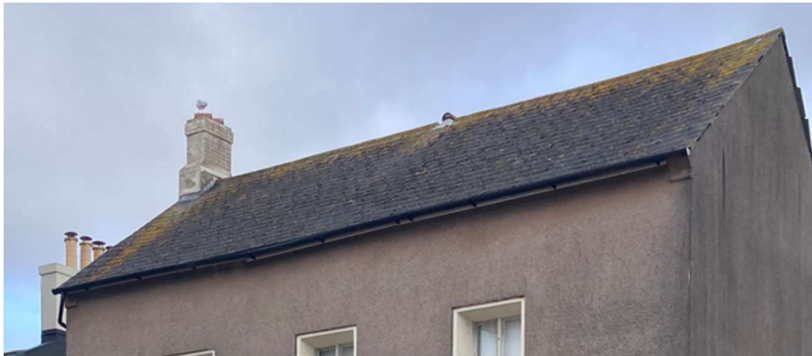
*Existing roof slate with heavy build-up of lichen and moss.*

The existing pitched roofs carry a heavy accumulation of lichens and mosses common to coastal areas, particularly to the South-facing New Road elevation. The existing finish is presumed to be natural slate; it is apparent from historic photographs that the roof has been replaced subsequent to the original construction and the current slates may be artificial.

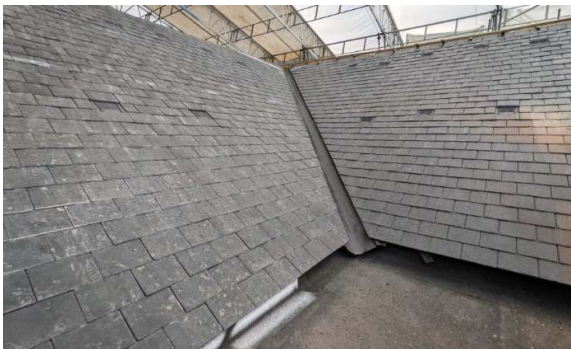
*SSQ Del Carmen (quarried North-West Spain)*

The roofs are to be wholly replaced. The pitched areas will be finished in natural slate; the stone selected, quarried in North-West Spain, has a smooth gently undulating riven face and trims to a sharp edge.

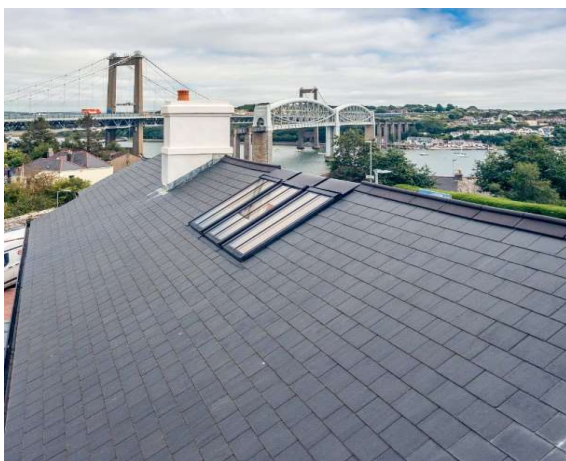
*SSQ Del Carmen in UK heritage context*

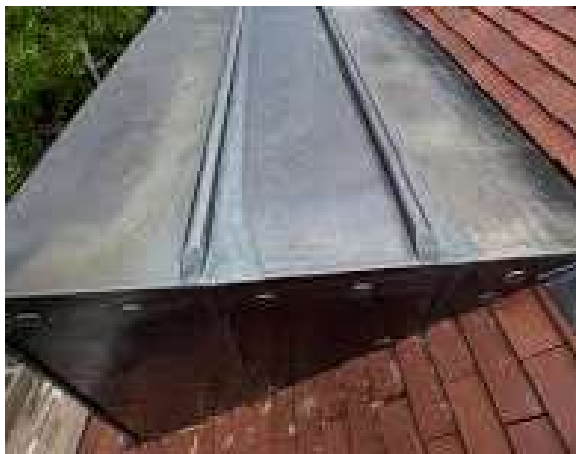
*Generic view of lead-roofed dormer*

The existing dormers appear to be currently finished in zinc with a mixture of standing and flat folded seams. The material has not weathered well in the marine climate, and its brittleness may have contributed to the leaks which characterize the upper storey of the building. It is therefore proposed that the new dormers be roofed in lead since the skills for repair are more readily available.

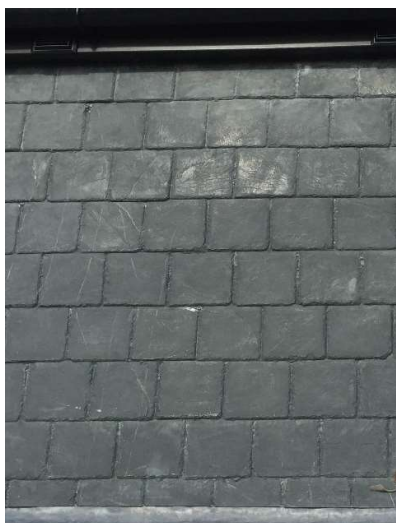
*Generic view of Spanish slate tile-hanging*

The Planning Application drawings show the existing rear dormers unified into a continuous roof extension with a single roof plane. The existing fenestration pattern, which consists of wide openings occupying three quarters of each structural bay, is extended upward into the dormer leaving narrow solid strips between. It is proposed that these areas are hung with slate tiles to match the pitched roof. The cheeks to the new dormer structure will be similarly treated.

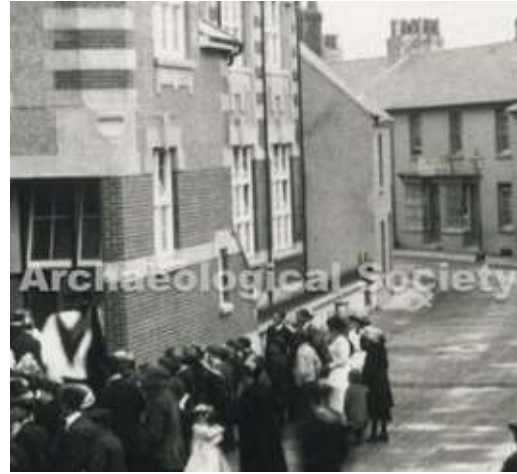
*Above: Historic photograph of the New Road elevation*

A historic photograph from the building's opening show cast iron railings topping a rendered masonry dwarf wall in front of the New Road elevation. It is proposed that the railings will replicate this arrangement that is typical of the period.

It is not possible to discern the exact railing design from the photograph but, on the single gate visible, there appear to be gate posts that extend above the railings. The number of reproduction designs available in the present day is limited.

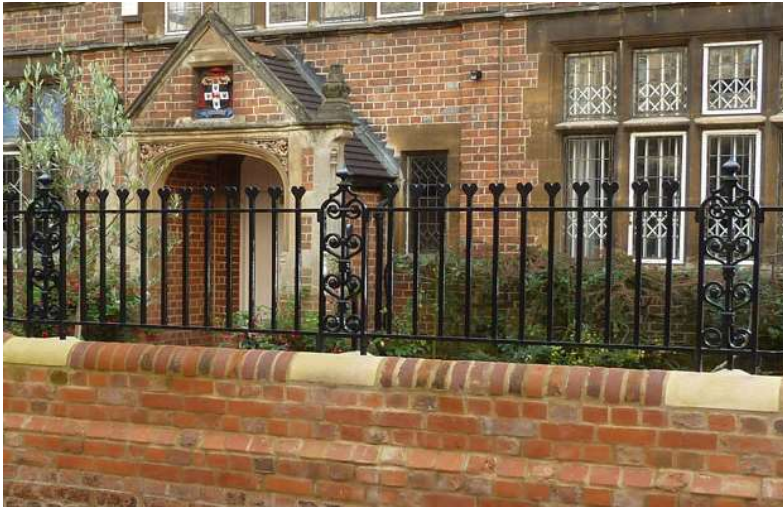
*Left: General view of Oxford Railings' Heart and Scroll cast iron railings.*

The Heart and Scroll design by Oxford Railings is considered an appropriate design which corresponds well with the detail that can be derived from the available historic photographs and sits well with the designs of the period, making use of the heart motif that was very popular at that time and appears regularly throughout the work of contemporary architects such as M. H. Baillie Scott and C.F.A. Voysey.

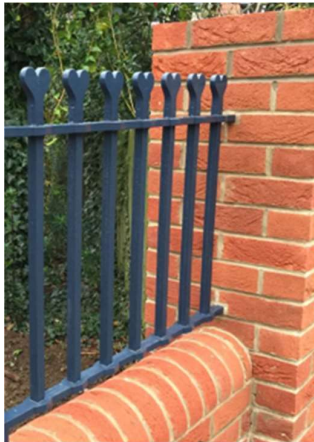
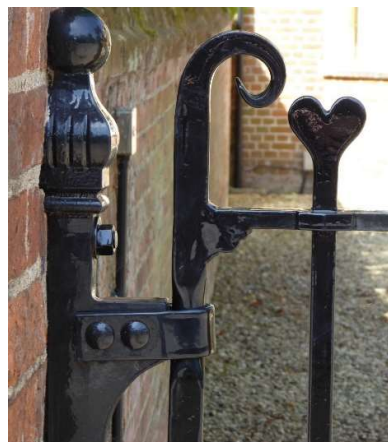
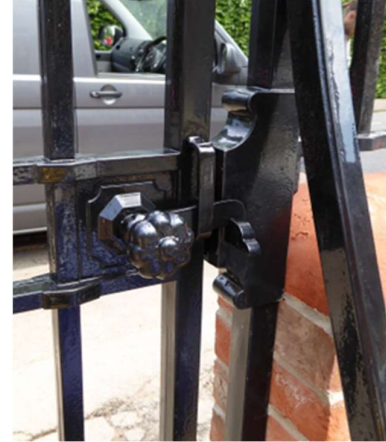
*Below: Detail views of Oxford Railings' Heart and Scroll cast iron railing components*

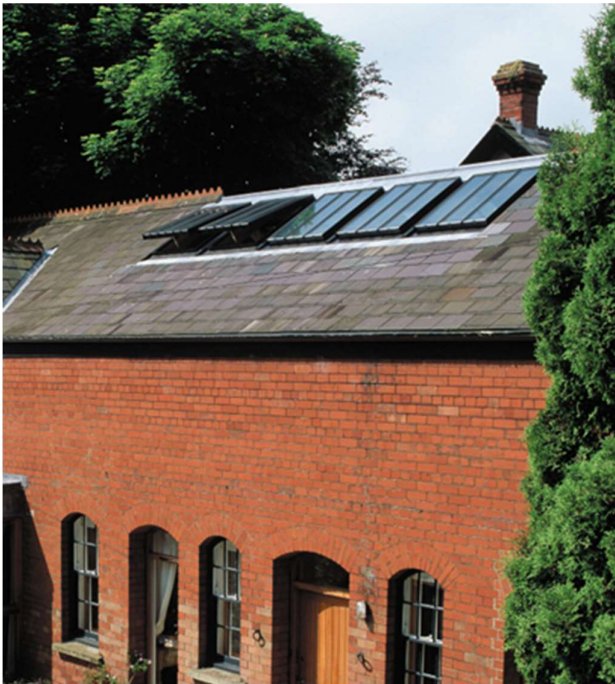
*Roof windows by The Rooflight Company*

Conservation roof windows by the Rooflight Company are proposed.

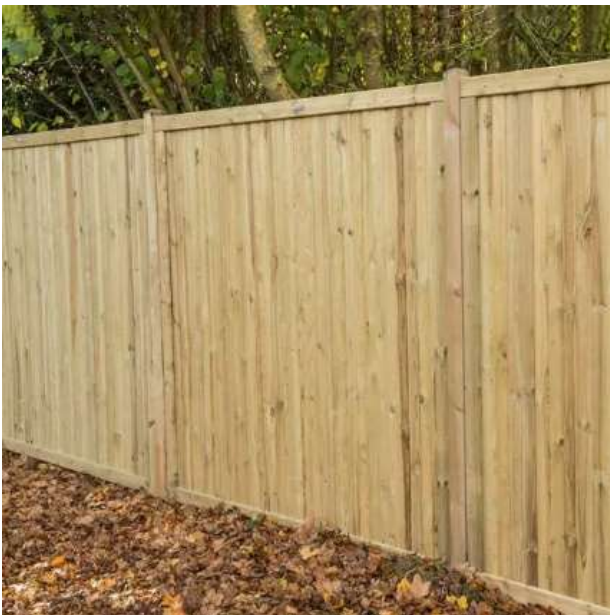
*Generic view of close boarded fence.*

The boundaries between the gardens to the houses will be separated by 1800mm high close-boarded fences.
