Site: St John's Court, Penstone Close, Lancing  
Prepared by: Phil Allen MCIWEM C.WEM  
Approved by: Neil Jaques  
Date: 21st May 2026

## 1.0 Introduction

1.1 This Technical Note has been prepared by Motion to address Conditions 6 and 7 of planning consent AWDM/0949/22 (dated 6<sup>th</sup> June 2023).

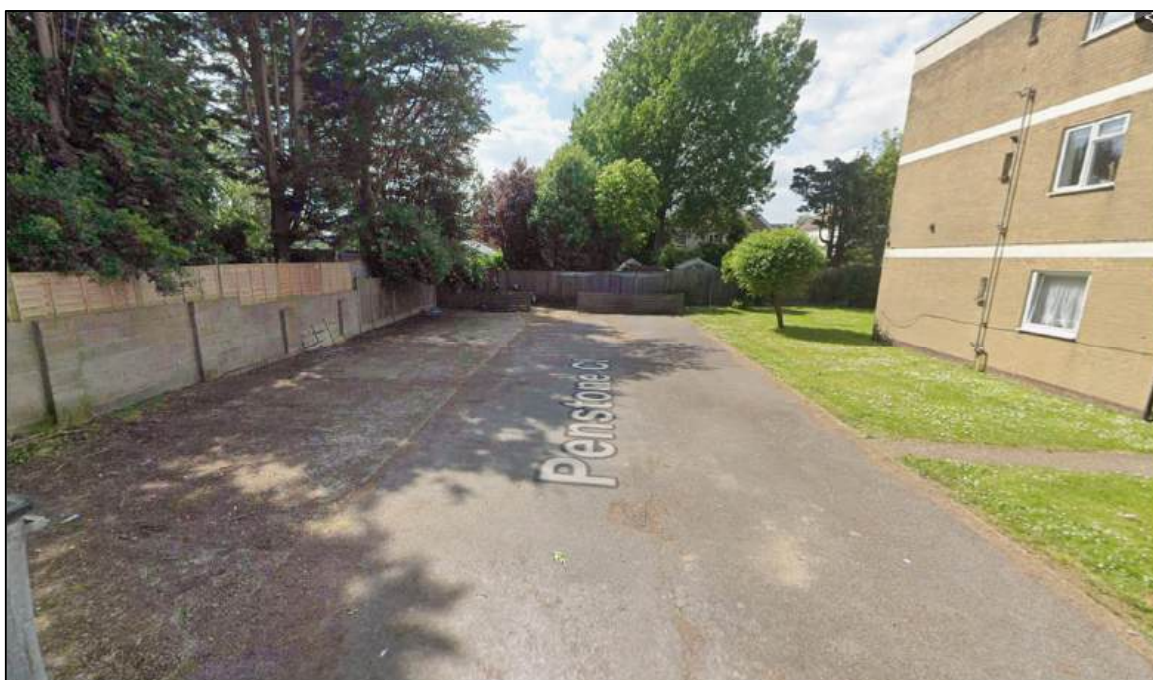
- 2.7 The development would also result in the removal of large areas of tarmacadam and concrete hardstanding and garages in the south/southwest of the site. The area of tarmacadam and concrete in the southwest corner of the site (c. 310m<sup>2</sup>) that is to be completely removed and replaced with soft landscaping and the extension to the block of flats can be seen in Figure 2.1, below.

*Figure 2.1 – Existing hardstanding areas to be removed*

- 6.1 It has already been discussed that the developed site will reduce the overall impermeable areas of the site over the existing situation.
- 6.2 Figures 2.1 and 2.2 showed the large area of existing tarmacadam and concrete hardstanding that is to be removed and, as noted above, the drainage serving this area is in poor condition.
- 6.3 Section 2 of this report also discussed the areas of the site that represent new or refurbished areas that require positive drainage and consideration in the drainage strategy, which total 411m<sup>2</sup>.

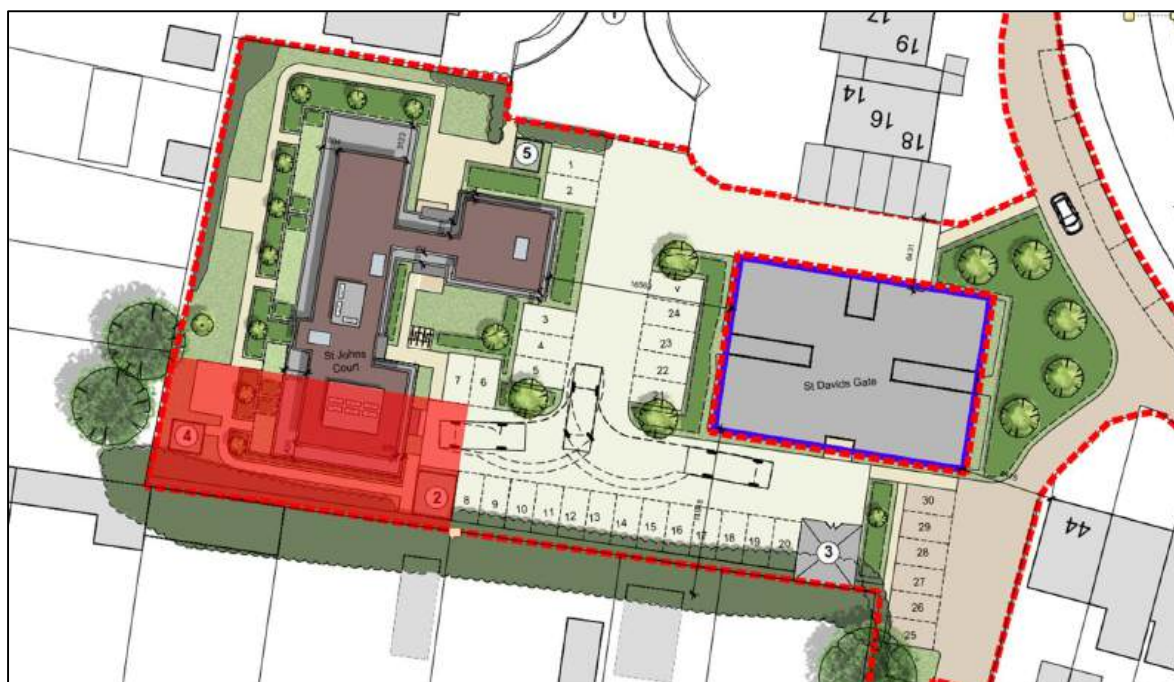
- 2.8 This will yield a post-development net reduction in impermeable, contributing areas to surface water runoff on site of 123m<sup>2</sup>.
- 2.9 This area of the site overlaid with the proposed development layout can be seen highlighted red in Figure 2.2 on the next page.

Figure 2.2 – Area of existing hardstanding to be removed

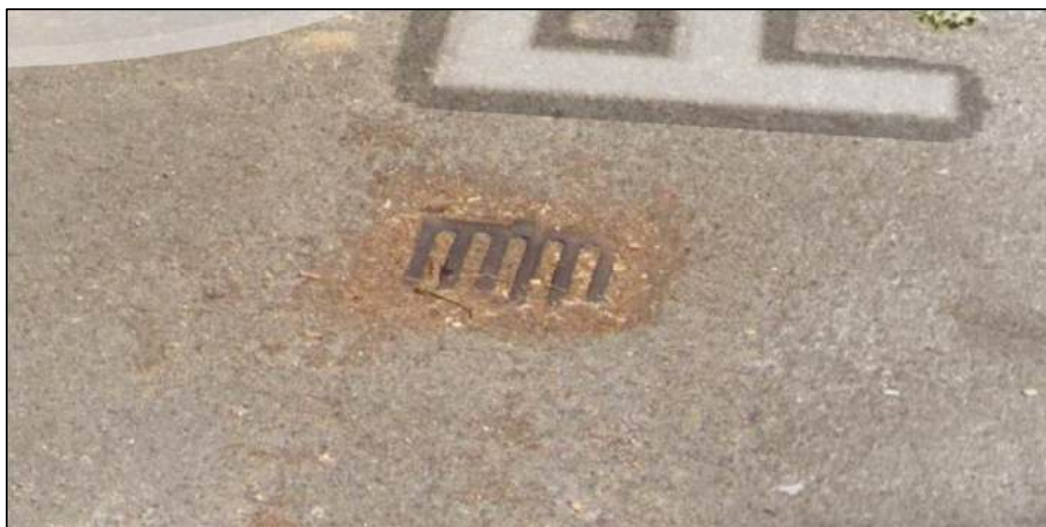
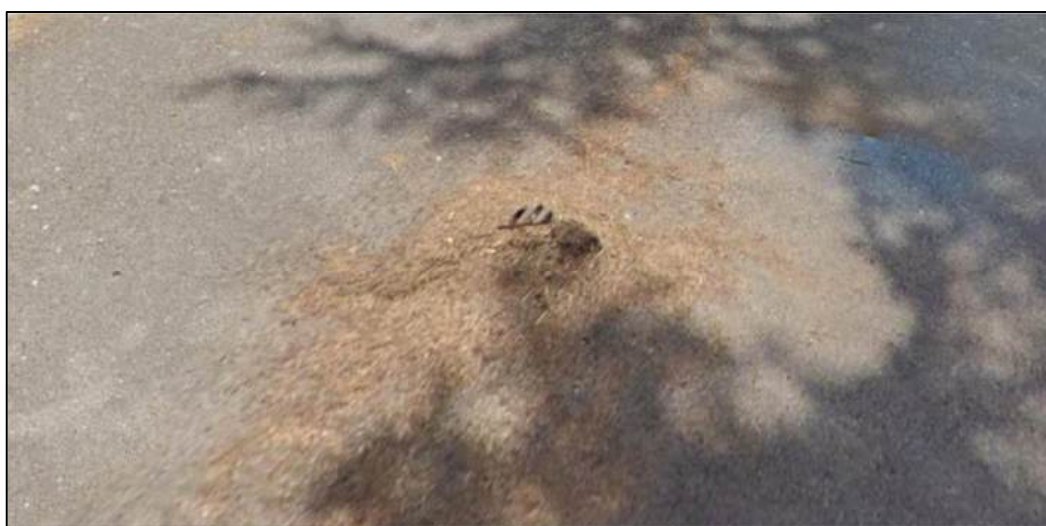
5.3 Also, as noted in the CCTV drainage survey in [Appendix C](#), some of the drainage in this area was unable to be surveyed. This is partly because the gulleys are completely blocked, as shown in the images on the next page.

Figures 5.2 and 5.3 – Blocked existing drainage gulley

- 5.4 Therefore, not only are the impermeable areas decreasing over the existing situation, but areas of poorly performing drainage are being decommissioned, which would have, in the existing situation, resulted in standing surface water and increased surface water runoff in heavy rainfall events. This means that the proposed development and the proposed drainage for the site will represent significant betterment over the existing situation and this should be considered.

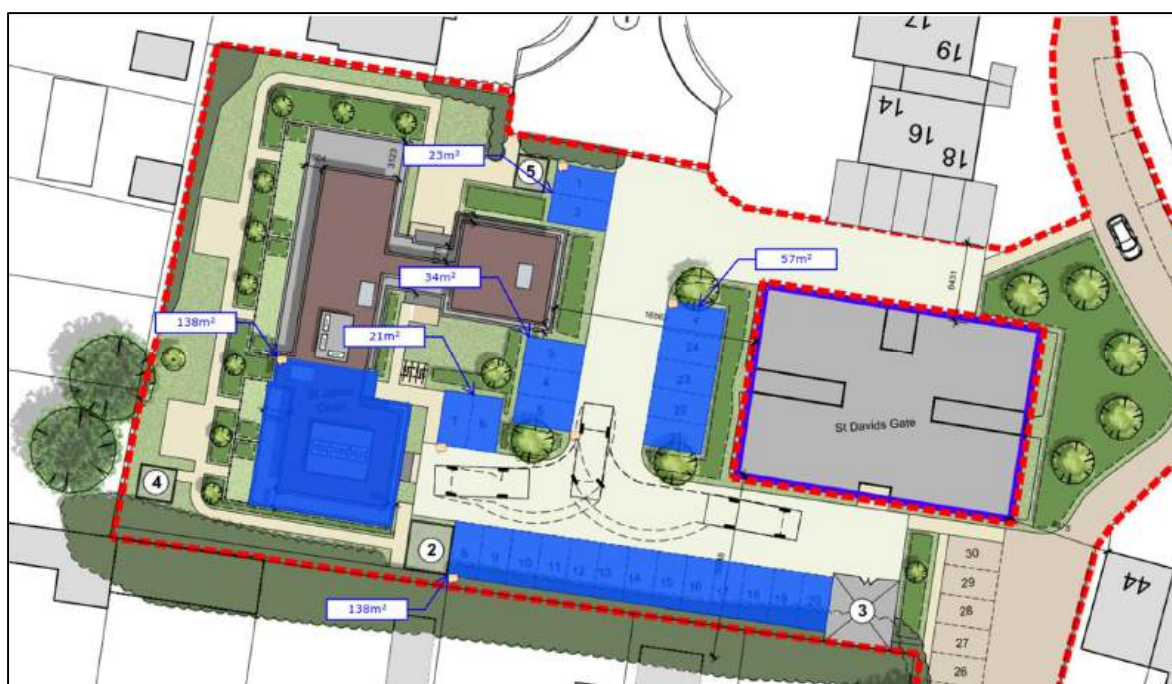
- 7.1 Section 2 of this report also discussed the areas of the site that represent new or refurbished areas that require positive drainage and consideration in the drainage strategy, which total 411m<sup>2</sup>. These areas are shown and the individual areas are labelled in the drainage areas plan in Figure 7.1 below.

*Figure 7.1 – Drainage areas plan*

- 7.2 To confirm, the areas that are to be drained are those that are to undergo development or refurbishment and that will positively contribute to surface water runoff on site. These total 411m<sup>2</sup>.

- 7.3 The drainage strategy prepared to support planning application AWD/0949/22 proposed that the new parking areas would be constructed from permeable pavements with an open-graded subbase. This approach is supported in the current drainage strategy and all the new and modified areas of parking, as highlighted blue in Figure 7.1 will be constructed from permeable pavements.

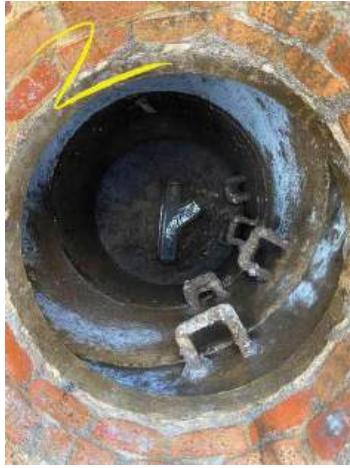
| Sheet A2 | | Photo | | | |

| Sheet A2 | | Photo | | | |
|---|---|---|---|---|---|
| Inspection Chamber | Manhole 2 | | | | |
| Invert level (m) | 2800mm | | | | |

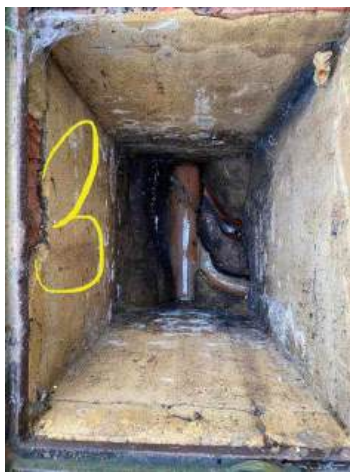
| Sheet A3 | | Photo | | | |

| Sheet A3 | | Photo | | | |
|---|---|---|---|---|---|
| Inspection Chamber | Manhole 3 | | | | |
| Invert level (m) | 1220mm | | | | |

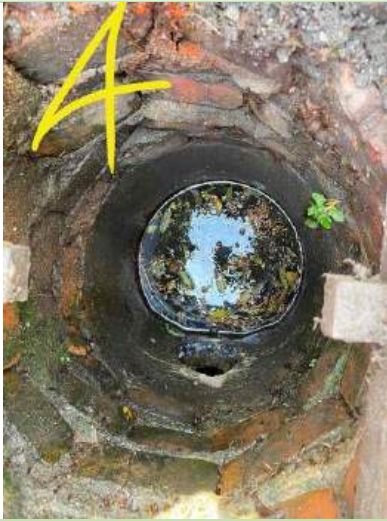
| Sheet A4 | | Photo | | | |

| Sheet A4 | | Photo | | | |
|---|---|---|---|---|---|
| Inspection Chamber | Manhole 4 | | | | |
| Invert level (m) | 2900mm | | | | |

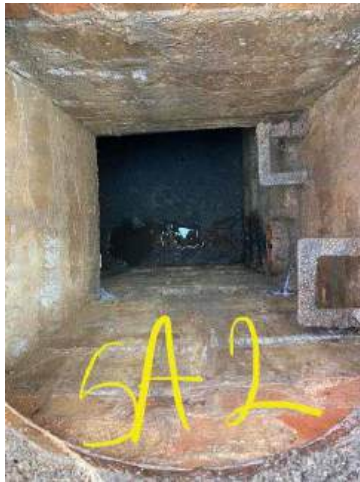
| Sheet A6 | | Photo | | | |
|---|---|---|---|---|---|
| Inspection Chamber | Soakaway 2 | | | | |
| Invert level (m) | 2100mm | | | | |

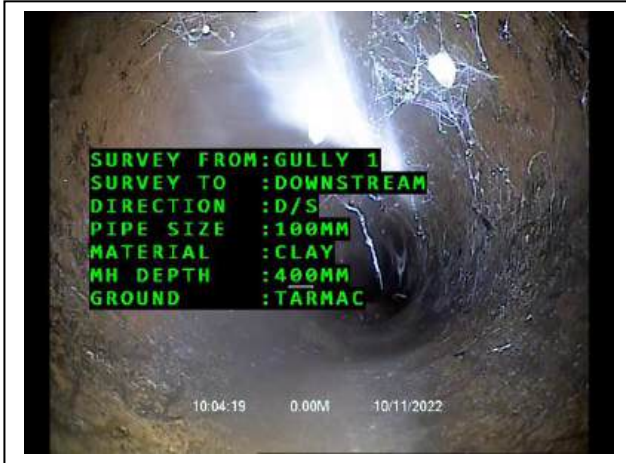
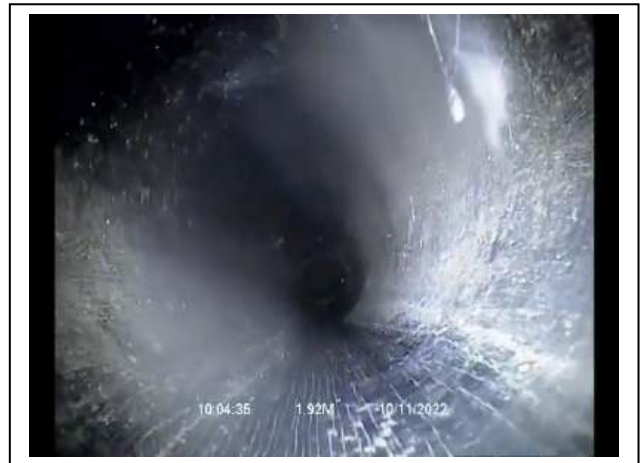
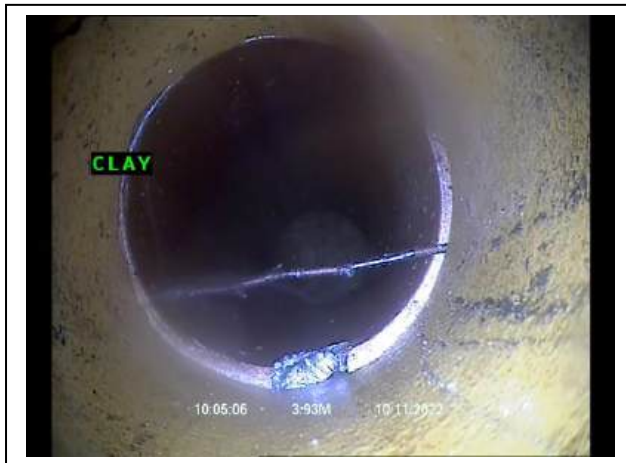
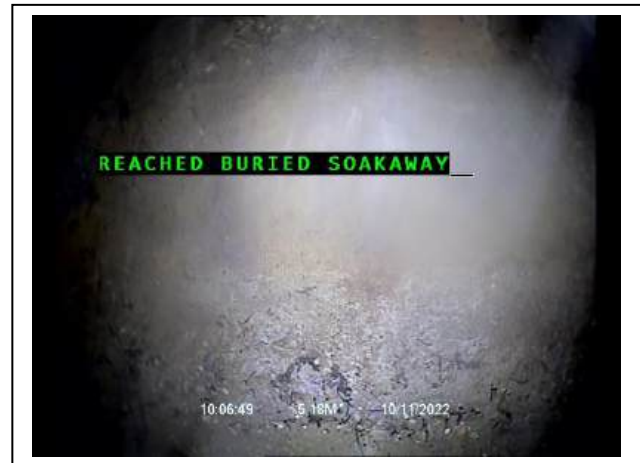
Gully 1 – Buried Manhole

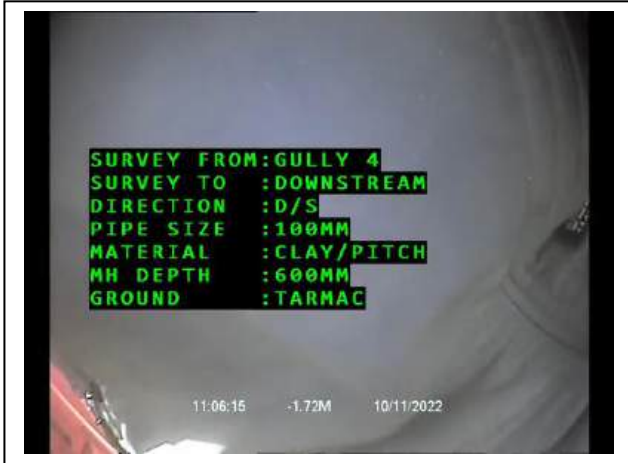
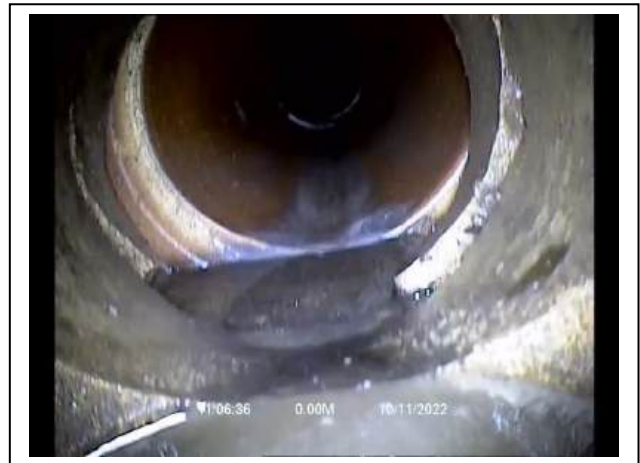
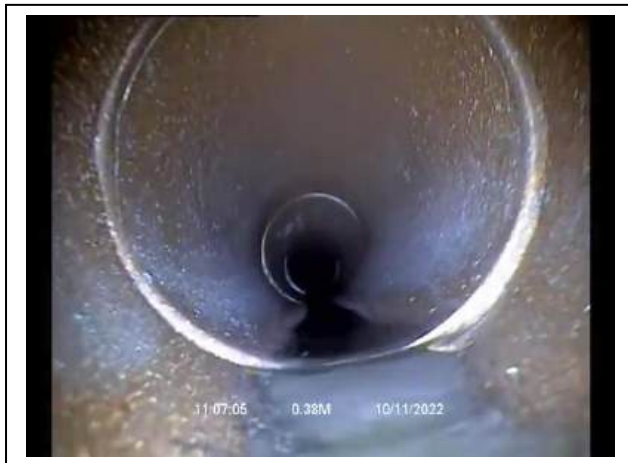
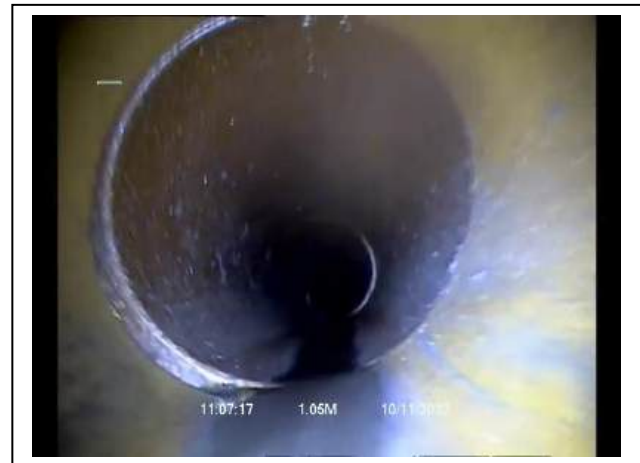
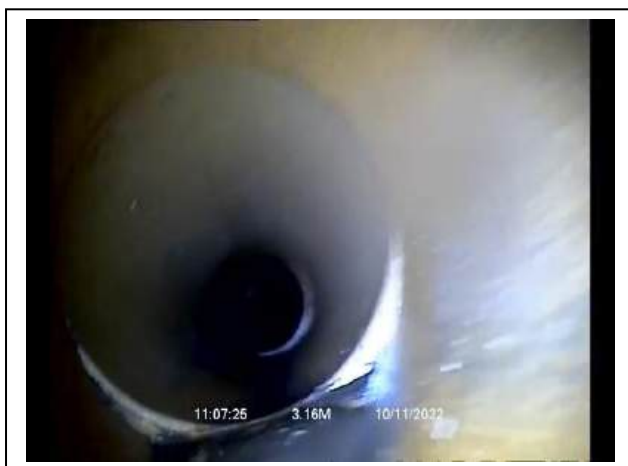
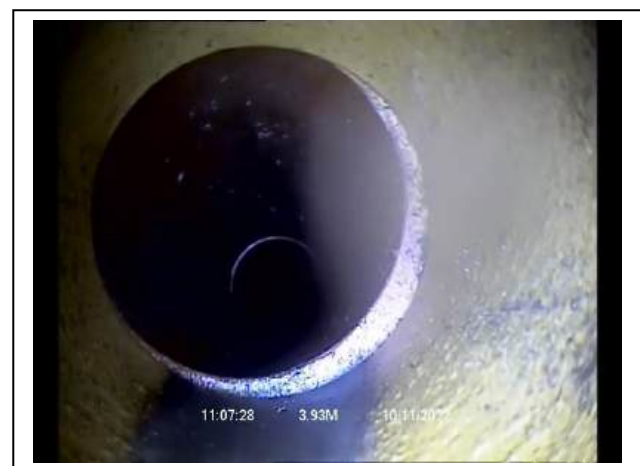
Gully 4 – Soakaway 2

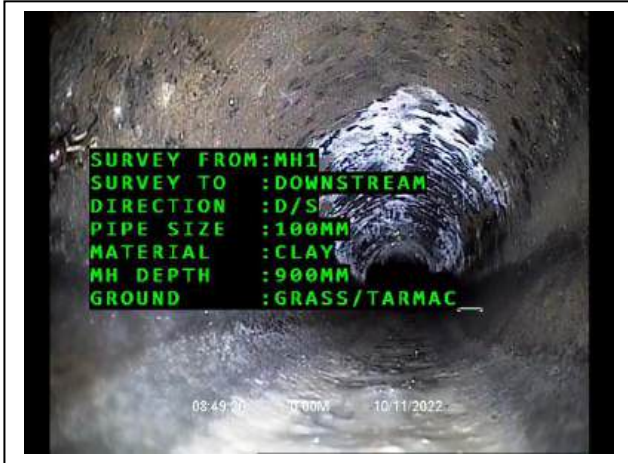
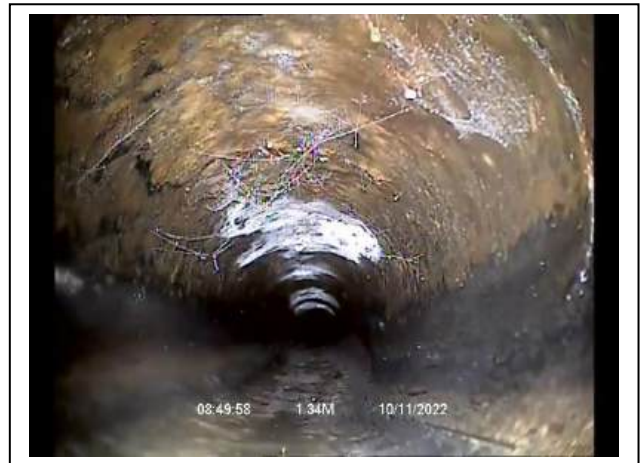
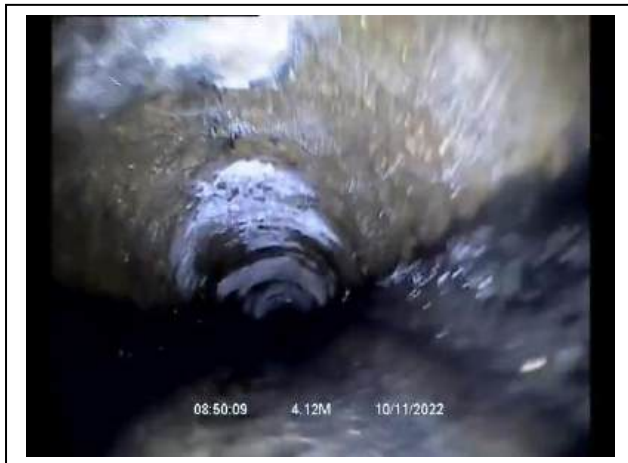
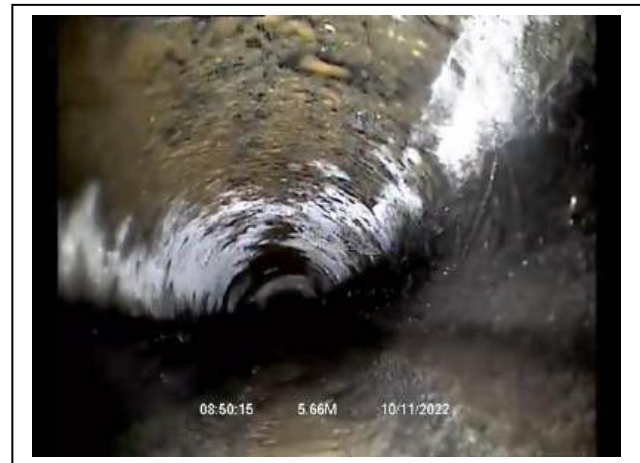
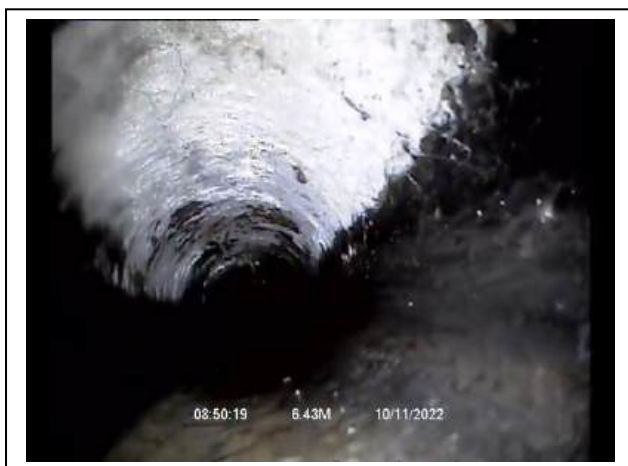
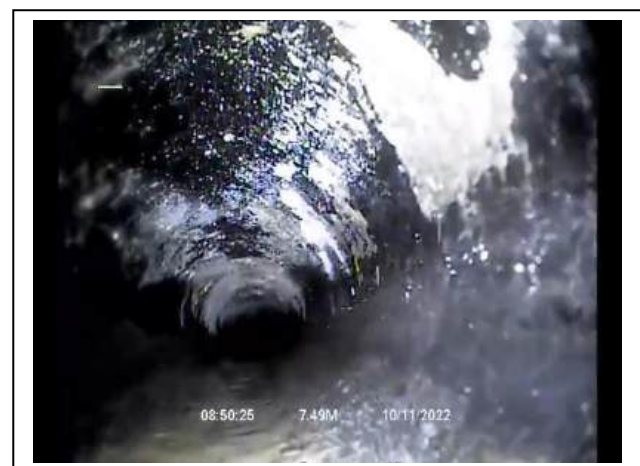
Manhole 1 – Manhole 2

| Drain Run in a serviceable condition? | | | No | | | | |

| Recommendations | | Our recommendations are:<br><br>1. Excavate & replace entire section of drainage run with new UPVC pipework to the correct alignment & fall.<br><br>All work undertaken by EDS is carried out by fully qualified operatives to the highest standard. | | | |

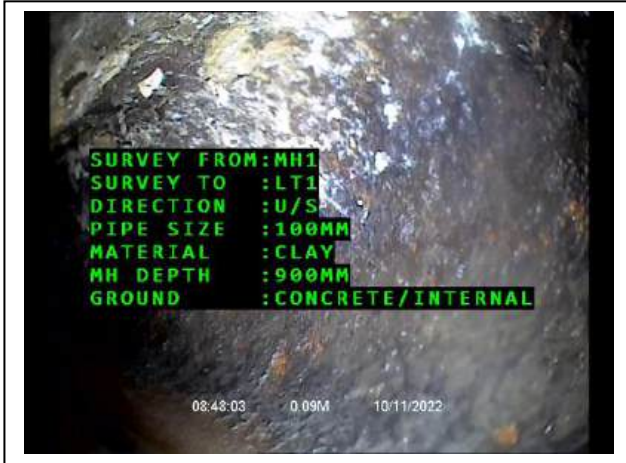
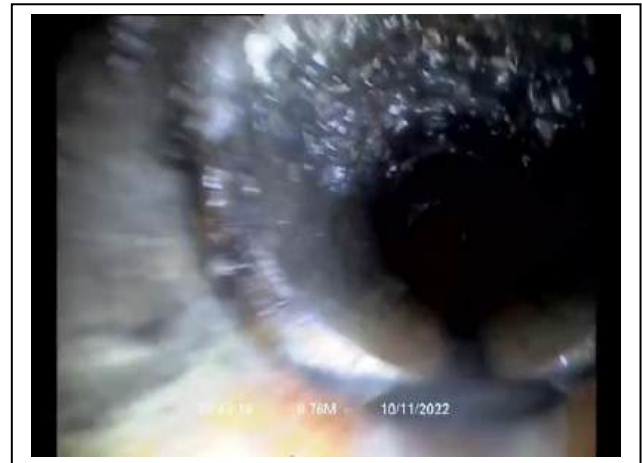
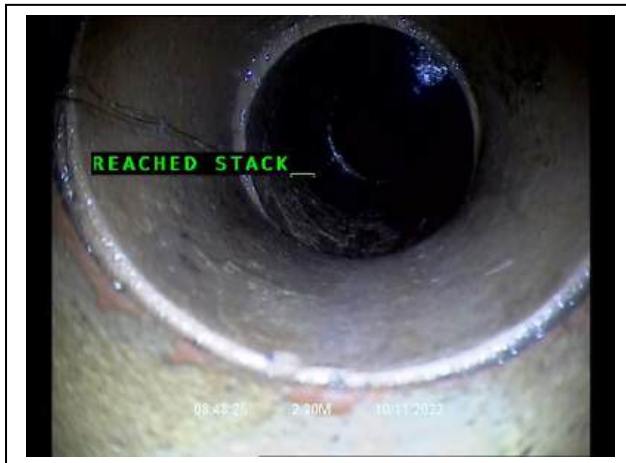
Manhole 1 – Lateral 1 - Stack

| Details | | | <p>The survey revealed a displaced joint within the drainage run.</p> <p>If you have any further queries or questions in relation to any of the above noted defects, please don't hesitate to contact the office on the number supplied on the covering letter.</p> | | | | |

| Recommendations | | Our recommendations are:<br><br><div><div>1.</div><div>High Pressure Water Jetting using a combination Tanker Unit to remove any Residual Debris.</div></div> <div><div>2.</div><div>Insertion of a Fibre Resin Linear Liner (100mm Super Flexi) for approximatively 3 metres.</div></div><br>All work undertaken by EDS is carried out by fully qualified operatives to the highest standard. | | | |

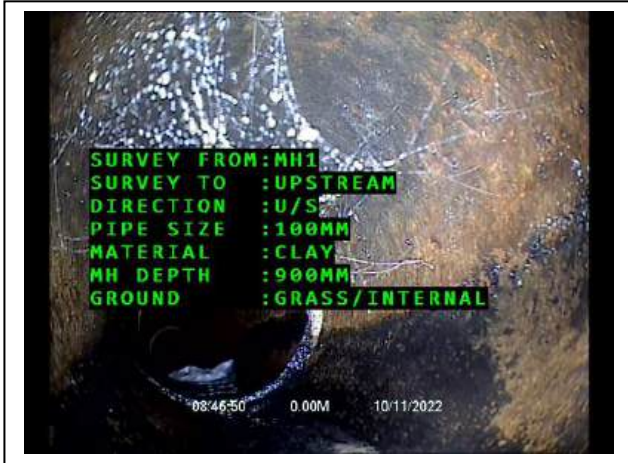
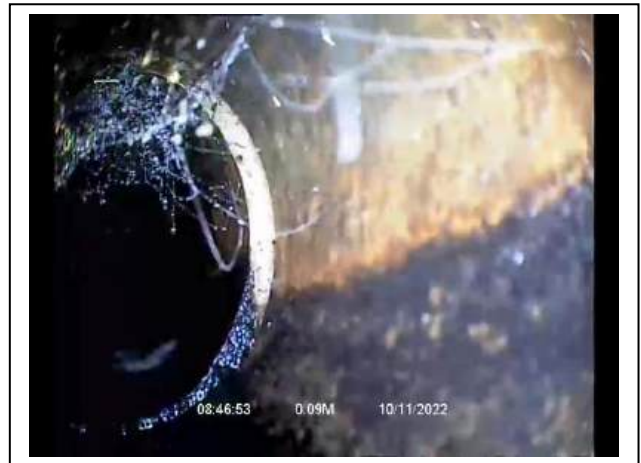
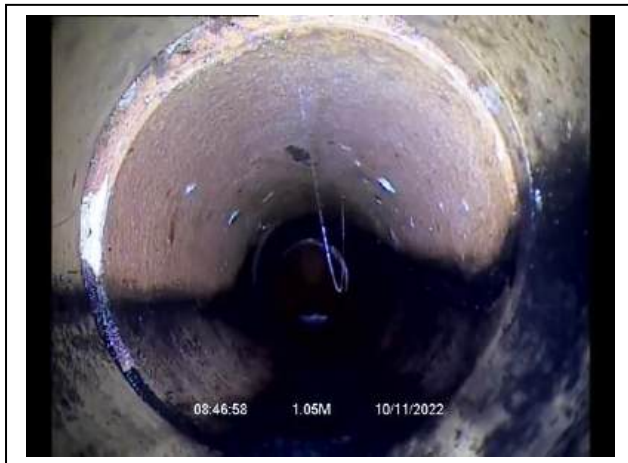
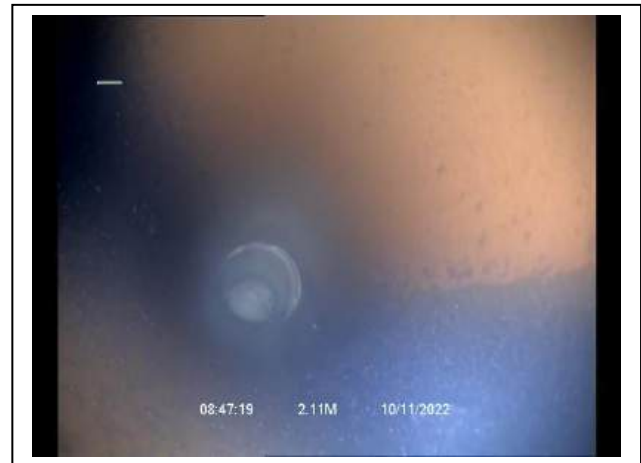
Manhole 1 — Upstream - Rest Bend

| Details | | | <p>The survey revealed displaced joints within the drainage run.</p> <p>If you have any further queries or questions in relation to any of the above noted defects, please don't hesitate to contact the office on the number supplied on the covering letter.</p> | | | | |

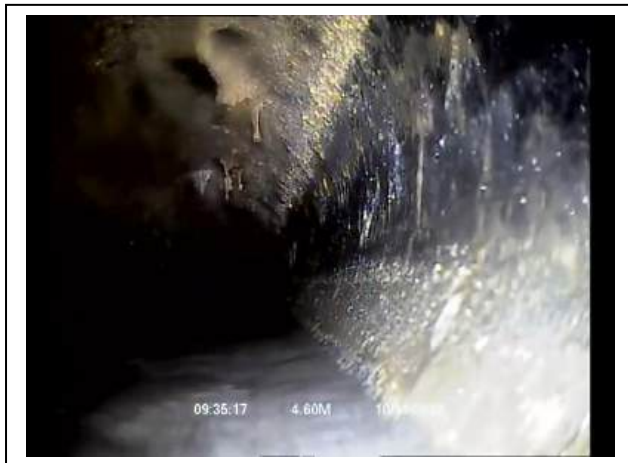
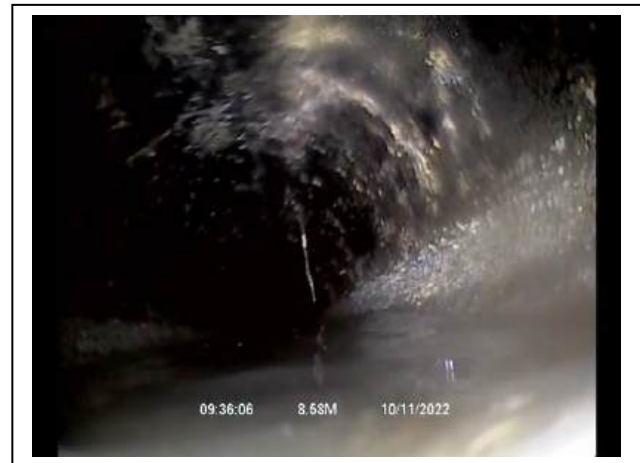
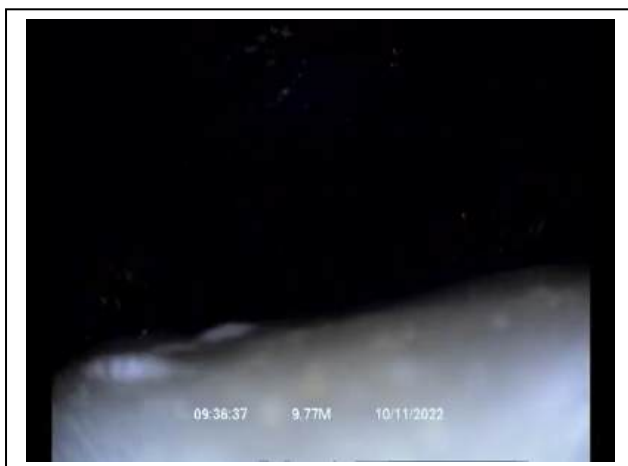
Manhole 2 – Manhole 4

| Details | | <p>The survey revealed Pitch fibre compisition and Water levels due to deformed pipework within the drainage run.</p> <p>If you have any further queries or questions in relation to any of the above noted defects, please don't hesitate to contact the office on the number supplied on the covering letter.</p> | | | |

| Recommendations | | Our recommendations are:<br><br>1. Excavate & replace entire section of drainage run with new UPVC pipework to the correct alignment & fall.<br><br>All work undertaken by EDS is carried out by fully qualified operatives to the highest standard. | | |

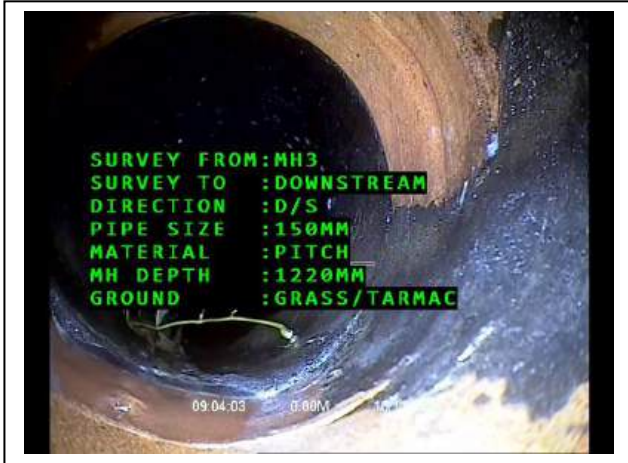
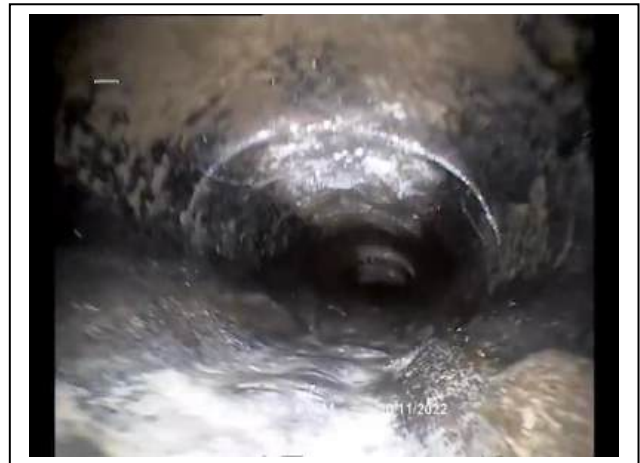
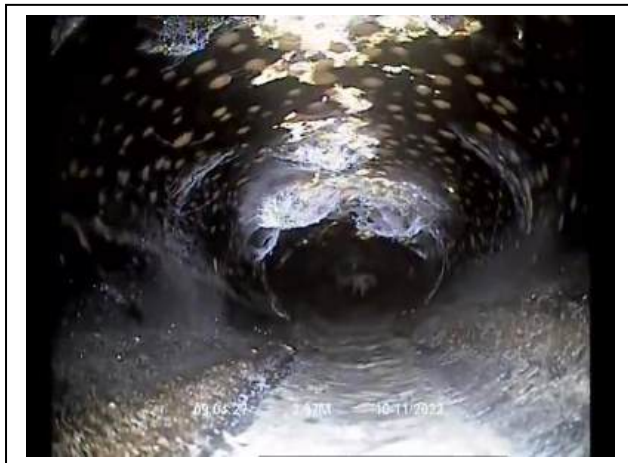
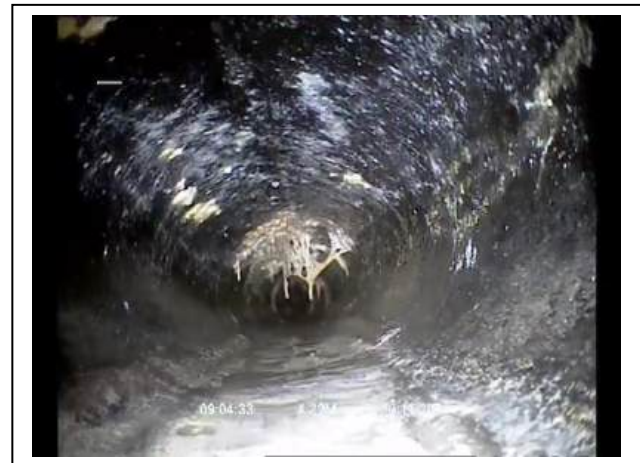
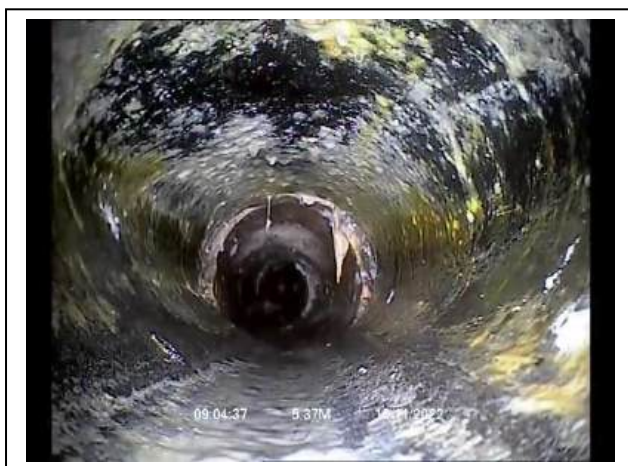
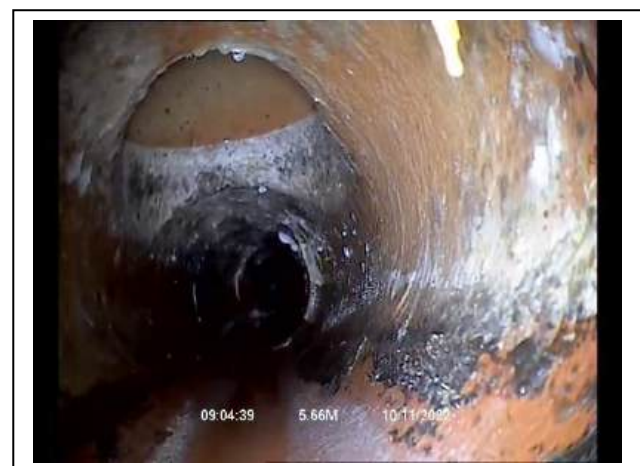
Manhole 3 – Manhole 2

| Details | | | <p>The survey revealed Pitch Fibre Composition and Deformed pipework within the drainage run.</p> <p>If you have any further queries or questions in relation to any of the above noted defects, please don't hesitate to contact the office on the number supplied on the covering letter.</p> | | | | | | | |

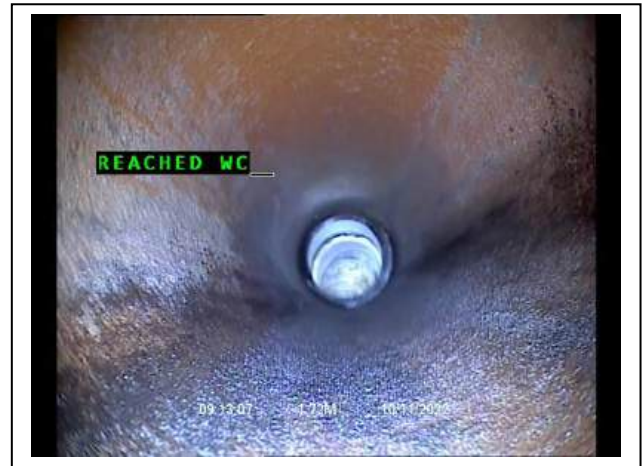
Mnahole 3 – Lateral 1 - WC

| Details | | The survey revealed no significant structural defects within the drainage run. | | | | | |

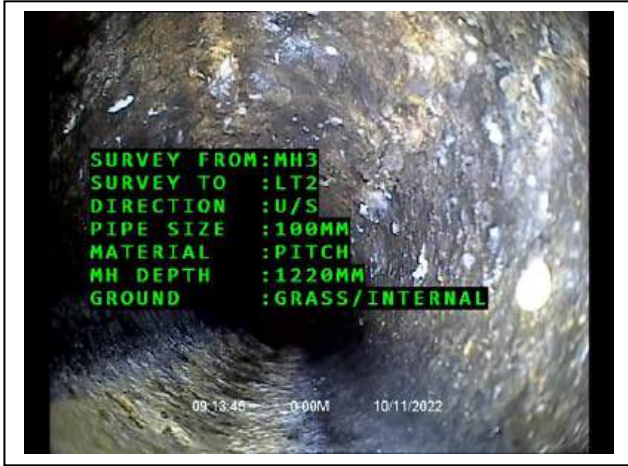
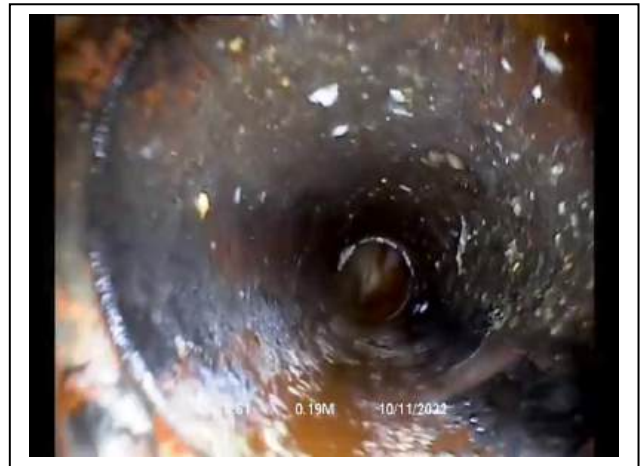
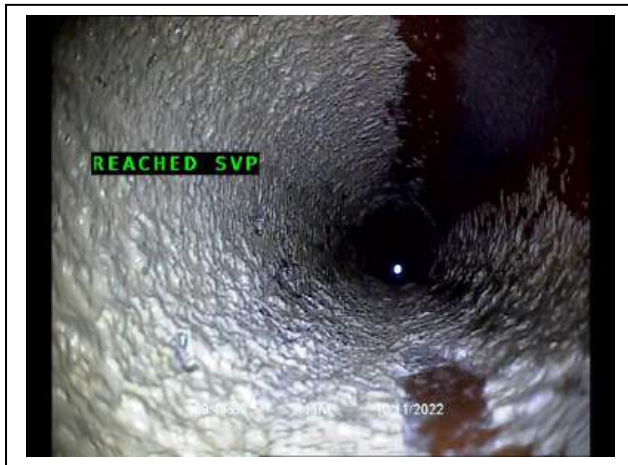
Manhole 3 – Lateral 2 - SVP

| Details | | The survey revealed no significant structural defects within the drainage run. | | | | | |

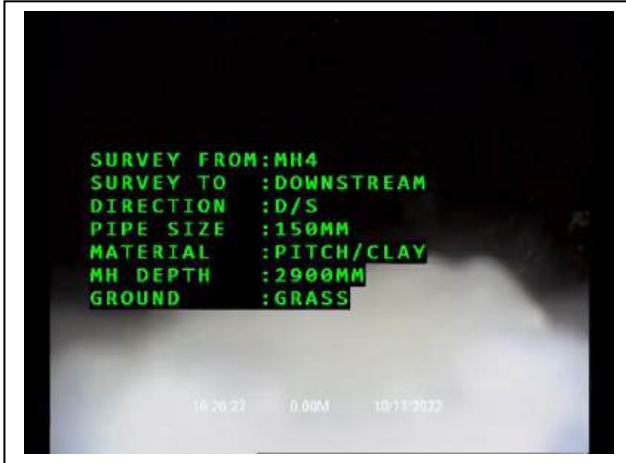
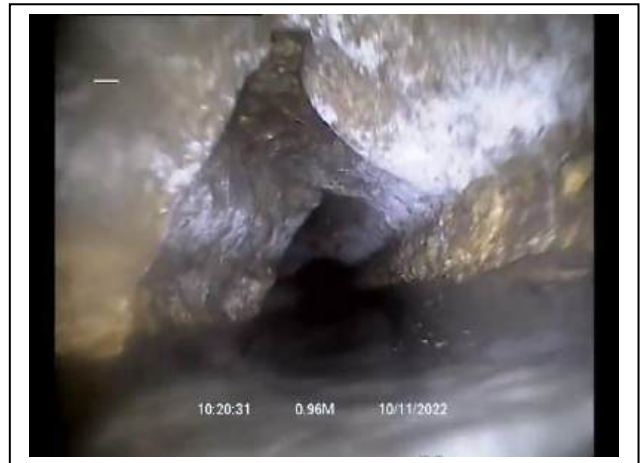
Manhole 4 — Downstream - Survey Abandoned

| Details | | <p>The survey revealed Water level due to Deformed pipework within the drainage run.</p> <p>If you have any further queries or questions in relation to any of the above noted defects, please don't hesitate to contact the office on the number supplied on the covering letter.</p> | | | |

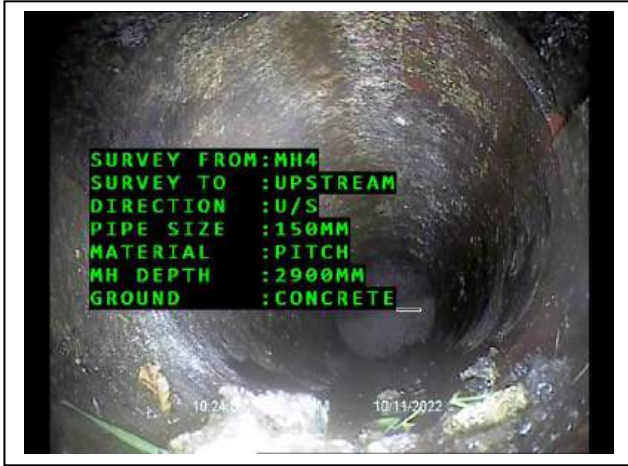
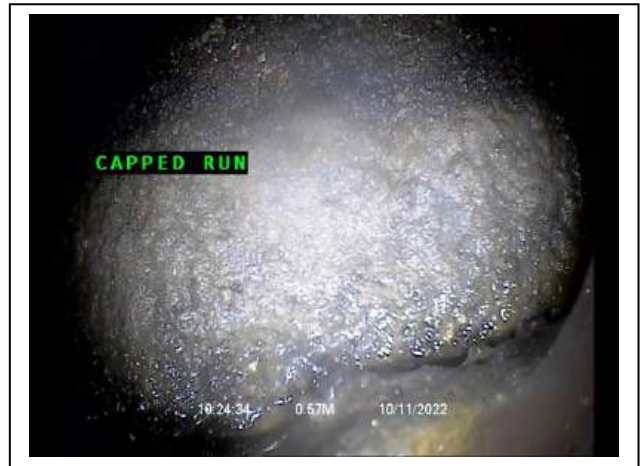
Manhole 4 – Upstream - Capped End

| Details | | The survey revealed no significant structural defects within the drainage run. | | | | | |

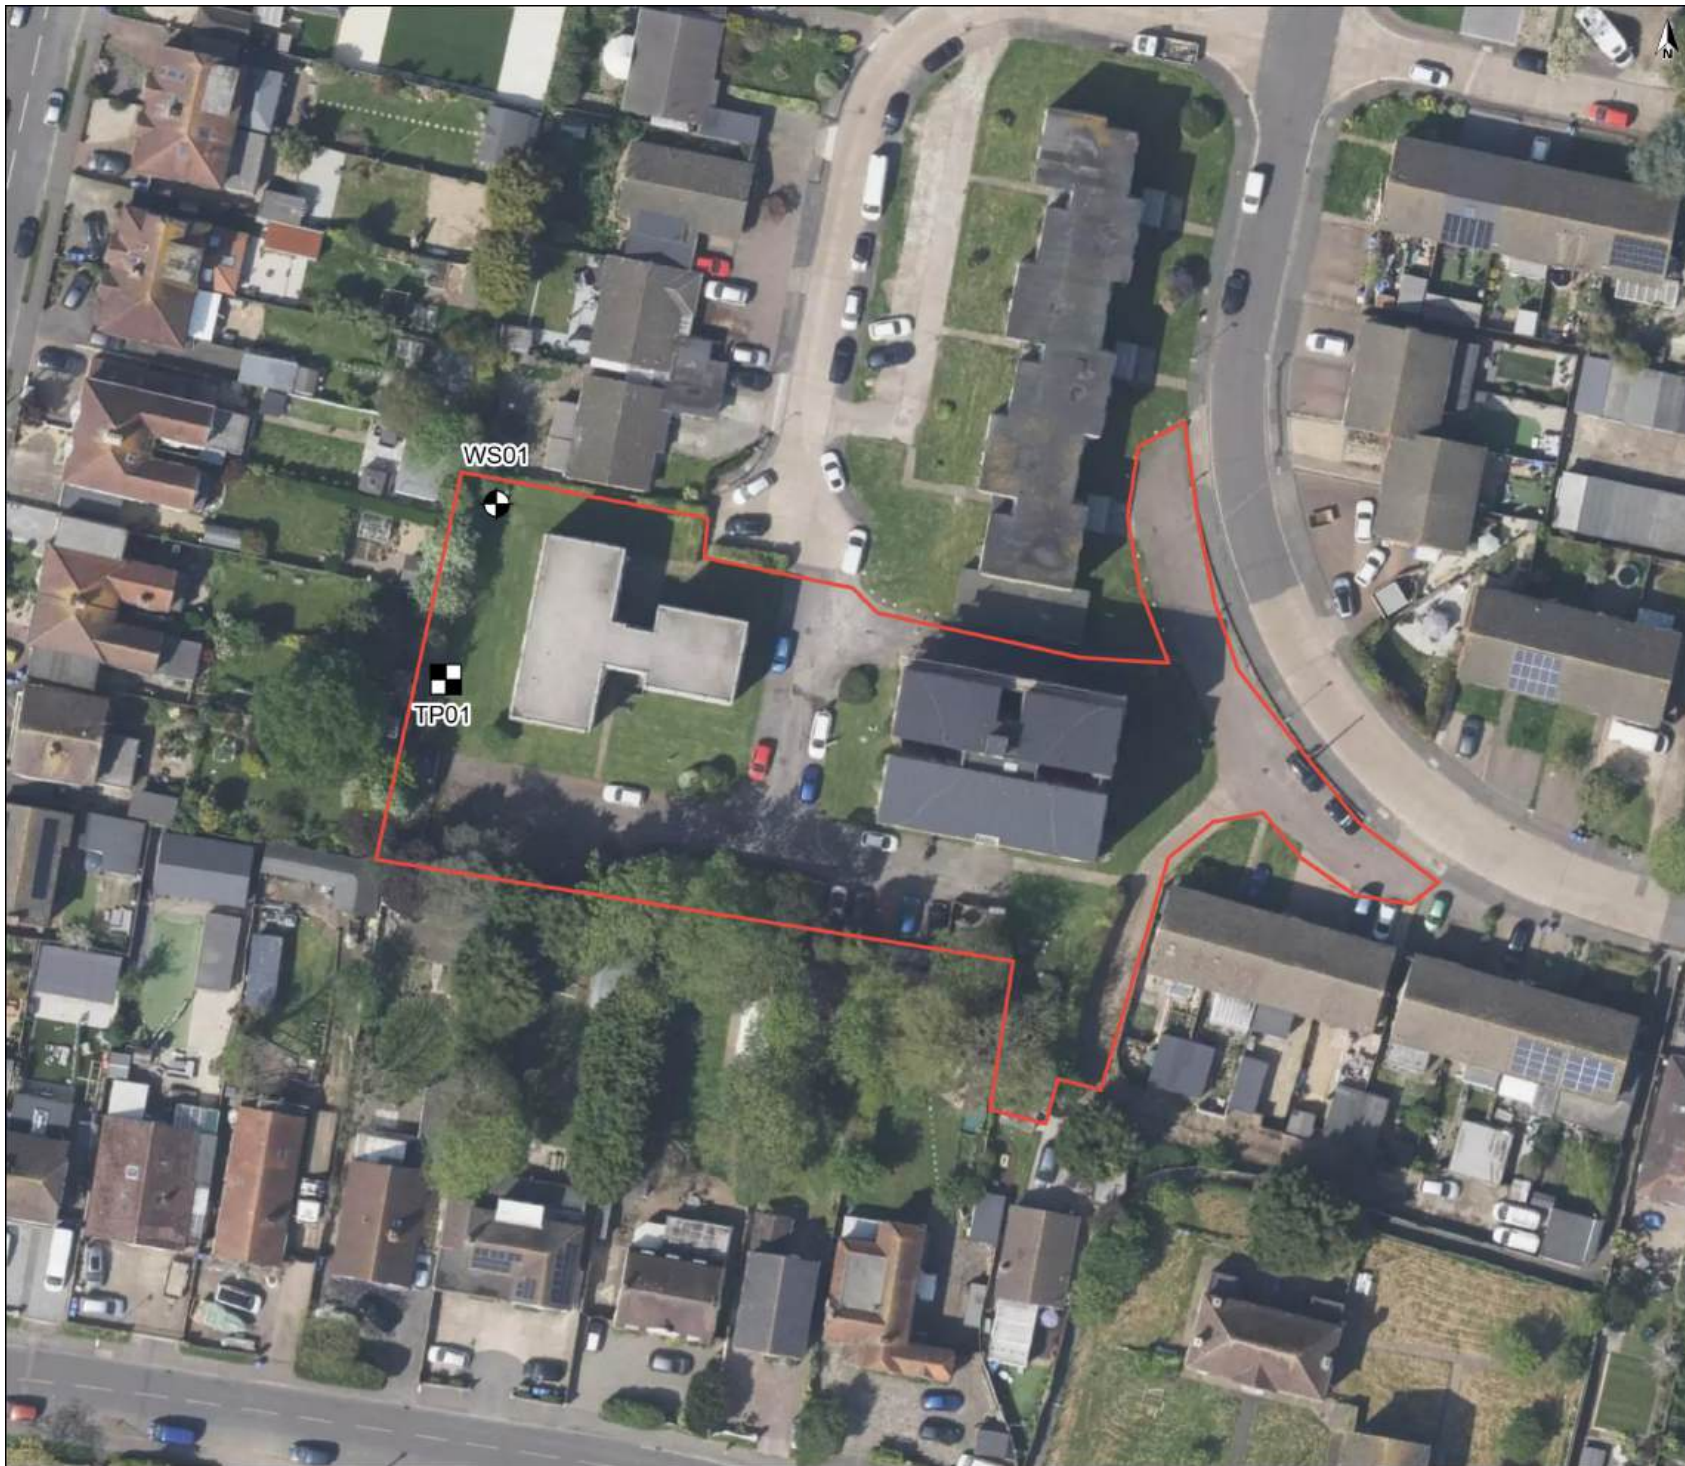
| Figure 2 | Exploratory Hole Location Plan |

- Legend**
- Trial Pitting For Soakage Testing
  - ⊙ Window sample locations
  - Site Boundary

The exploratory positions are shown on Figure 2.

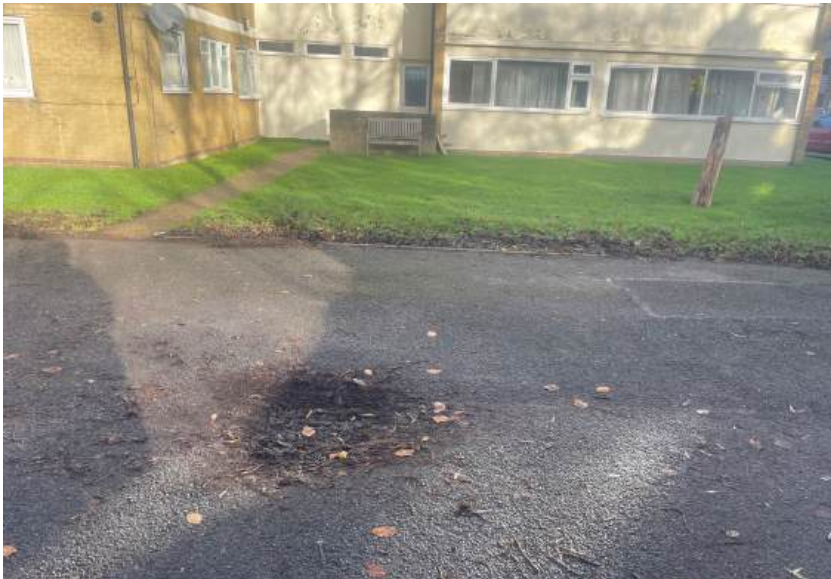
Plate 7 – drain system on  
southern edge by garages

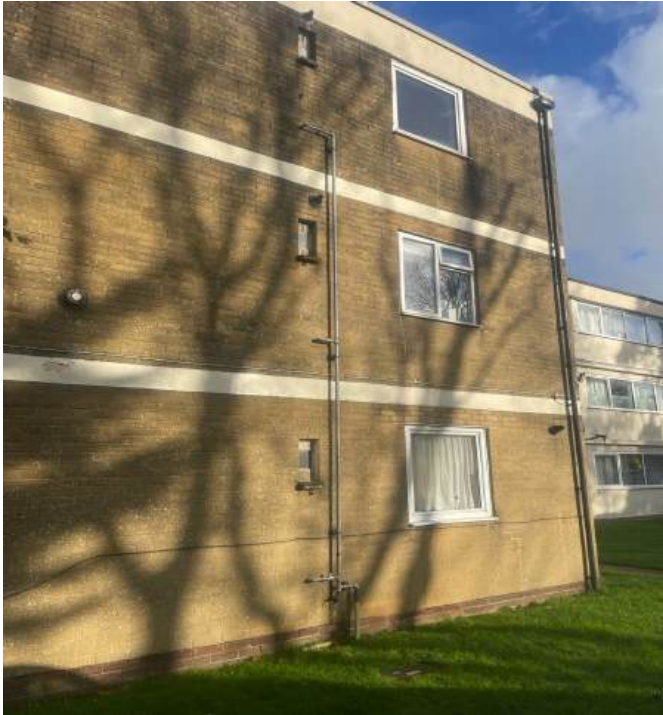
Plate 8 – drain system on  
southern edge by garages

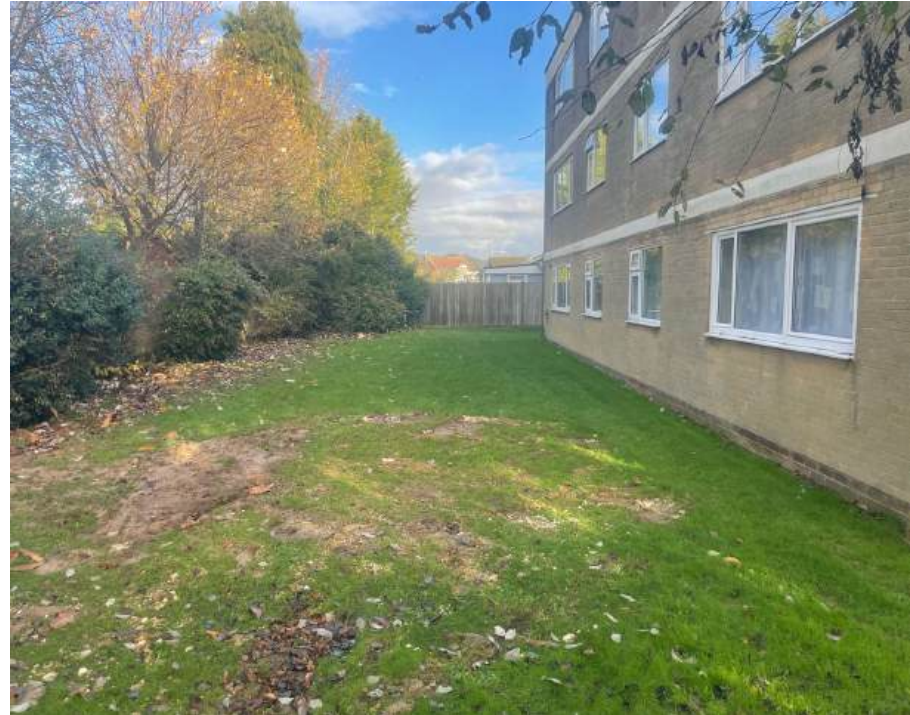
Plate 9 – Gas main down western block of flats - south side.

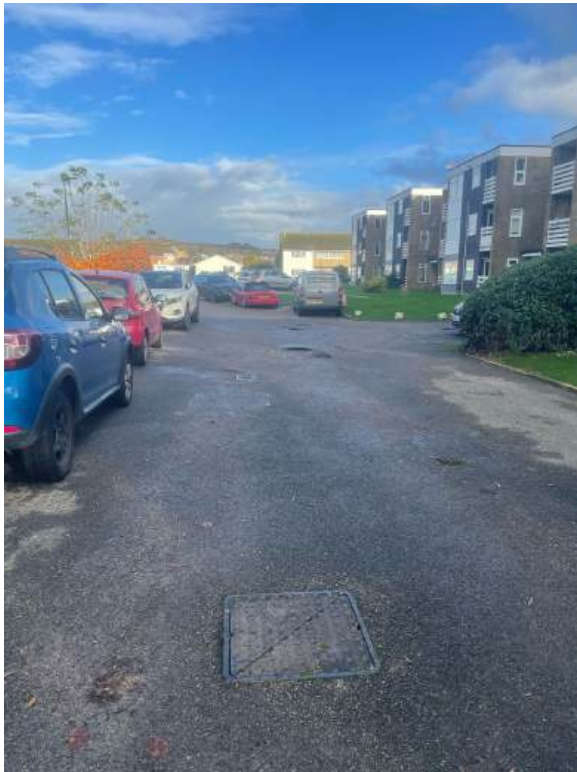
Plate 12 - continuation of water line

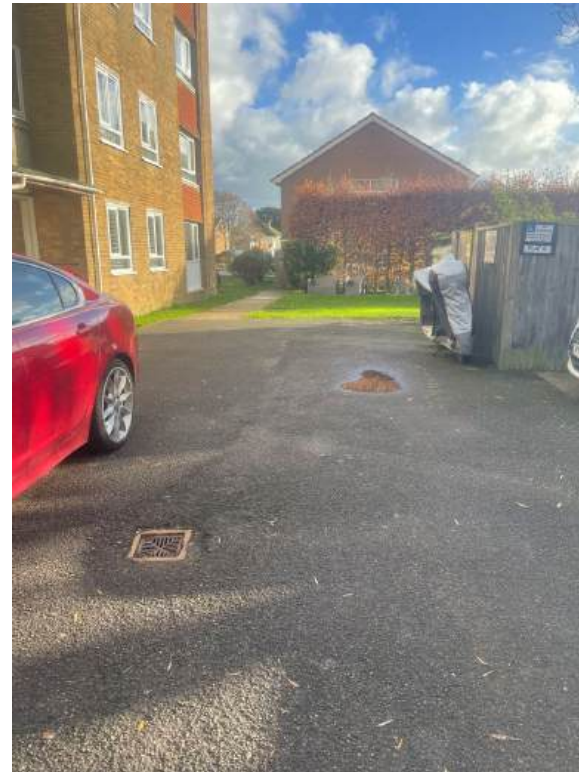
Plate 13 - connecting services from north to south of site
