Site: St John's Court, Penstone Close, Lancing  
Prepared by: Phil Allen MCIWEM C.WEM  
Approved by: Neil Jaques  
Date: 21st May 2026

## 1.0 Introduction

1.1 This Technical Note has been prepared by Motion to address Conditions 6 and 7 of planning consent AWDM/0949/22 (dated 6<sup>th</sup> June 2023).

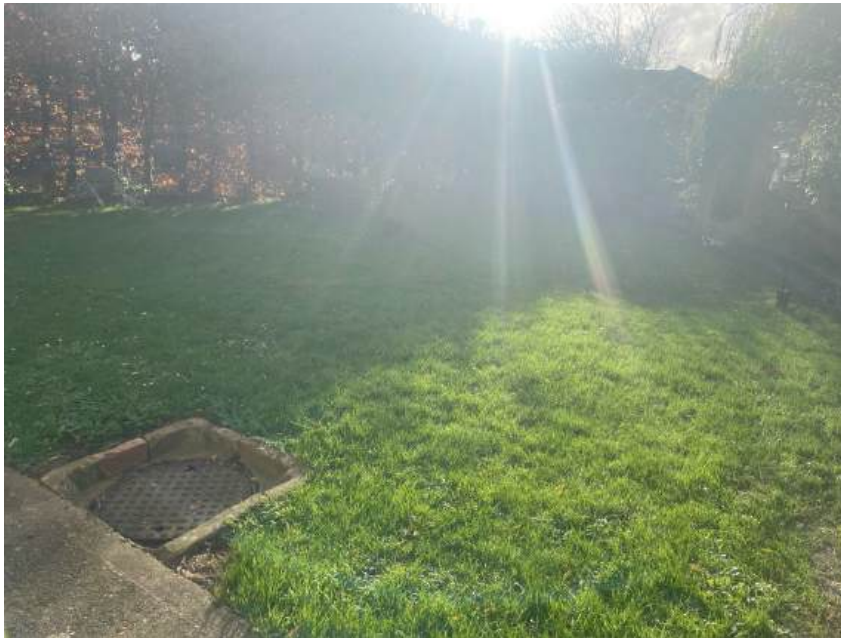
Plate 14 - continuation of services down to eastern border

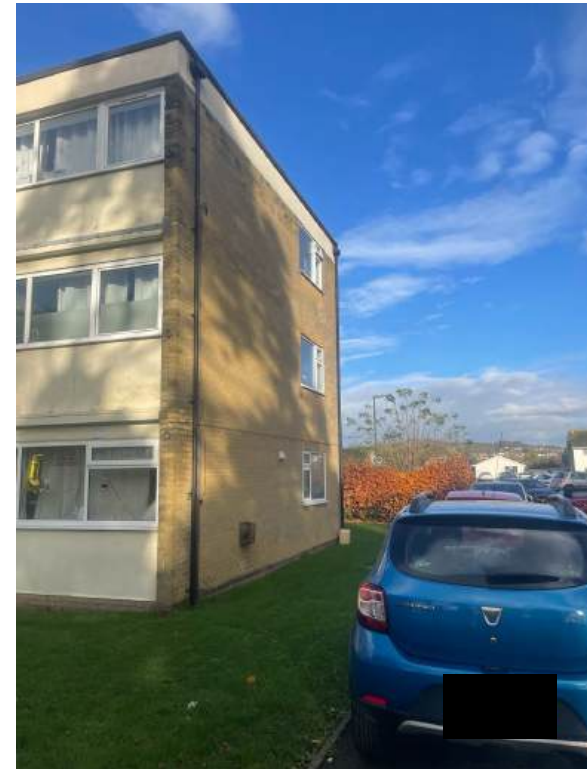
Plate 15 - buried service by substation

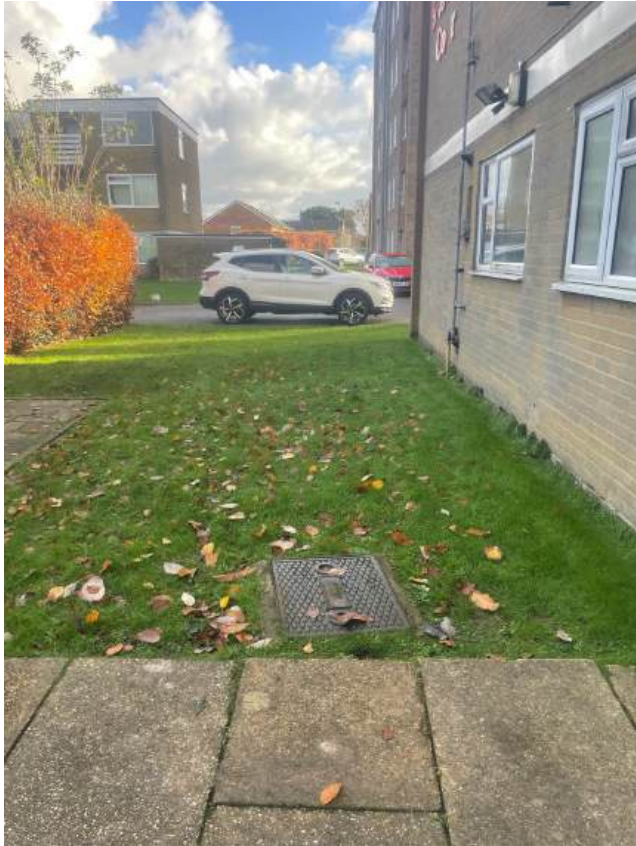
Plate 16 - guttering down western block of flats

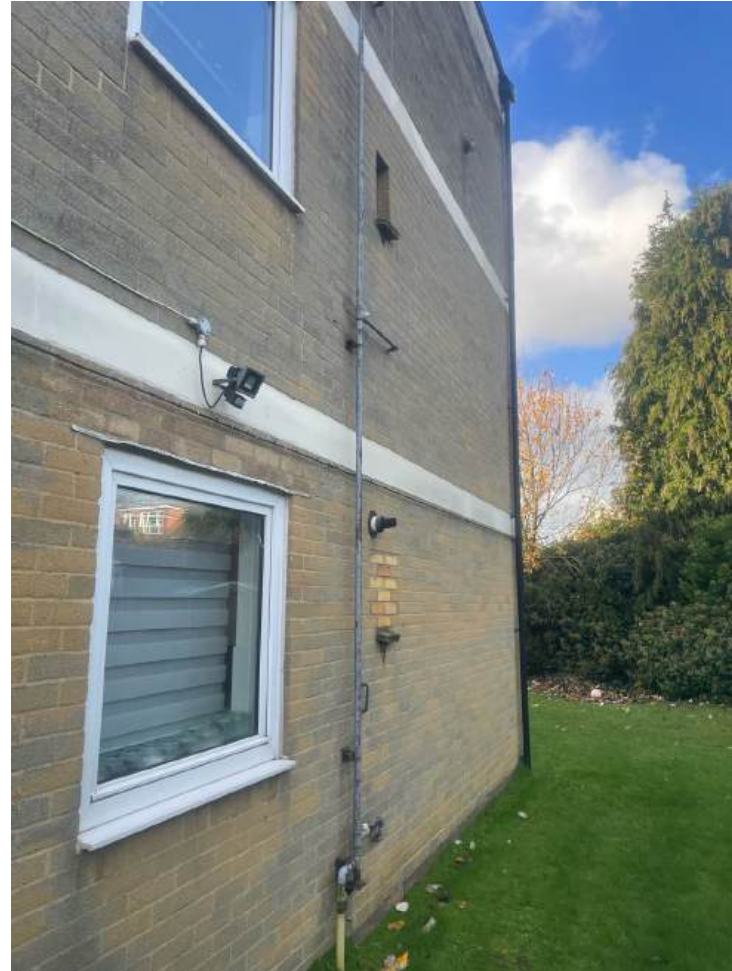
Plate 17 - services by northern border

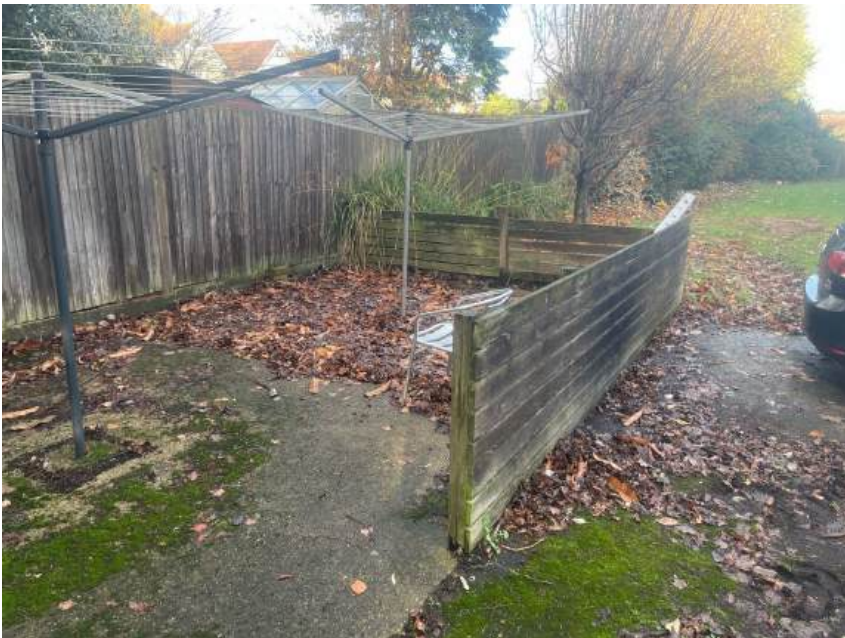
Plate 18 - gas main down northern side of site

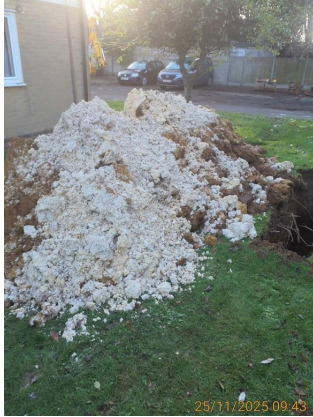
| Remarks | | | | | <br><small>25/11/2025 09:43</small><br>Photo of Spoil | | | | | | | | | | | | | | | | | | | | | | | | | |
| Ground wet from 3.8m | | | | | | | | | | | | | | | | | | | | | | | | | | | | | | |
