**DESIGN AND ACCESS AND HERITAGE STATEMENT – Internal Alterations, Replacement of Flat-Roof Coverings, Replacement Lead Flashings, Replacement Side Window, Replacement Front Door and Alterations to Rear Ground-Floor Window Openings with Installation of New Windows @ 207 Brighton Road, Worthing, West Sussex, BN11 2HA**

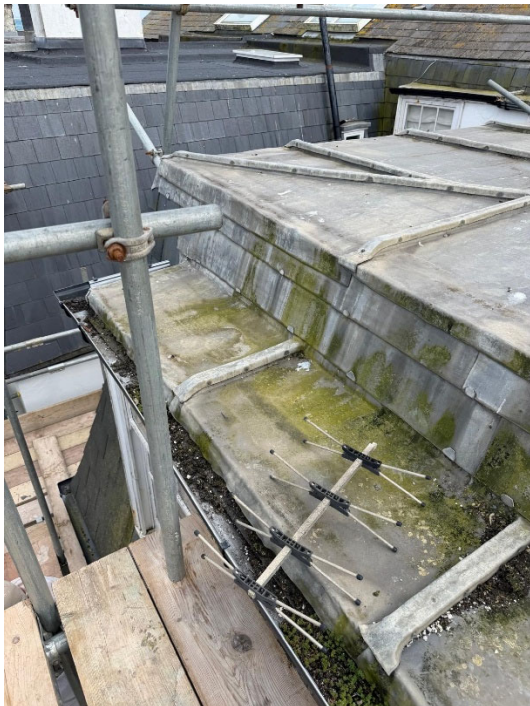
Flat roof showing multiple sheets and nailed seams.

6.2 The existing rear flat roof lead covering has been very poorly laid and is in need of replacement. Lead has been laid in multiple sheets rather than in one roll, and seams have been nailed, creating failure points for water ingress. Flashings at the junction of the roofs and chimneys / roof and rooflight have mostly failed and require replacement, with raking out of mortar joints and new lime mortar bedding to be installed. The damaged flat roof and flashings have allowed significant water ingress into bedroom 6 that has caused loss of original plaster. The whole roof covering requires replacement to stop rainwater ingress and to protect the building fabric. The proposal is to replace the entire flat-roof covering and all flashings with new lead roofing and flashings, to match existing.

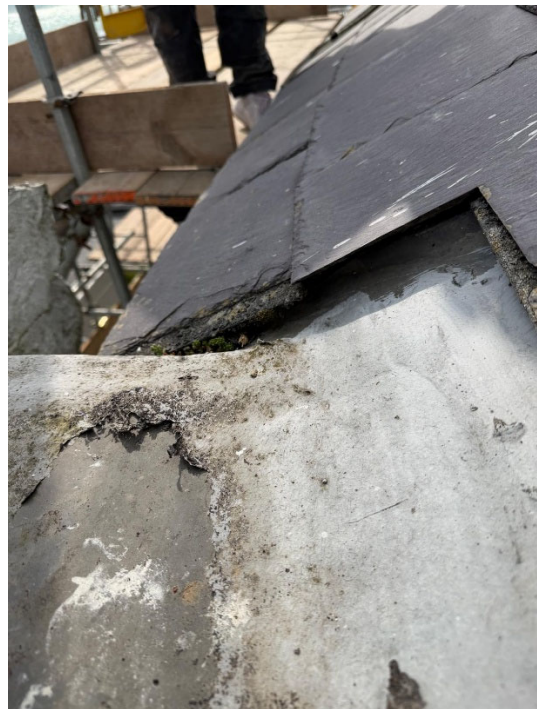
Example of failed flashing at roof junction.
