## DESIGN & ACCESS STATEMENT

### MONARCH VIEW HOUSE

### DUKE VIEW HOUSE

This Design and Access Statement accompanies a Section 73 planning application for comprehensive remedial alterations to the principal south-facing façades of two recently constructed residential blocks at Albion Street, Southwick.

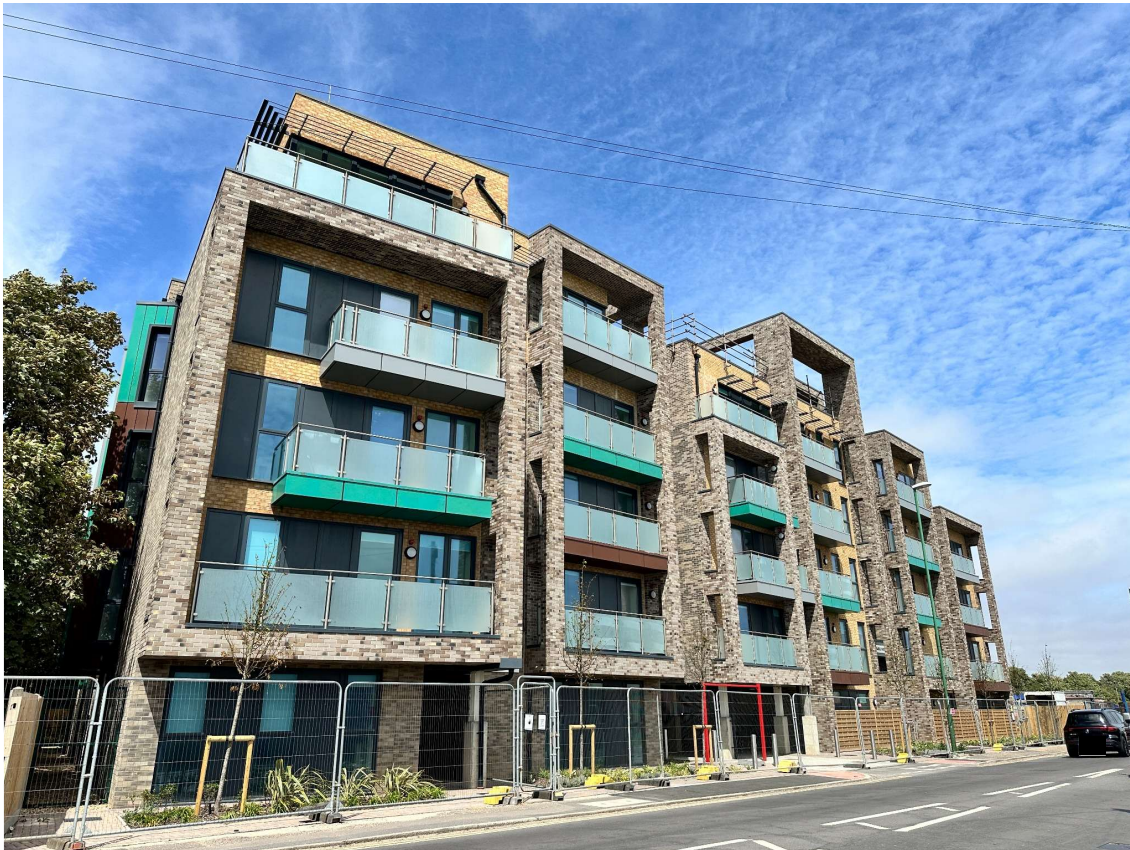
The existing south elevation is articulated by projecting brick frames, coloured balcony fascias and glazed balustrades

The south elevation is the principal public frontage, and the most weather exposed façade. The east elevation of Monarch and west elevation of Duke are also prominent, however apart from a minor interaction at fifth-floor level on Monarch to remove a steel element, these flank façades do not have major alterations.
