## Heritage and Design & Access Statement

Job Name: Lloyds Bank - Wellingborough  
Author: Peter Williams  
Job number: 105689-08  
Reference: Lloyds, Worthing  
Date: December 2025  
Revision: 1

Lloyds Bank – 41-43 South Street, Worthing, West Sussex BN11 3AU

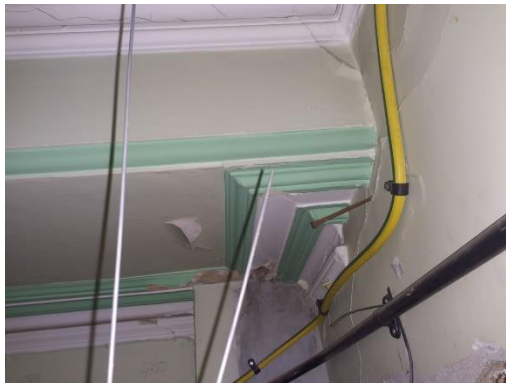
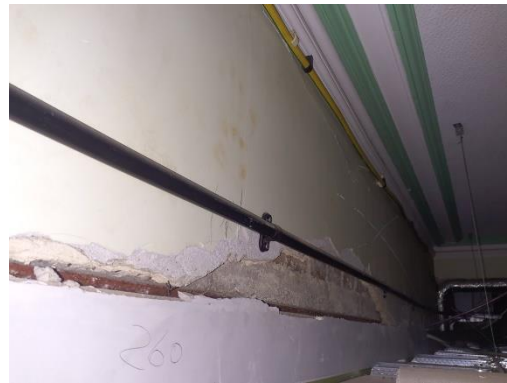
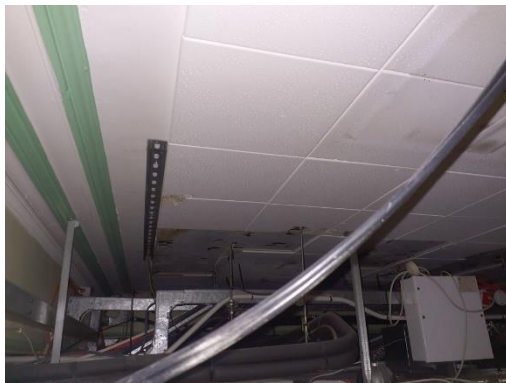
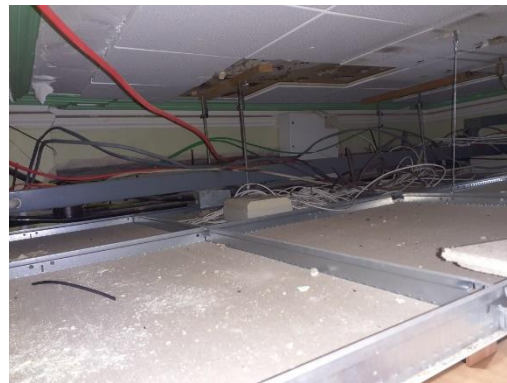
**Photos of Coving/cornice within ACM contaminated ceiling void**

The presence of a decorative Victorian style plasterwork coving/cornice has been observed to the perimeter and possible down stand beams appears to be in place. With the limited access, the extent together with its integrity cannot be confirmed. The intention is to retain the coving/cornice in place. Following the removal of the modern suspended ceiling, MEP systems and the removal of ACM's contaminants, a full review of the coving will be undertaken.

therefore removing/limiting any potential damage to the coving from the removal of the lath and plaster ceiling.
