NOTE:  
This drawing is only relevant to the Ground floor ACM removal, fire compartmentation, associated branch reinstatement works and the compression works for the relocation of the staff welfare facilities from the second floor to the first floor with the inclusion of a tea point at ground floor level

OUTLINE SCOPE OF WORKS RELATING TO ASBESTOS REMOVAL

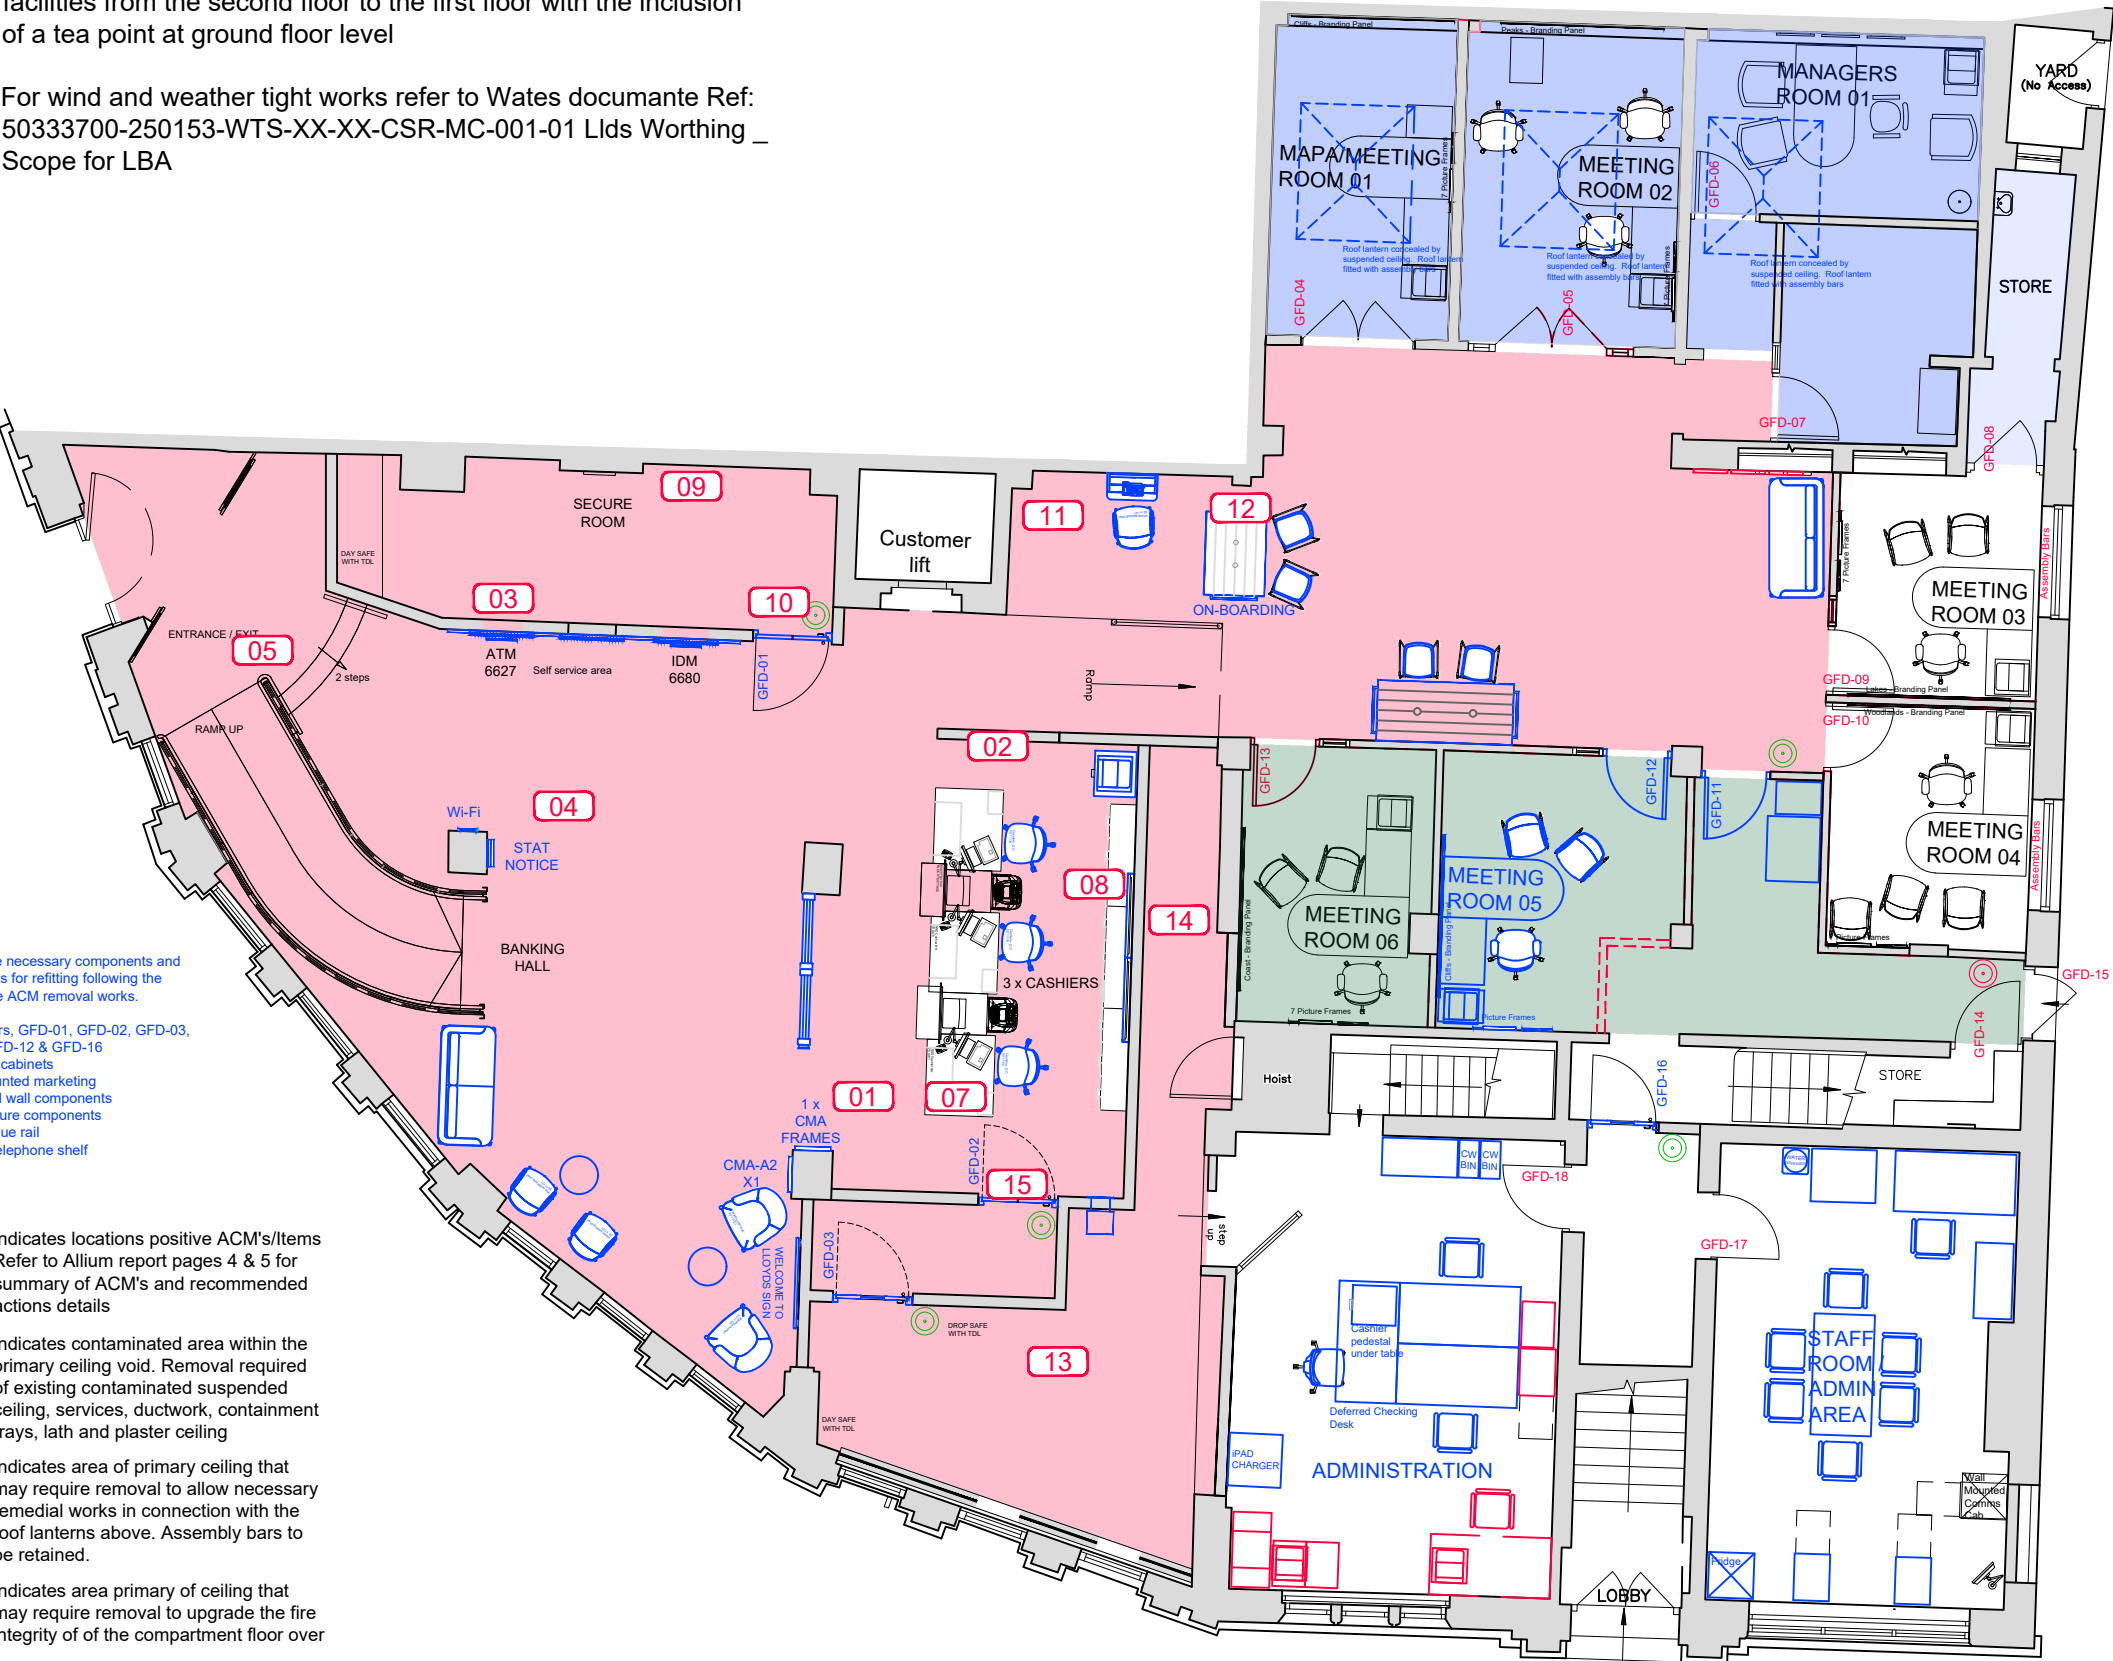
Carefully remove necessary components and store in readiness for refitting following the completion of the ACM removal works.

- Secure doors, GFD-01, GFD-02, GFD-03, GFD-11, GFD-12 & GFD-16
- Secure key cabinets
- All wall mounted marketing
- ATM slatted wall components
- Loose furniture components
- counter queue rail
- Customer telephone shelf

00 Indicates locations positive ACM's/items Refer to Allium report pages 4 & 5 for summary of ACM's and recommended actions details

Indicates contaminated area within the primary ceiling void. Removal required of existing contaminated suspended ceiling, services, ductwork, containment trays, lath and plaster ceiling

Indicates area of primary ceiling that may require removal to allow necessary remedial works in connection with the roof lanterns above. Assembly bars to be retained.

Indicates area primary of ceiling that may require removal to upgrade the fire integrity of of the compartment floor over

- Full asbestos removal methodology to be provided by Allium Environmental
- AMD to provide cause and effect schedule for MEP service
- Mitie F&S to provide cause and effect schedule for security systems
- Removal existing furniture components and obstructions to allow for positioning of mobile access equipment
- Removal of existing primary suspended ceiling and associated MEP
- Removal of existing lath and plaster secondary ceiling where first floor void has been compromised. Extent of removal to be confirmed
- Removal of ceiling void service, ducts and cabling due to historic contamination
- Removal of non load-bearing partitions to contaminated areas that require removal to form the proposed interim layout.
