Barrington Road, Worthing

## Industrial Development

Document Title: Remediation Strategy

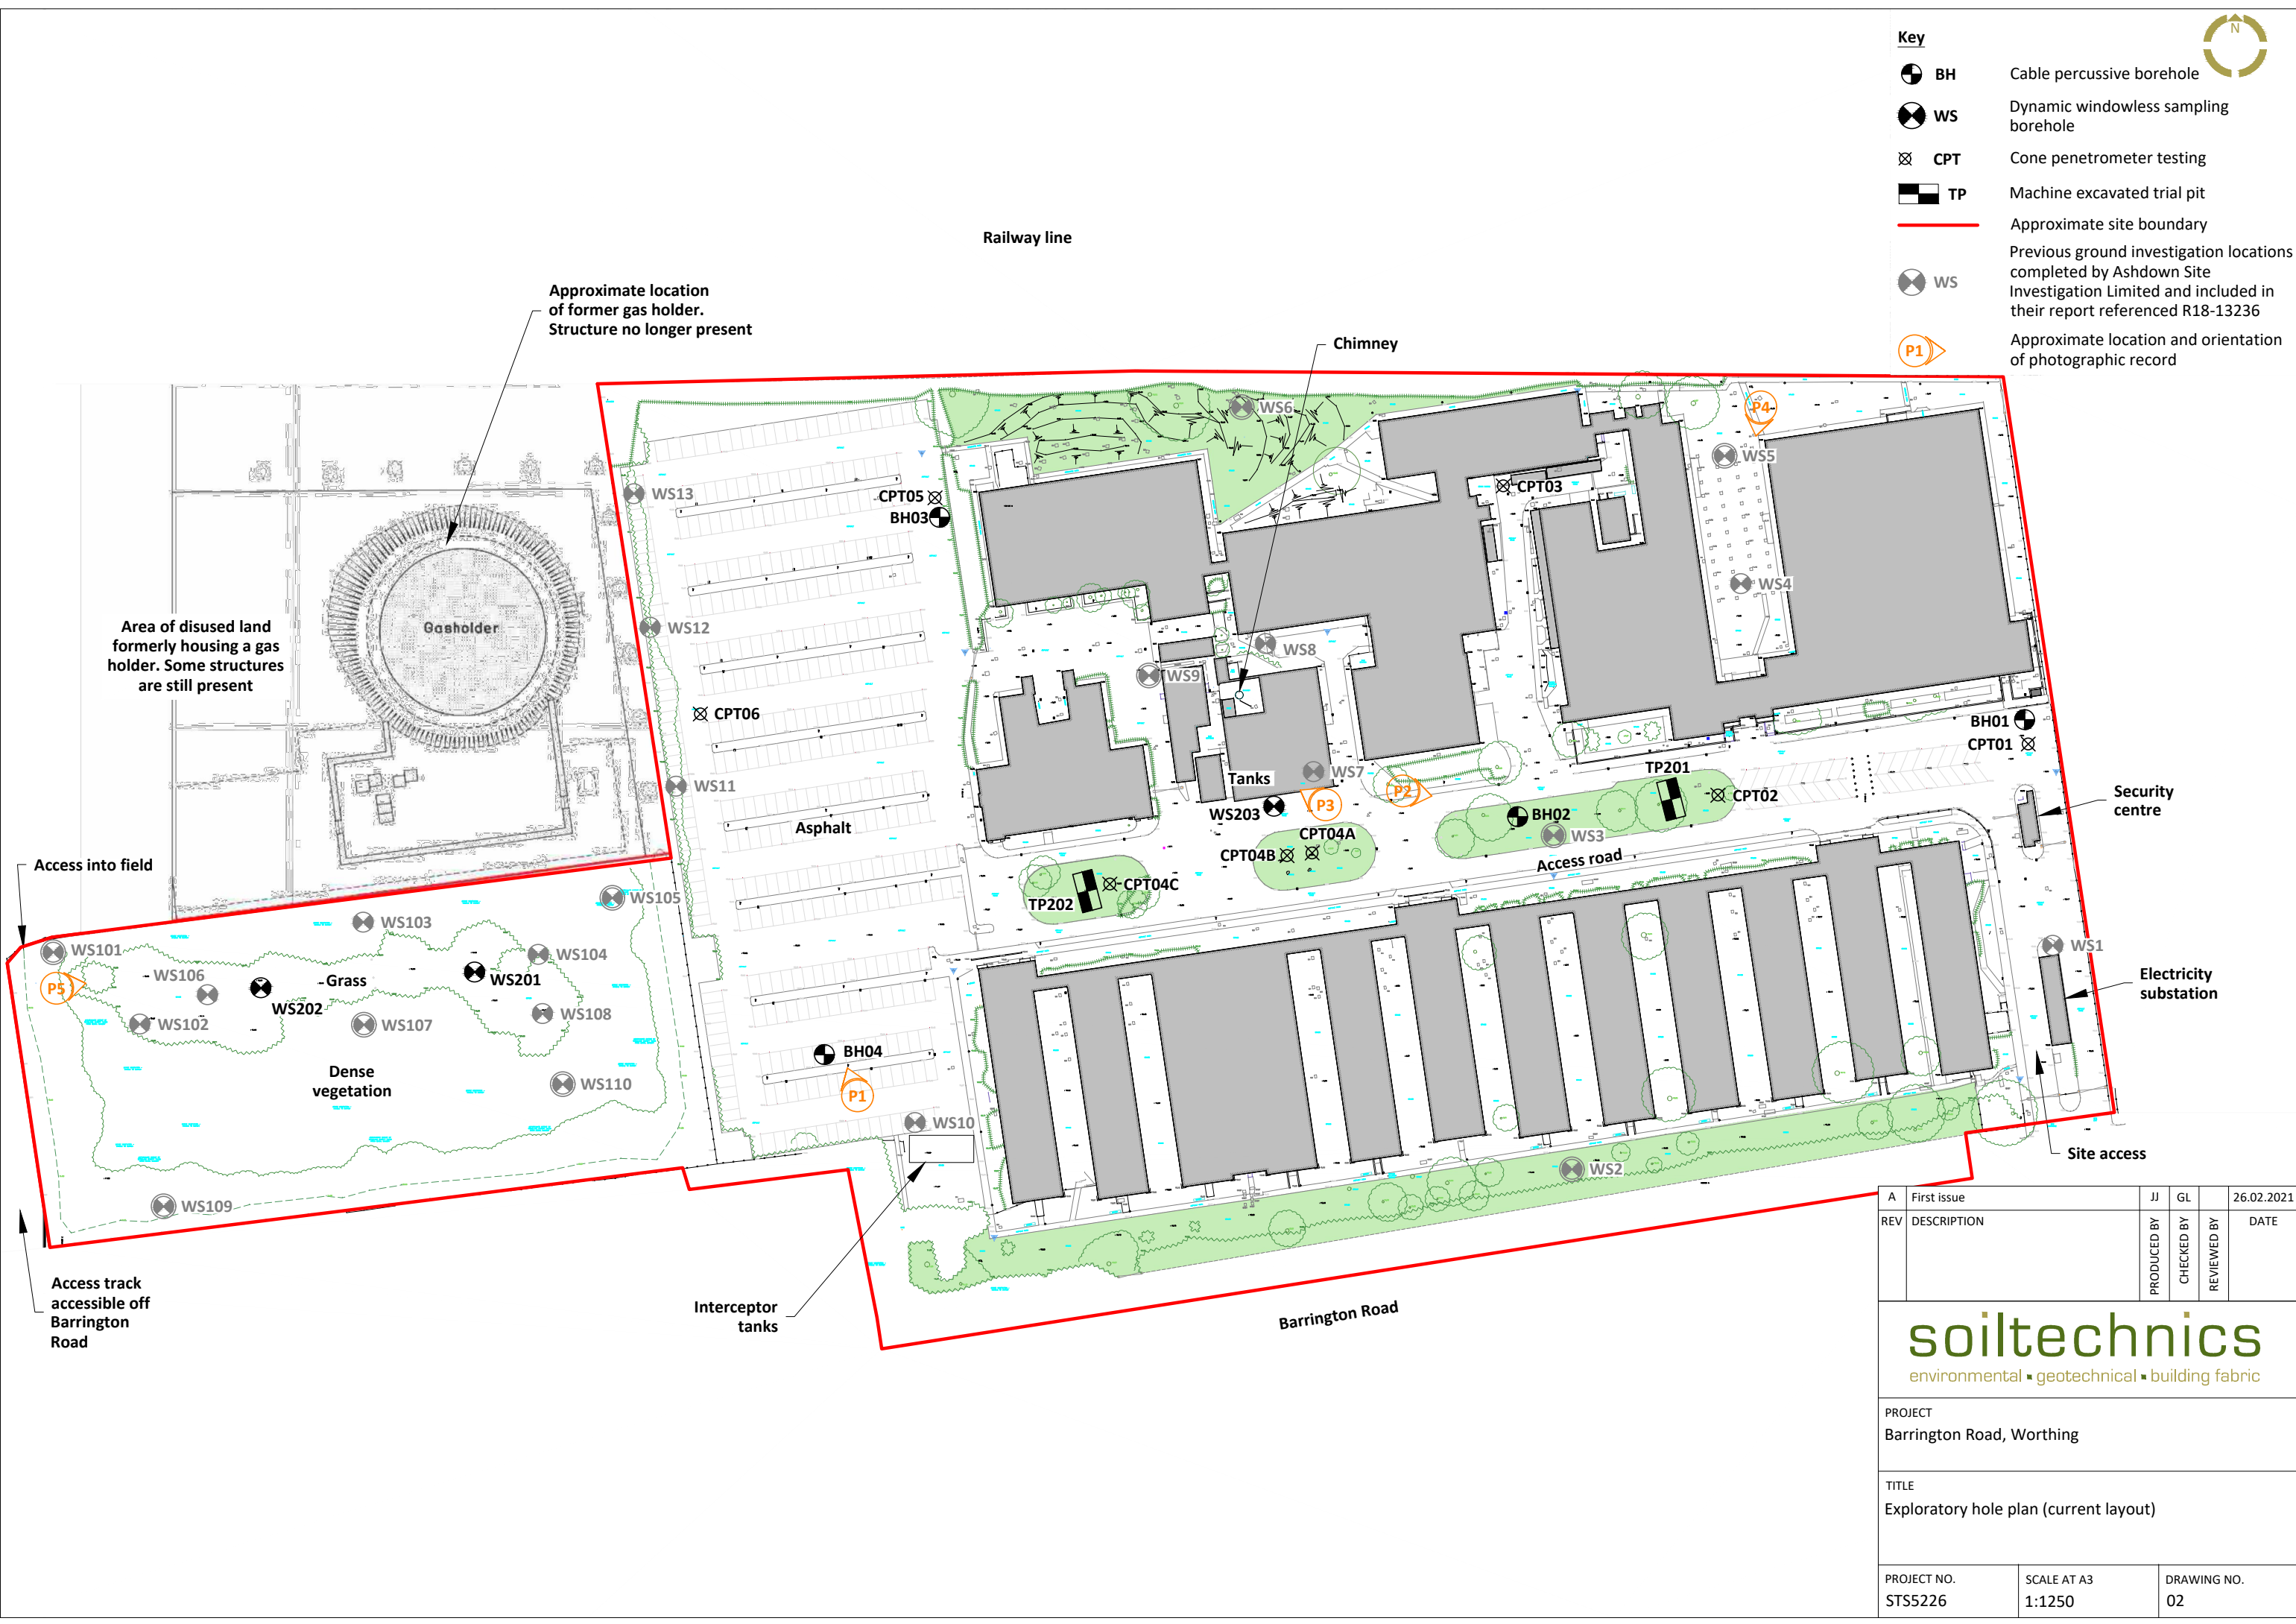
## **Appendix A   Drawings**

- 11.3.2 An indicative proposed exploratory hole plan is provided in Appendix A.
- 11.3.3 The borehole locations, sampling regime and installation designs are provided in the table overleaf. The investigation strategy is indicative only and may be subject to change based upon visual observations of the ground conditions and any contamination encountered during the works.

- 11.3.1 To address the data-gaps outlined above, it is recommended to undertake exploratory boreholes along the western boundary and within the facilities maintenance area to depths of between 2-10m bgl. A watching brief is also required during removal of the interceptor tank and the sub-station (if this is to be removed), along with undertaking verification sampling and testing. This should comprise a full-time presence during removal of any tank or interceptor, to help verify the works and aid in identifying areas of contamination. Further details on the verification of tank removal is presented in Appendix B.
