Blenheim Estates

37-41 BRIGHTON ROAD, SHOREHAM-BY-SEA

Preliminary Risk Assessment

OUR REF. NO. 70118838-PRA REV.01

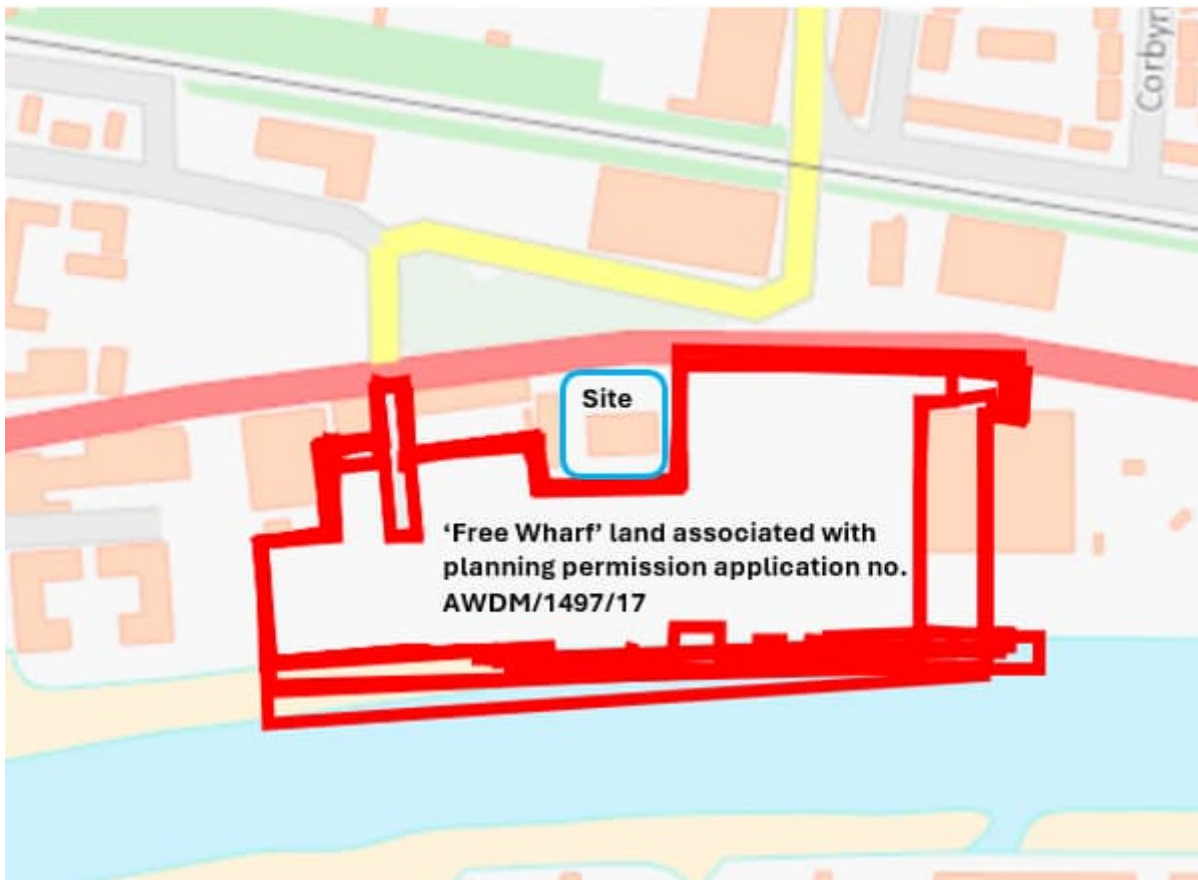
Figure 1: Location of ‘Free Wharf’ land relative to the study Site

Planning permission searches uncovered previous ground investigation and remediation details for a parcel of land located immediately south, east and west of the Site. It is understood that the western portion of this land was historically occupied by a Vauxhall Dealership and the eastern portion by Minelco Ltd, a wholesale importer, processor and distributor of decorative stone aggregates and scallop shells for processing into other by-products. This land is also referred to as ‘Free Wharf’, Shoreham-by-Sea. The location of the ‘Free Wharf’ land in relation to the study Site is provided in Figure 1.

Further remediation work may be ongoing; however, the planning records reviewed to date indicate that the Free Wharf land is being remediated as necessary to make it suitable for its intended use.

While the Free Wharf site may have historically posed an offsite source of contamination, the remediation work completed to date means that it is unlikely to do so in the future with ongoing contaminant source removal.
