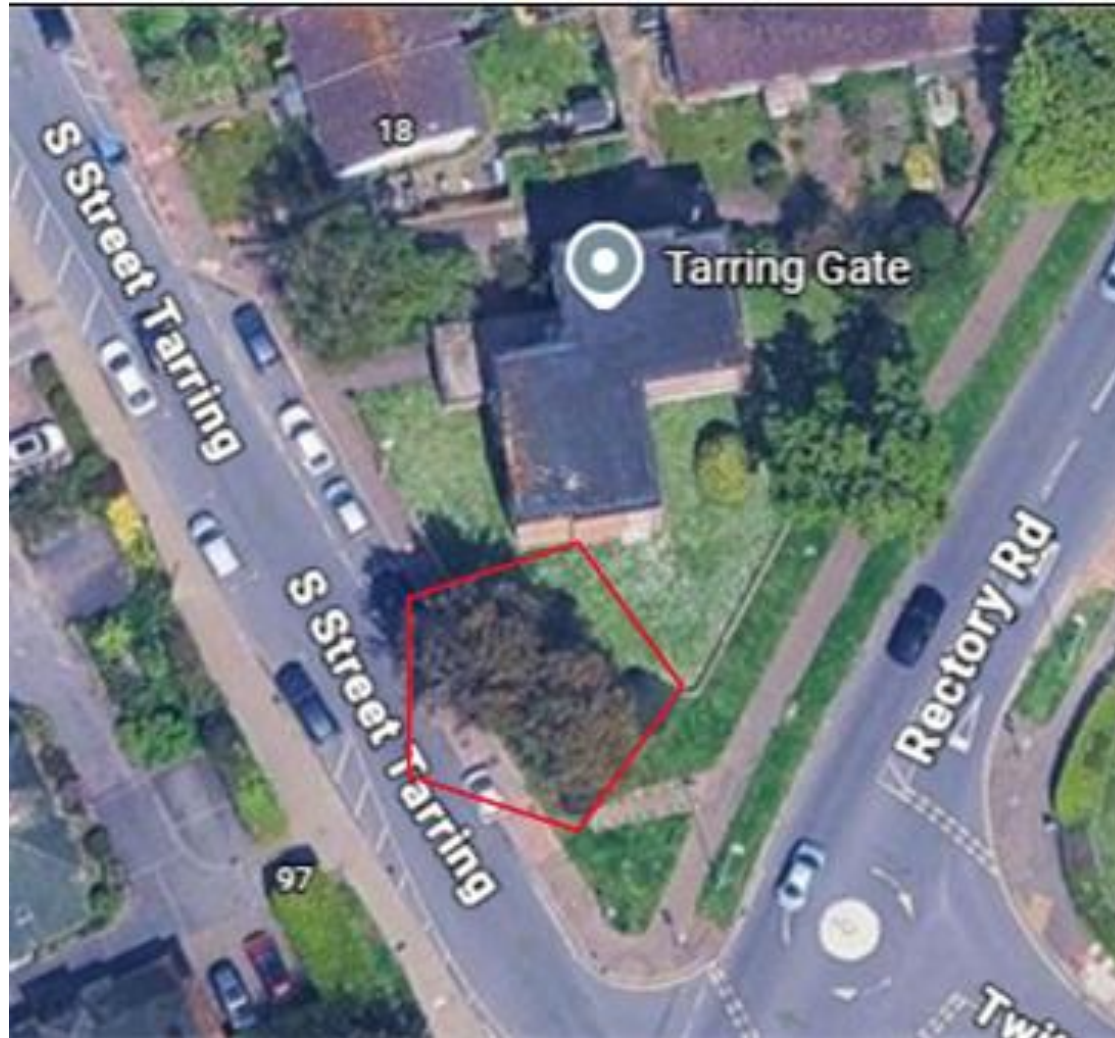
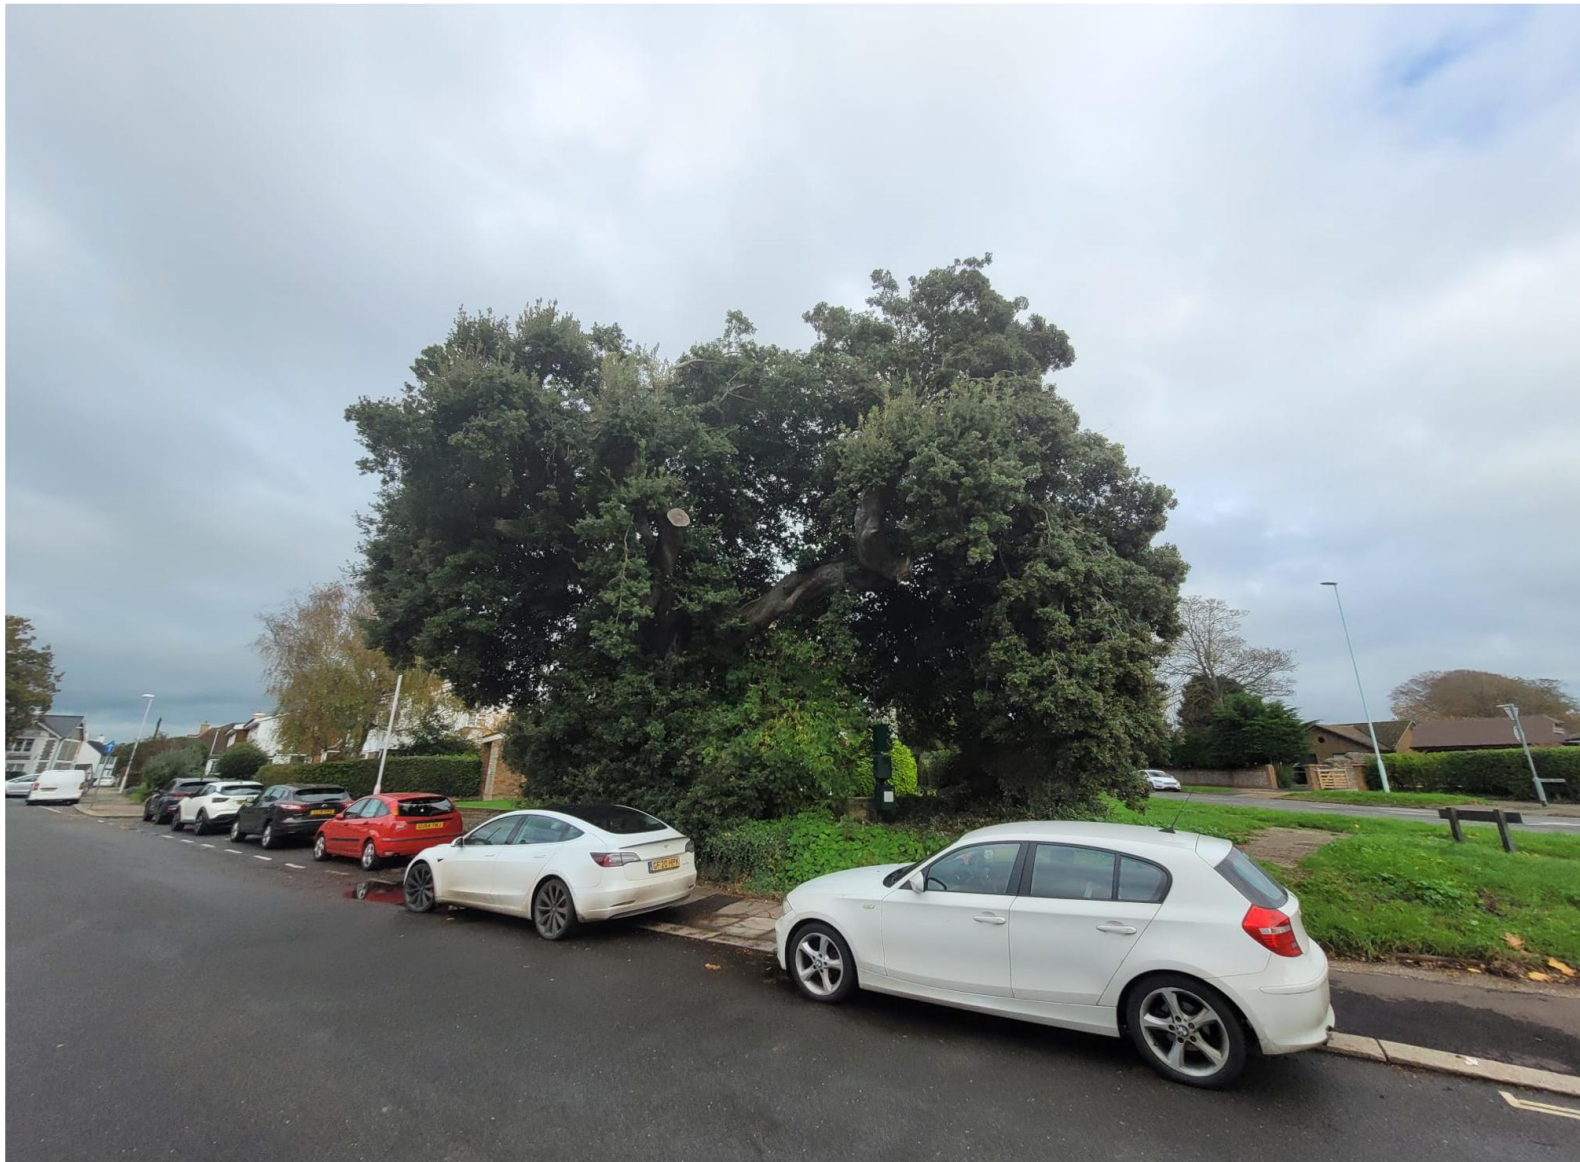
1x Holm Oak, Reduce all aspects overhanging the ERS back to boundary of the adjoining property approximately 2 to 3 m leaving in a finished natural shape. Tree is in need to preventative maintenance to ensure suitable clearance from ERS and to ensure no aspects are at risk of falling on to and damaging the site
