**GEOTECHNICAL AND  
QUANTITATIVE GROUND  
CONTAMINATION RISK  
ASSESSMENT REPORT**

**77 MARLBOROUGH ROAD  
LANCING  
WEST SUSSEX**

**PROJECT REFERENCE: P17891**

**REPORT REFERENCE: R17289**

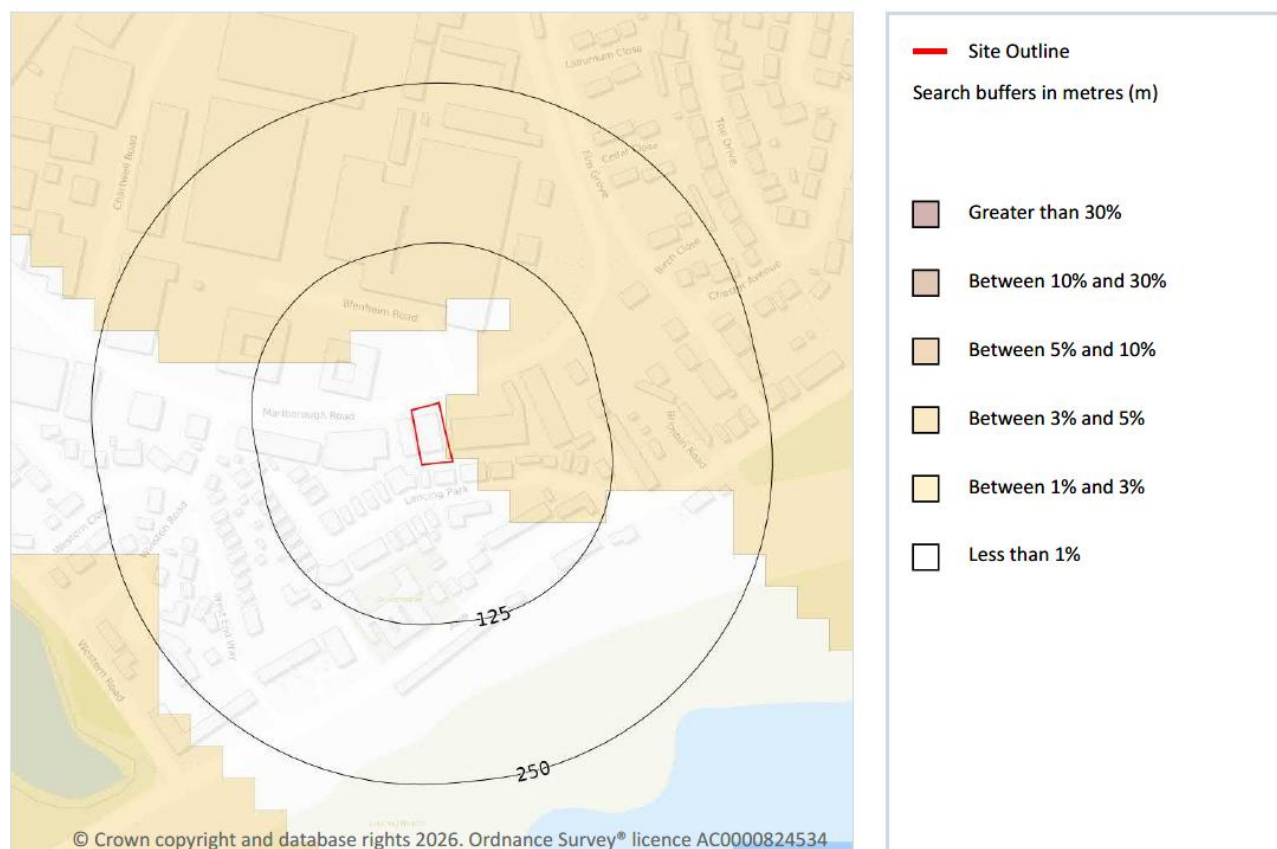
#### 20 Radon

*Radon Data from Groundsure Report included within Phase 1 Desk Study*

The radon maps are based on a 25m resolution, with a 25m buffer and 25m x 25m pixelization applied. The maps are based on indoor radon measurements and simplifications of the BGS 1:50,000 geological mapping.

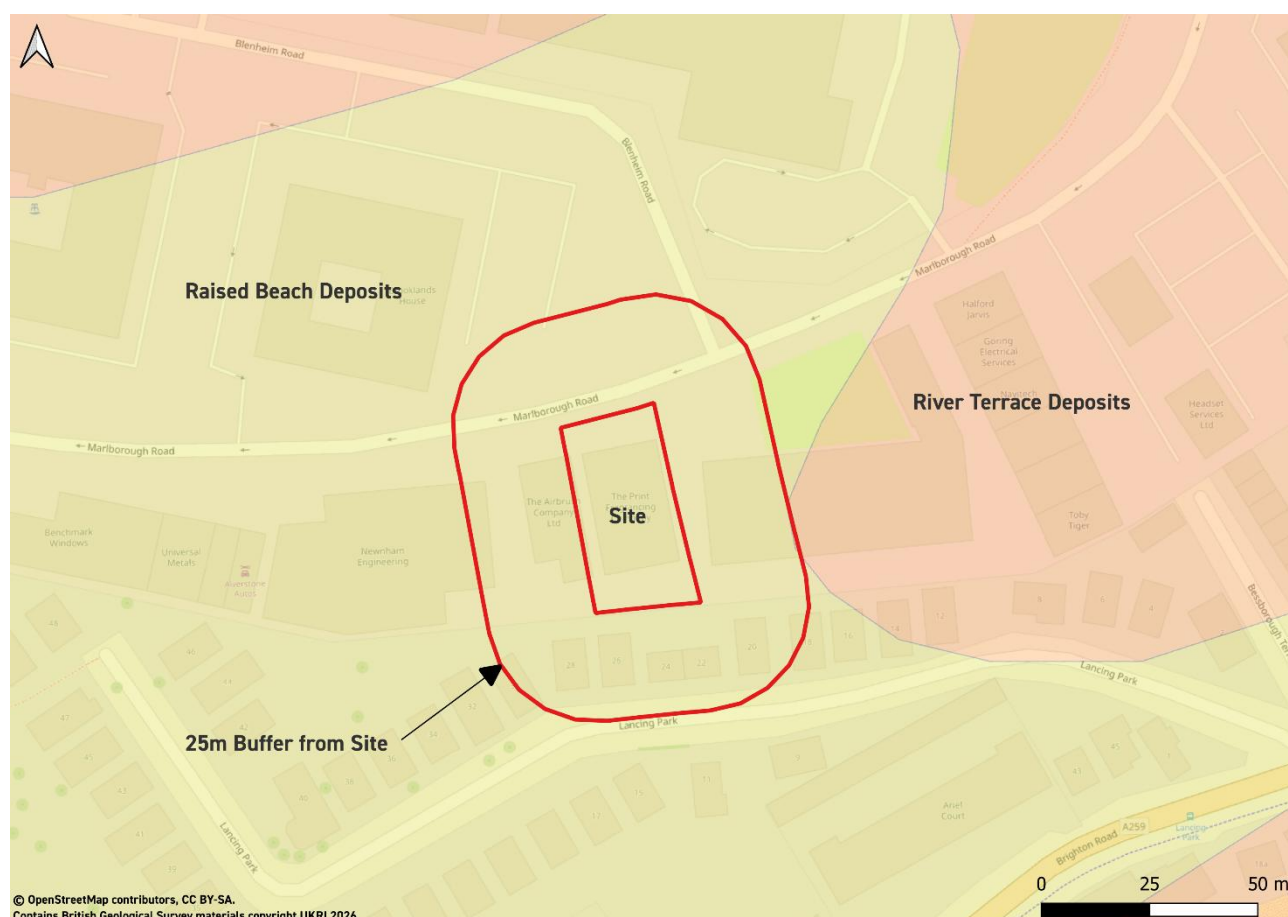
*BGS Superficial Geology Map overlain with Site and 25m Buffer*

The higher risk area relates to situations where the River Terrace Deposits overlie the Lambeth Group and where the site is shown within 25m of this geology, as is shown in the diagram below:

Therefore, there is not considered to be an unacceptable risk from elevated radon levels that would impact the site, and radon protection measures are not considered to be warranted.

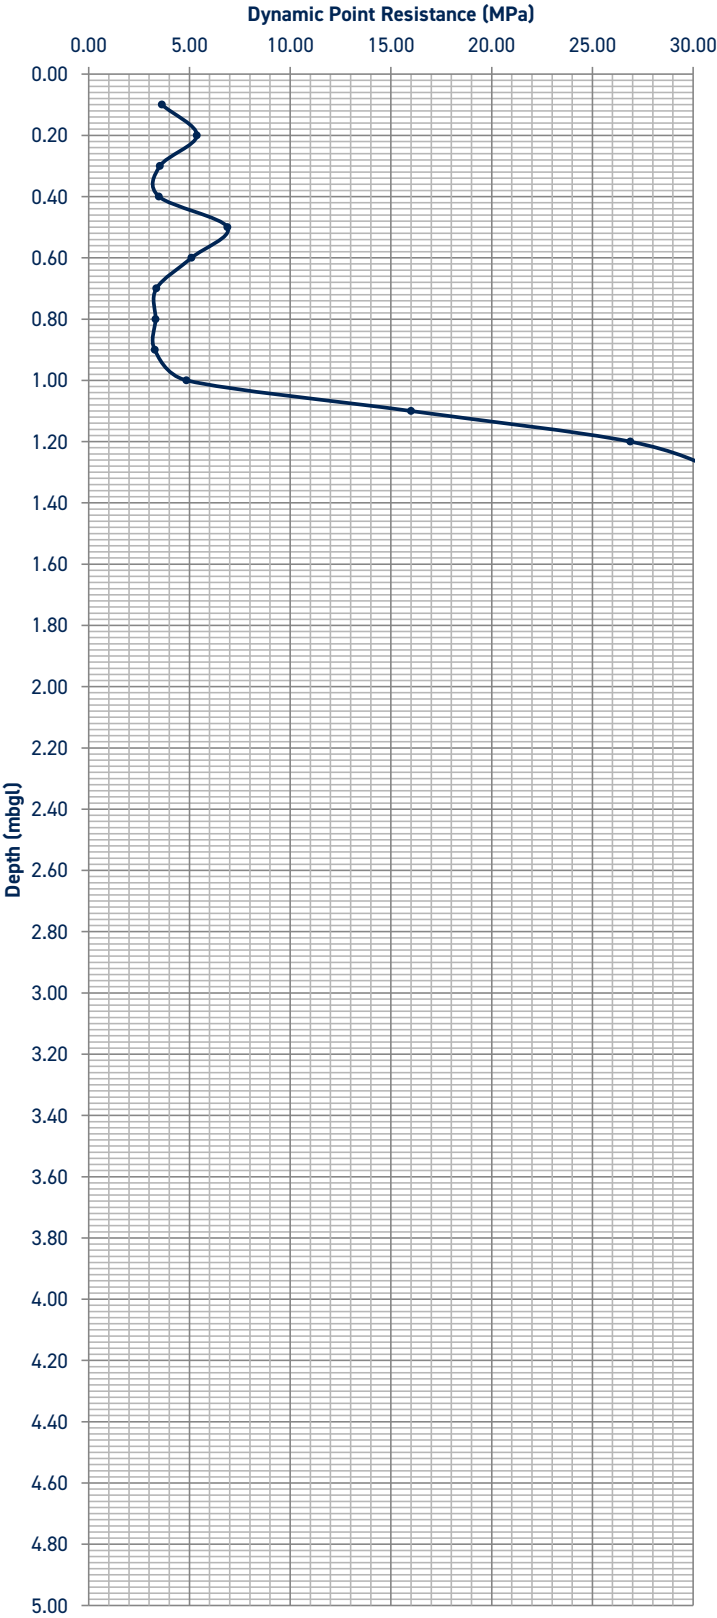
No further progress below 1.80m depth - hammer bouncing.

Cone penetrometer tests were undertaken to establish the California bearing ratio (CBR) of the in situ soils at the time of the investigation. The range of values determined is presented on the test result records within Appendix C, and the table and graphs contained within Appendix F. A summary of the in situ test data is presented below. It is noted that in situ CBR values are, in part, dependent on the moisture content of the tested soils and are consequently subject to seasonal variation.

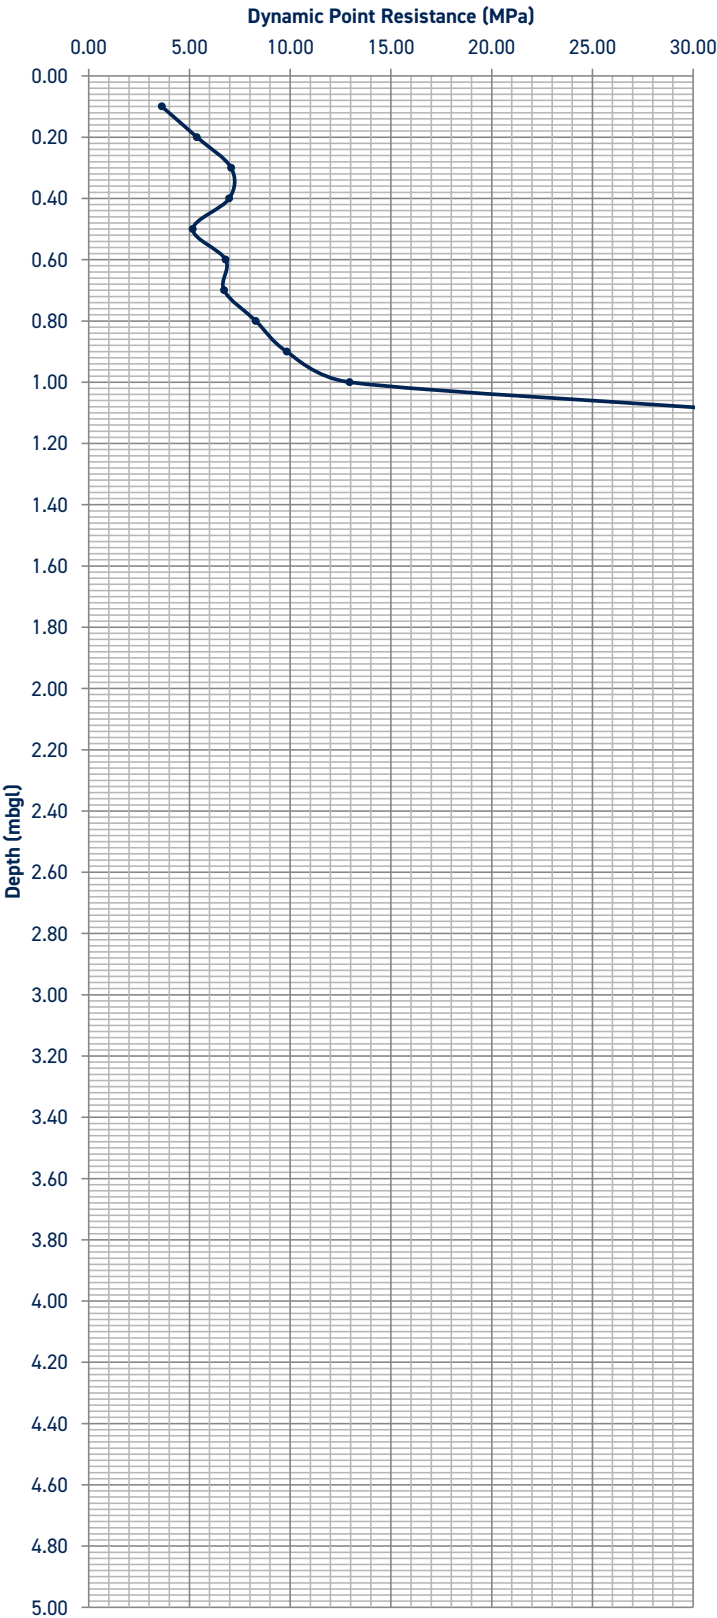
Notes:
No further progress below 1.20m depth - hammer bouncing.

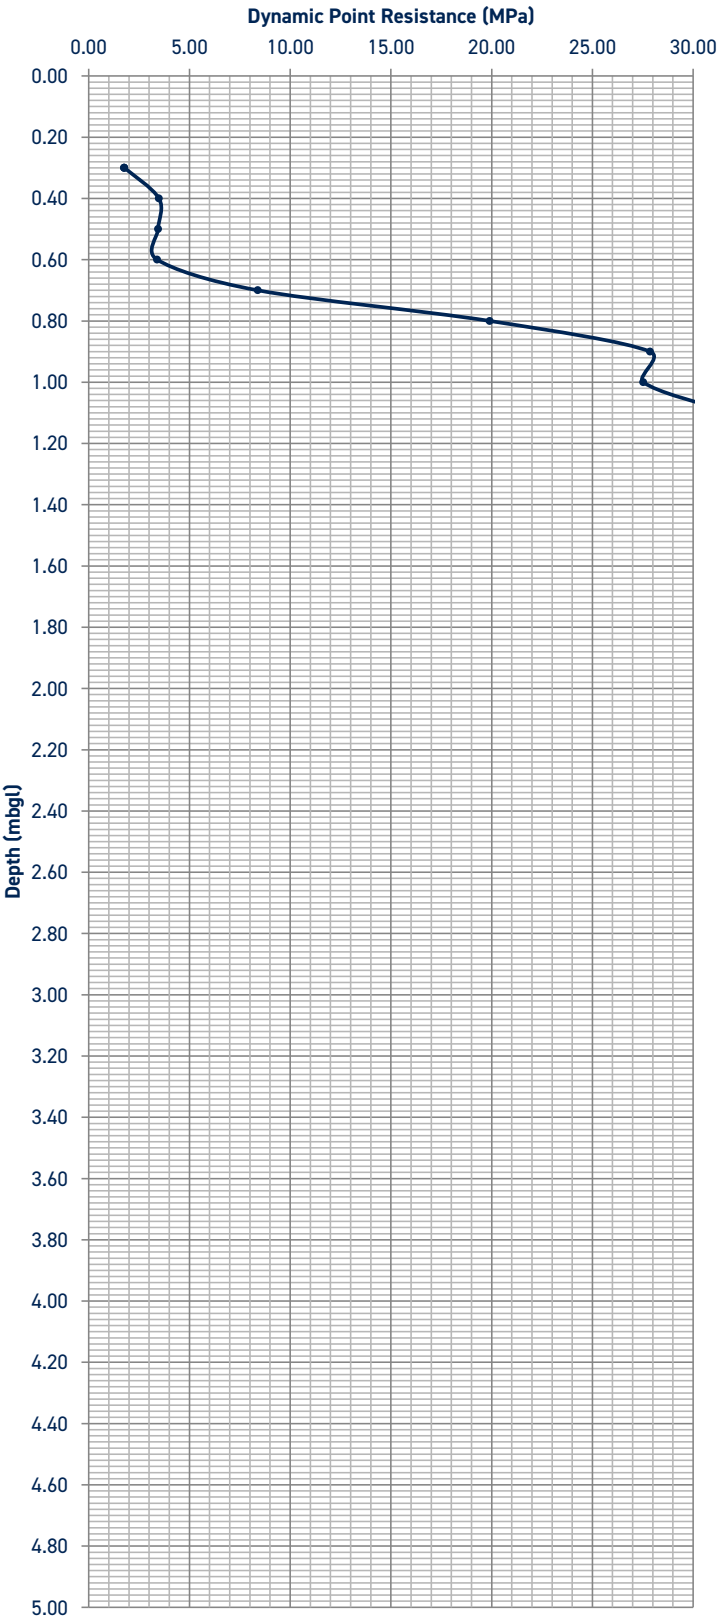
Notes:
No further progress below 1.30m depth - hammer bouncing.

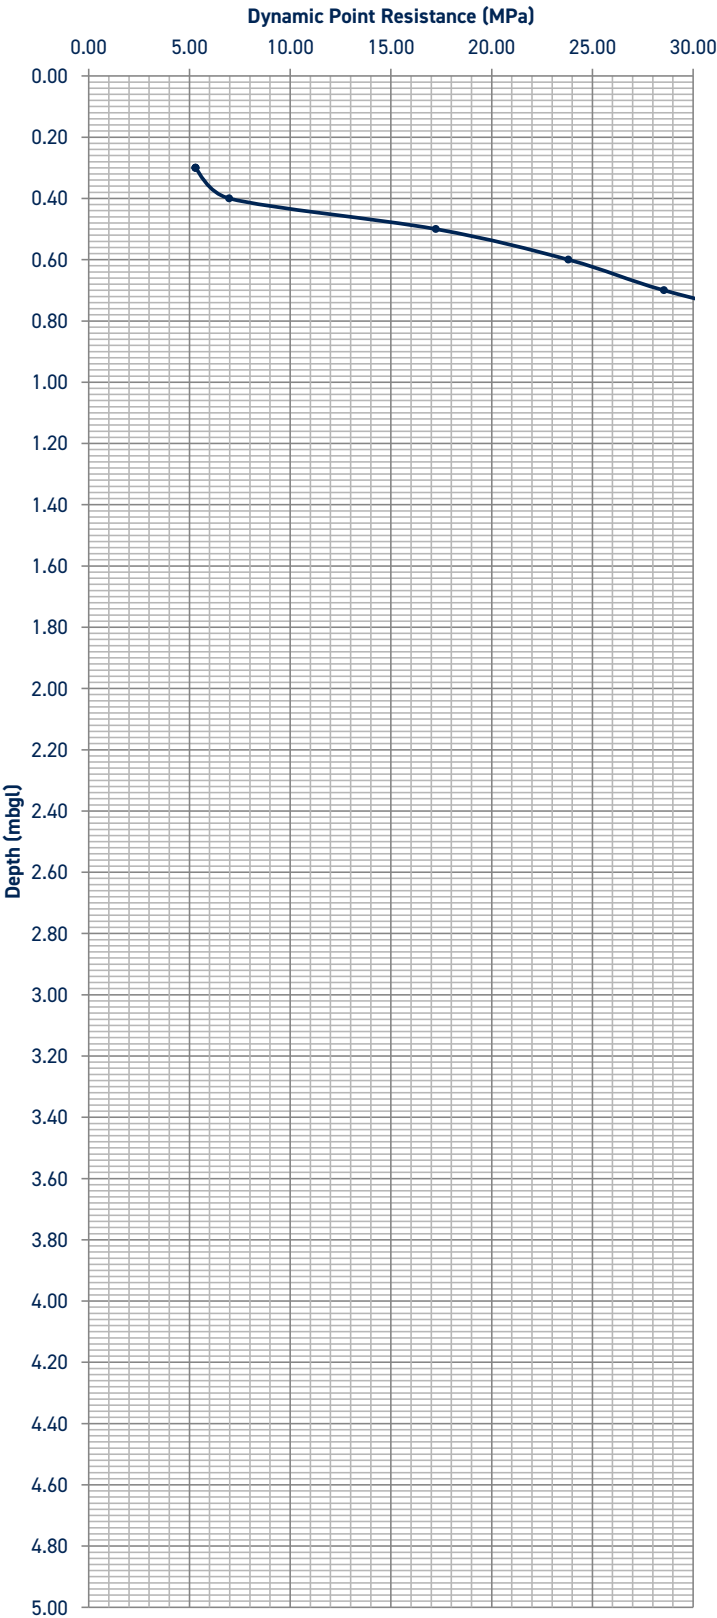
Notes:  
No further progress below 1.10m depth - hammer bouncing.

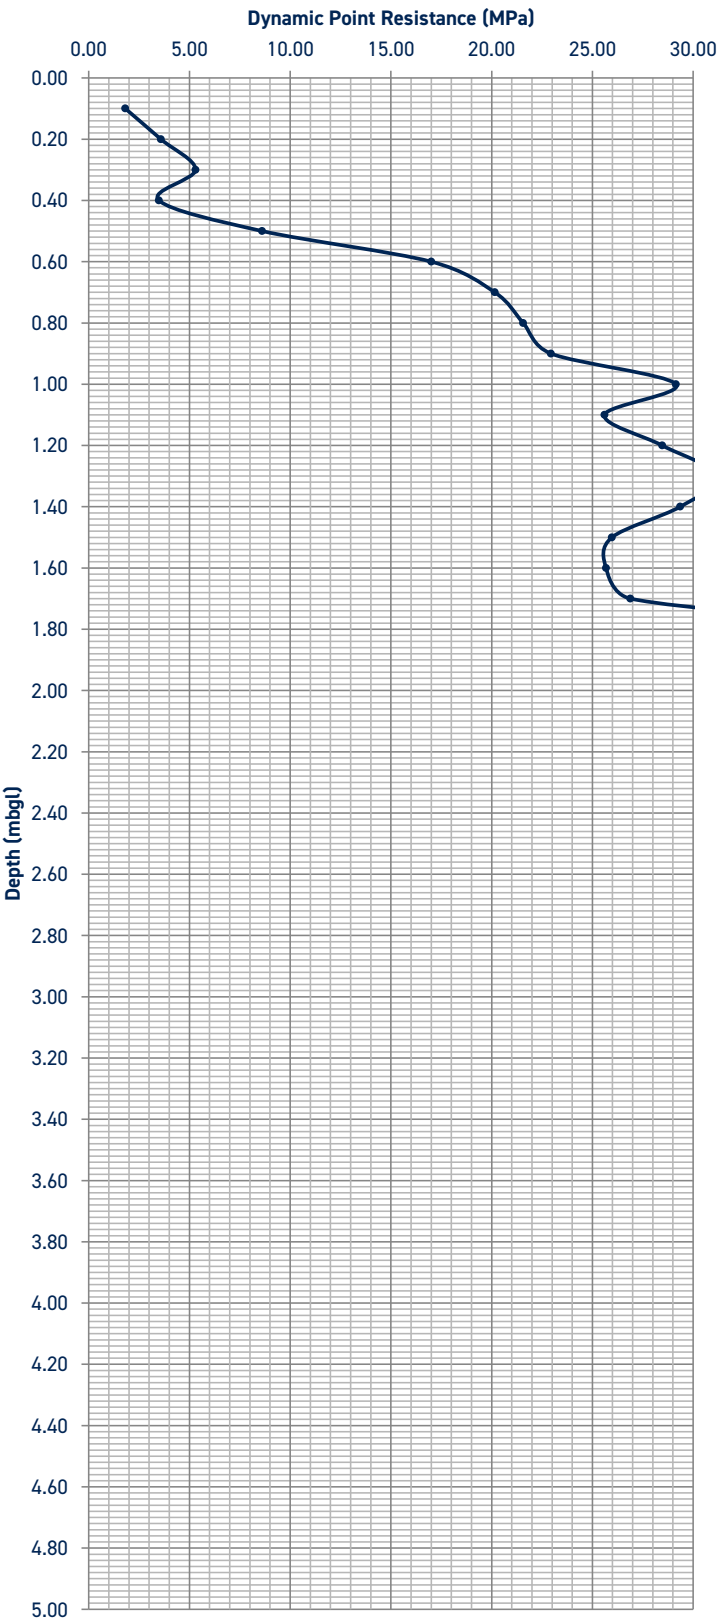
Notes:  
No further progress below 1.90m depth - hammer bouncing.

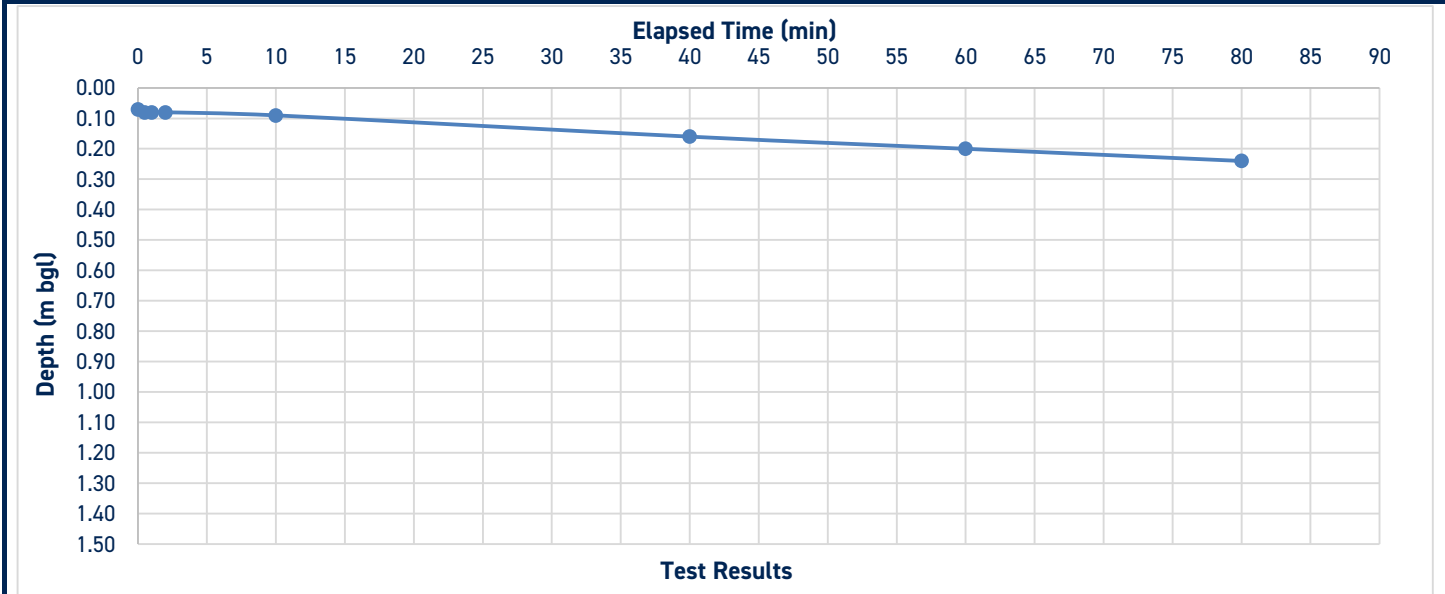
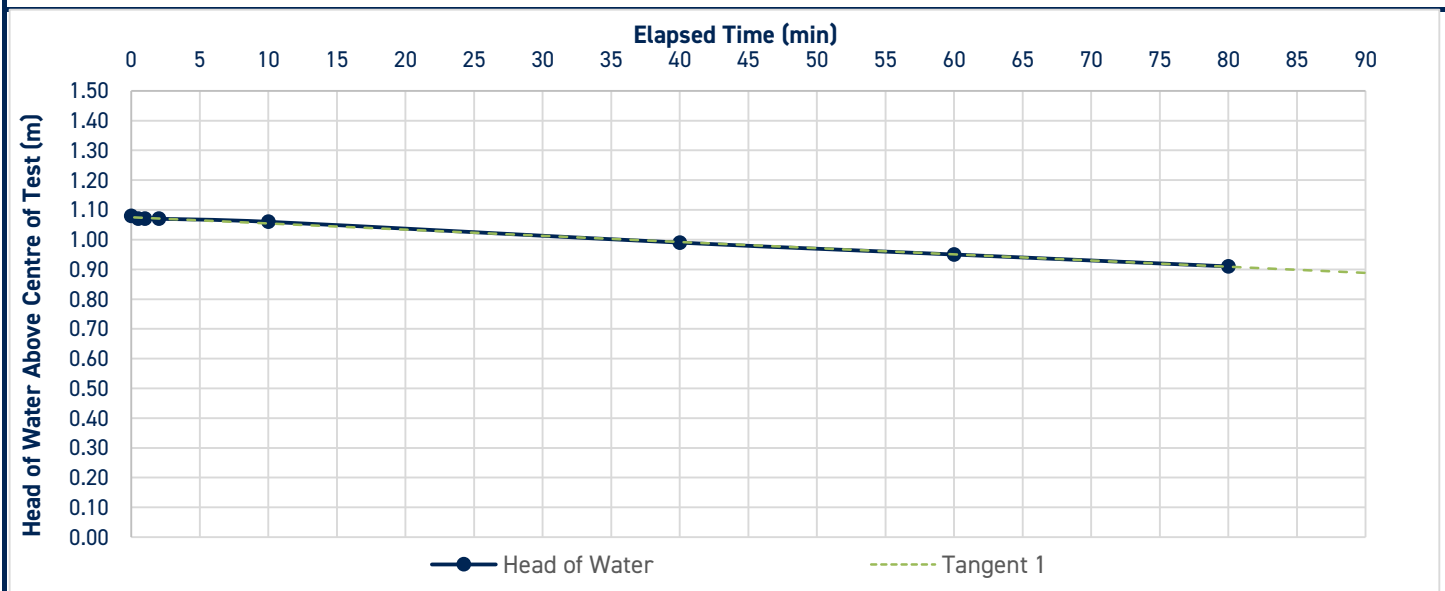
3.46E-06 m/sec

Calculation method: Variable (falling) head test method procedure carried out in general accordance with BS EN ISO 22282-2:2012. Infiltration rate calculated for each of the above given value of head of water using the tangent Head intercept (Hp) and the tangent Time intercept (th) and the area of exposed test section using the following formulae -  $250.H_p.d^2/D.L.th$

Variable (falling) head testing<sup>9</sup> was undertaken in boreholes WS02 and WS04. From the test results, calculations were made to estimate the infiltration rate that could be expected for soakaways constructed to discharge into the underlying soils within the test zone.

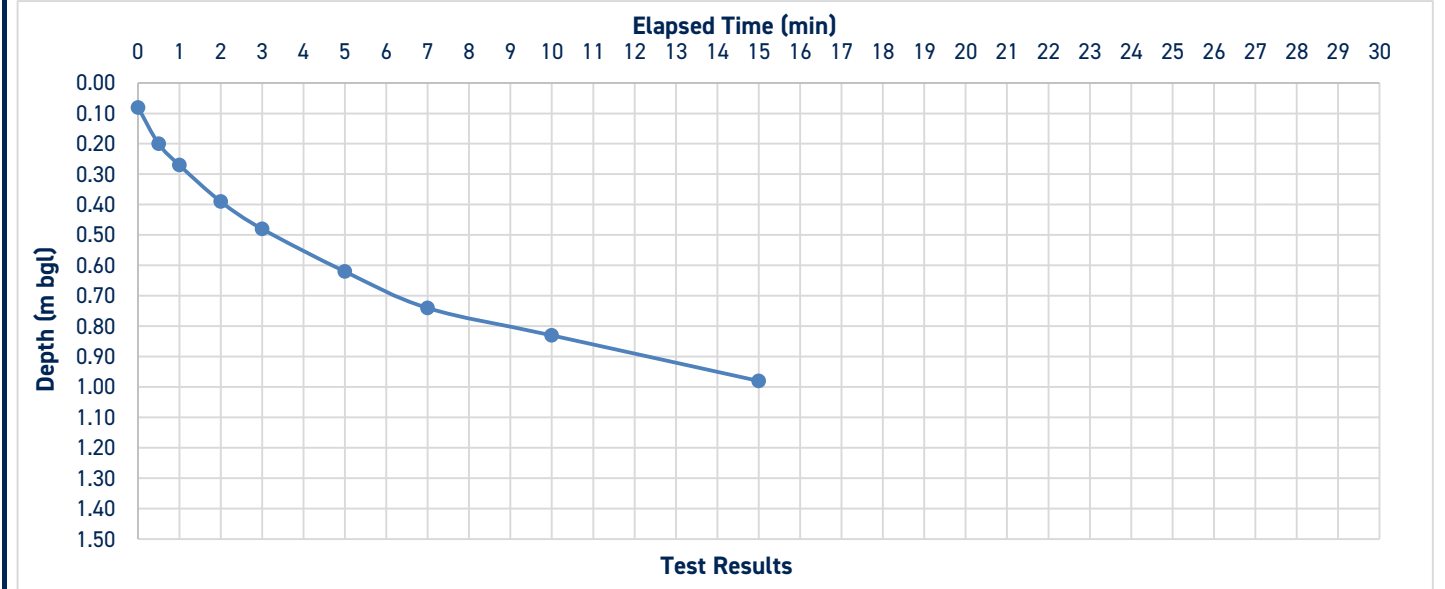
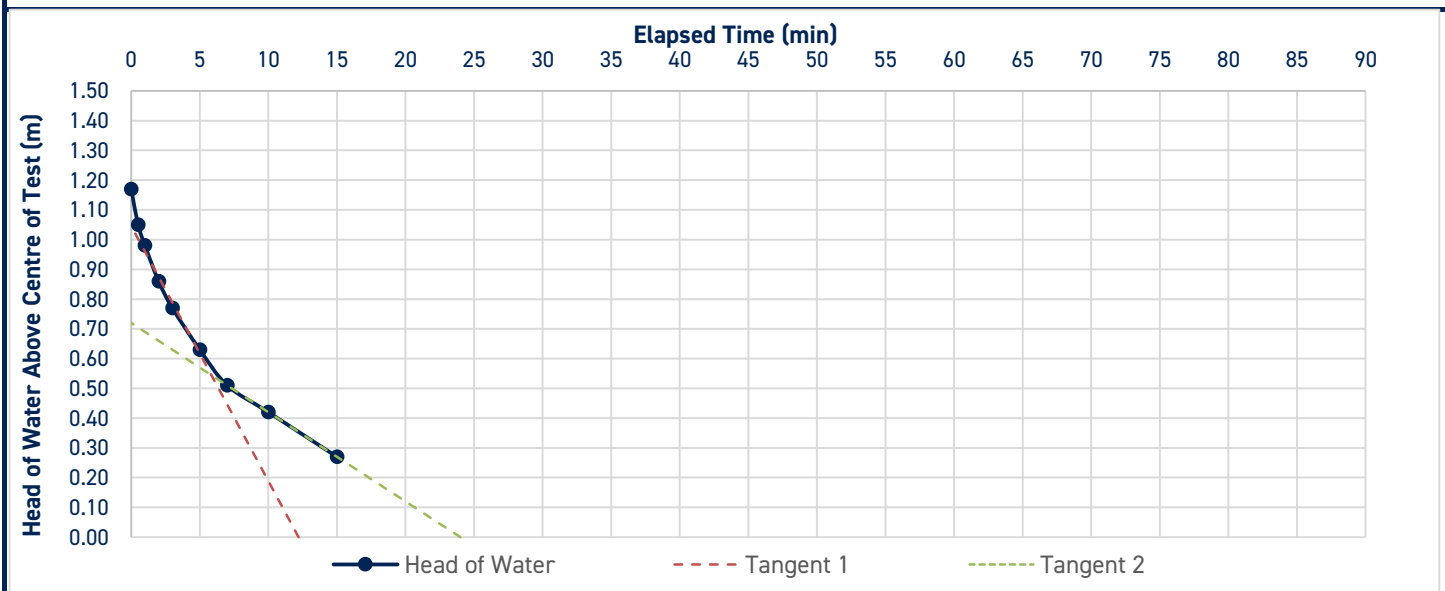
| Infiltration rate | 1.13E-04 | 3.94E-05 m/sec |
| Calculation method: | Variable (falling) head test method procedure carried out in general accordance with BS EN ISO 22282-2:2012. Infiltration rate calculated for each of the above given value of head of water using the tangent Head intercept (Hp) and the tangent Time intercept (th) and the area of exposed test section using the following formulae - $250.H_p.d^2/D.L.th$ | |

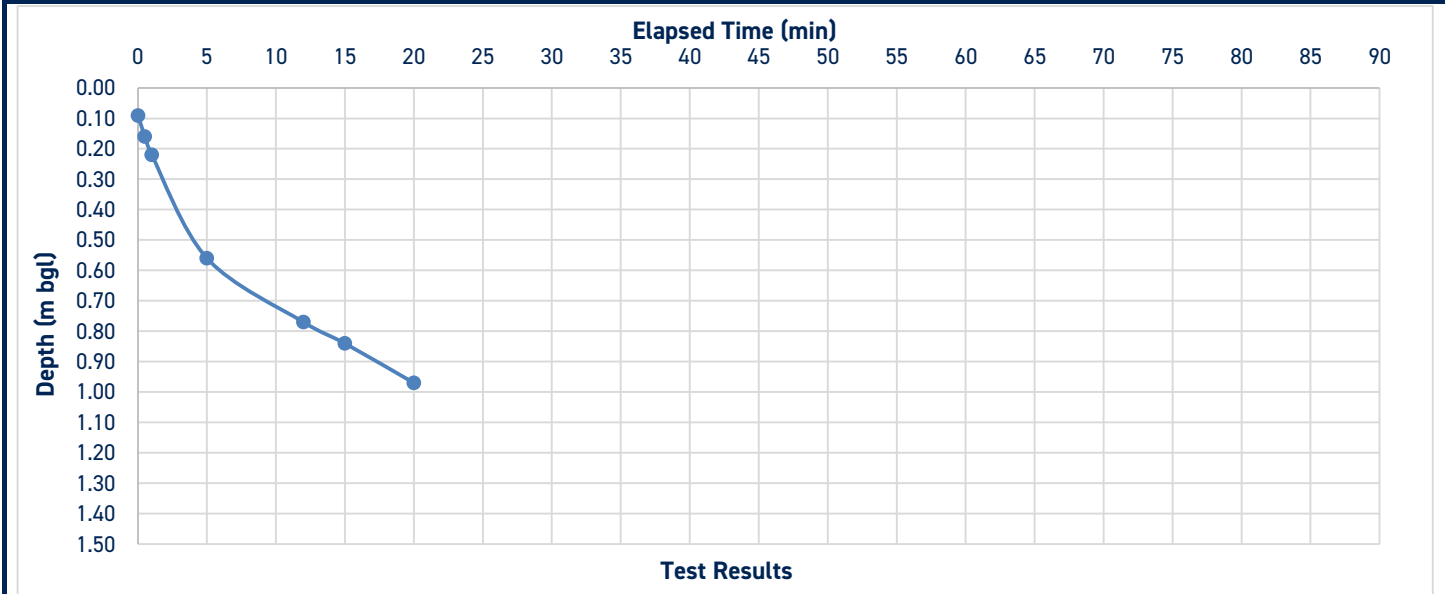
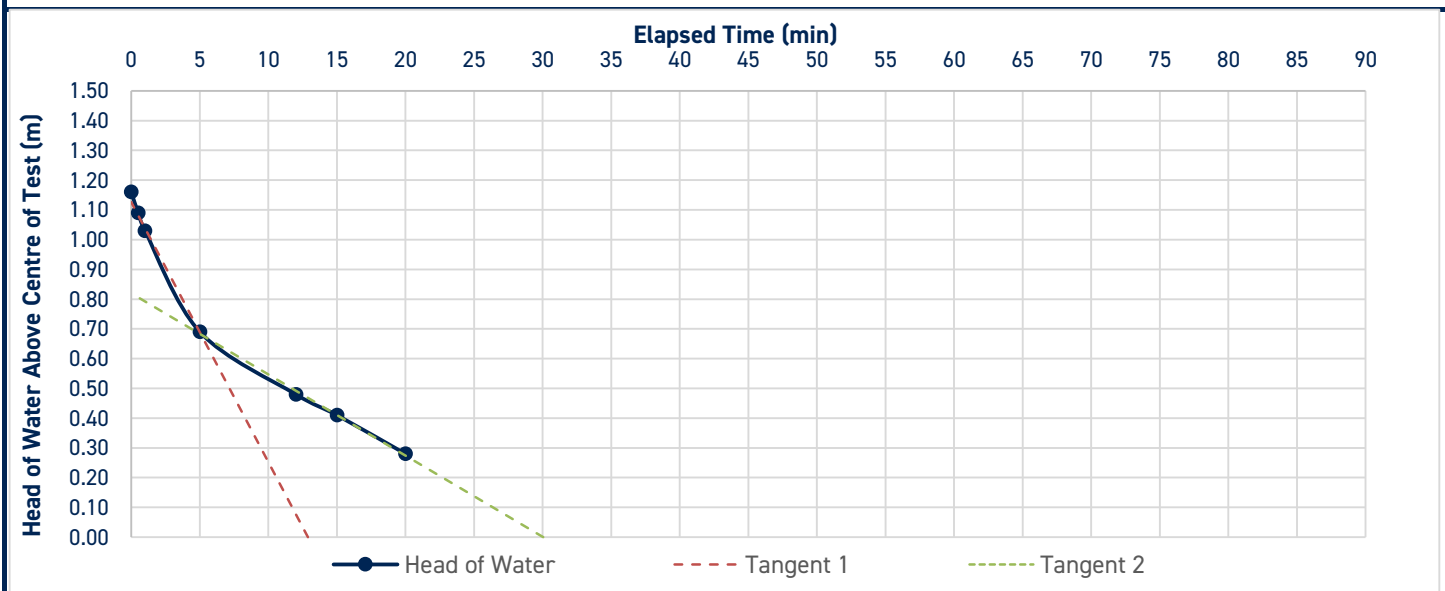
| Infiltration rate | 1.15E-04 | 3.58E-05 m/sec |
| Calculation method: | Variable (falling) head test method procedure carried out in general accordance with BS EN ISO 22282-2:2012. Infiltration rate calculated for each of the above given value of head of water using the tangent Head intercept (Hp) and the tangent Time intercept (th) and the area of exposed test section using the following formulae - $250.H_p.d^2/D.L.th$ | |

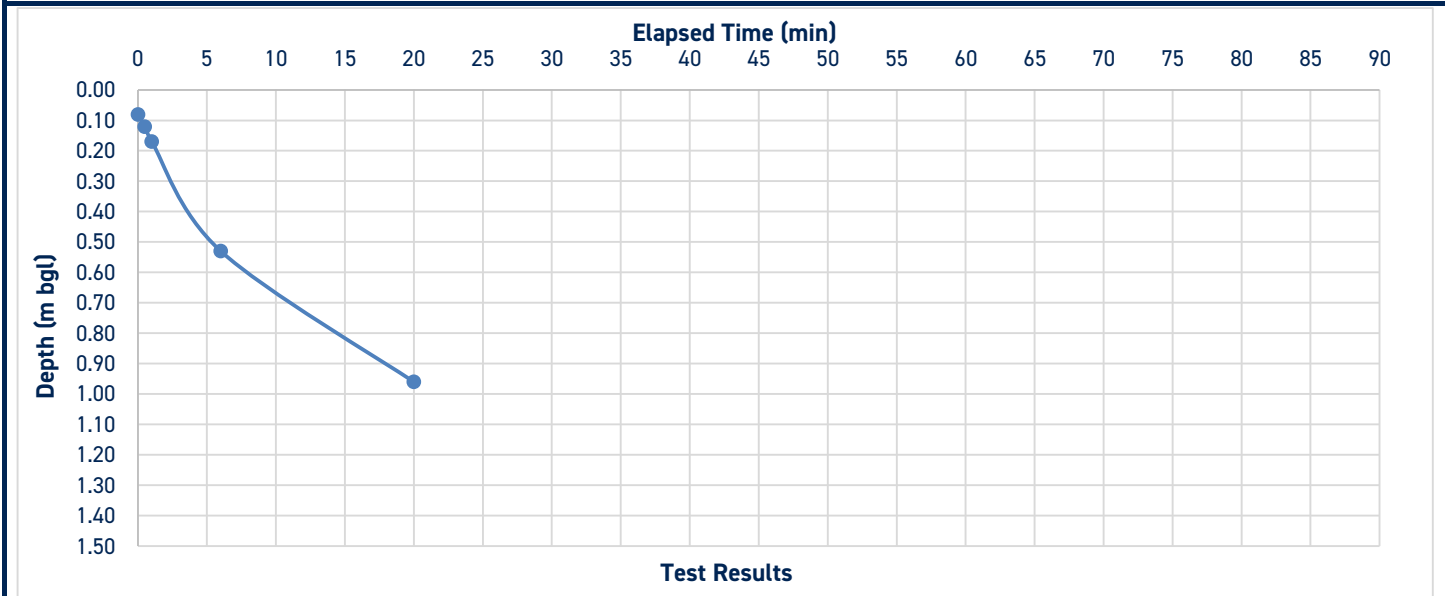
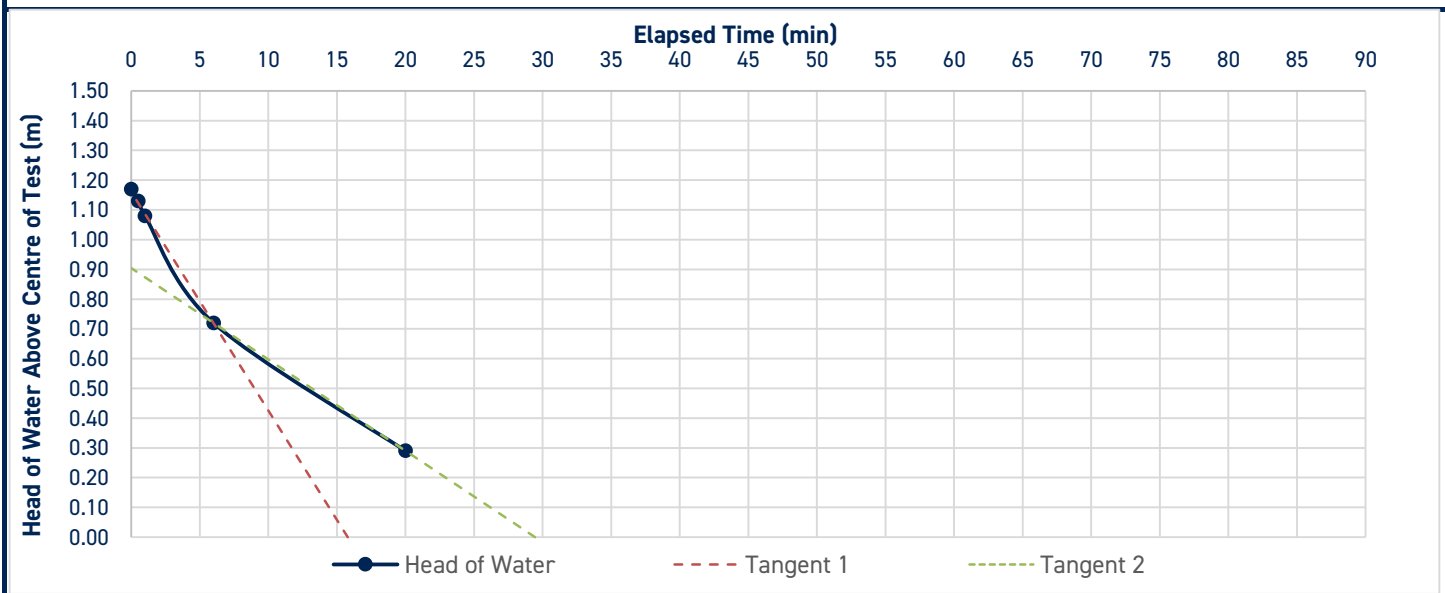
| Infiltration rate | 9.65E-05 | 4.03E-05 m/sec |
| Calculation method: | Variable (falling) head test method procedure carried out in general accordance with BS EN ISO 22282-2:2012. Infiltration rate calculated for each of the above given value of head of water using the tangent Head intercept (Hp) and the tangent Time intercept (th) and the area of exposed test section using the following formulae - $250.H_p.d^2/D.L.th$ | |
